EMERGENCY AIRWORTHINESS DIRECTIVE

DATE: September 17, 2003
AD #: 2003-19-51

Transmitted as follows is emergency airworthiness directive (AD) 2003-19-51, for the attention of all owners and operators of certain Bombardier Model CL-600-2C10 (Regional Jet Series 700 & 701) and CL-600-2D24 (Regional Jet Series 900) series airplanes.

2003-19-51 BOMBARDIER, INC. (Formerly Canadair): Docket No. 2003-NM-209-AD.

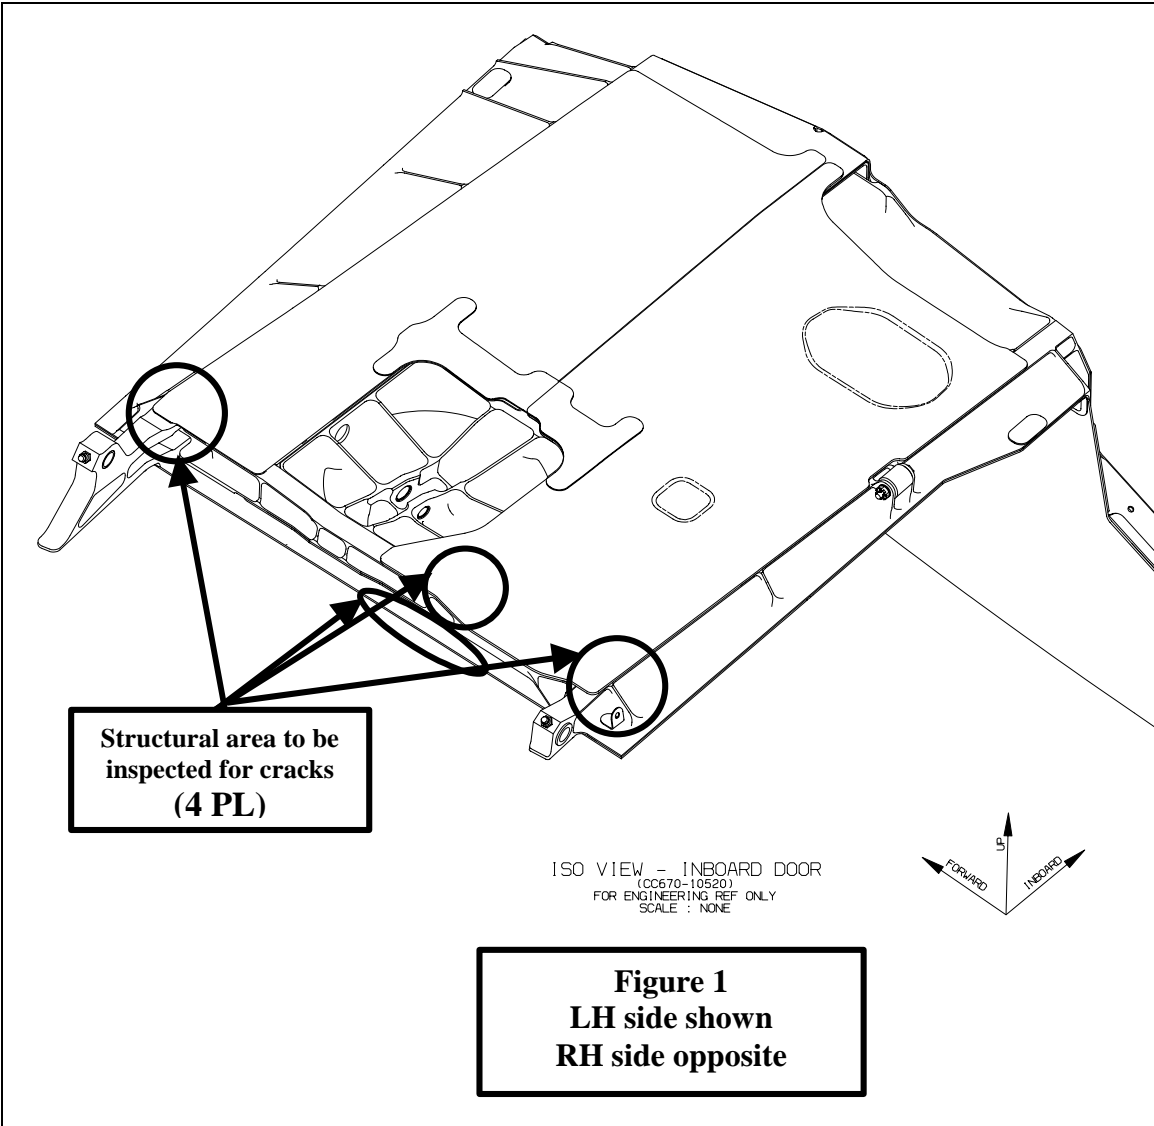
(b) Perform detailed inspections of the lower panel, P/N CC670-10520, of the left- and right-hand MLG doors for the conditions and in the areas specified in paragraphs (b)(1), (b)(2), (b)(3), and (b)(4) of this AD; and Figures 1, 2, and 3 of this AD.

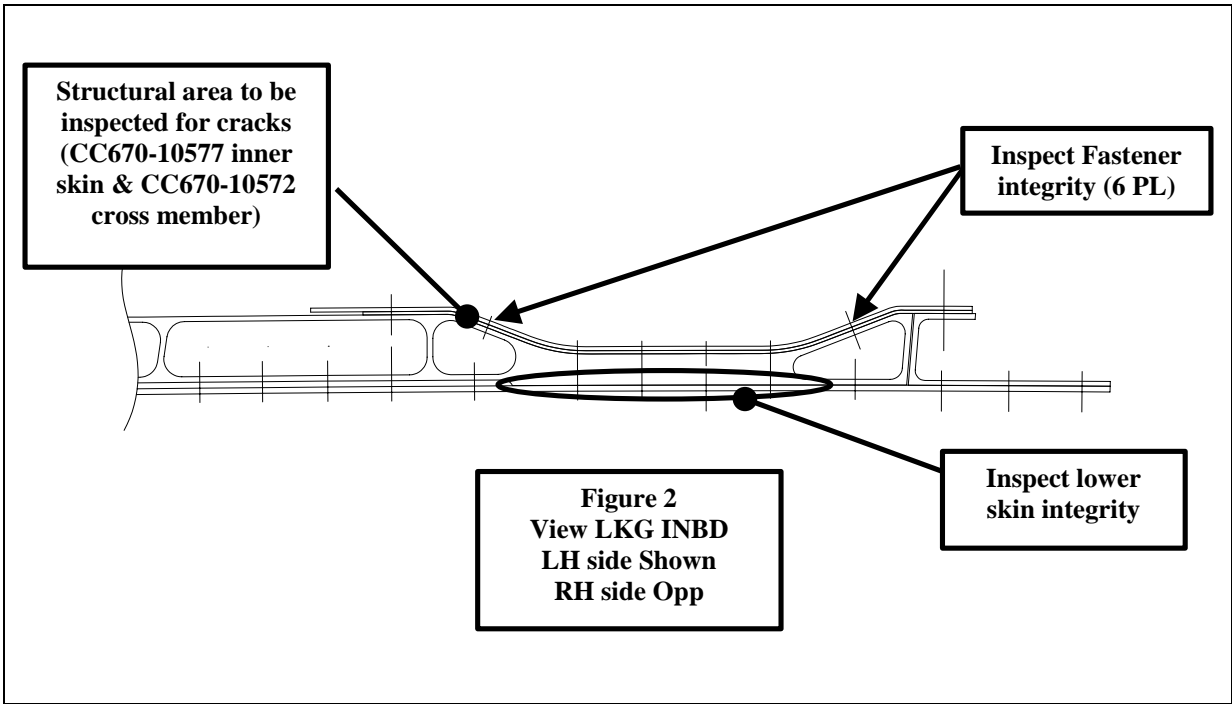
(1) Inspect the cross member, part number (P/N) CC670-10572, of the MLG door lower panel for cracking or deformation, in accordance with Figure 2 of this AD.

(2) Inspect the inner skin, P/N CC670-10577, of the MLG door lower panel at the cross member (P/N CC670-10572) for cracking or deformation, or pulled or missing fasteners, in accordance with Figure 2 of this AD.

(3) Inspect the outer skin, P/N CC670-10574, of the MLG door lower panel at the cross member (P/N CC670-10572) for cracking or deformation, or pulled or missing fasteners, in accordance with Figure 2 of this AD.

(d) If any cracking or deformation, or pulled or missing fastener, as applicable, is found during any inspection in accordance with paragraph (b) or (c) of this AD: Before further flight, accomplish paragraph (d)(1), (d)(2), or (d)(3) of this AD.

(1) Repair the damage in accordance with a method approved by either the Manager, New York Aircraft Certification Office (ACO), FAA; or Transport Canada Civil Aviation (or its delegated agent); and accomplish repetitive inspections in accordance with a method and at a repetitive interval approved by same.

(2) Replace the lower panel assembly, P/N CC670-10520, of the affected MLG door with a new or serviceable lower panel assembly having the same P/N, in accordance with Task Cards 32-12-01-000-801-A01 and 32-12-01-400-801-A01 of the CRJ 700/900 Series Regional Jet Aircraft Maintenance Manual; and repeat the inspections specified in paragraph (b) of this AD at intervals not to exceed 100 flight cycles.

(3) Remove the lower panel assembly, P/N CC670-10520, of the affected MLG door, and accomplish paragraph (d)(3)(i) or (d)(3)(ii), as applicable.

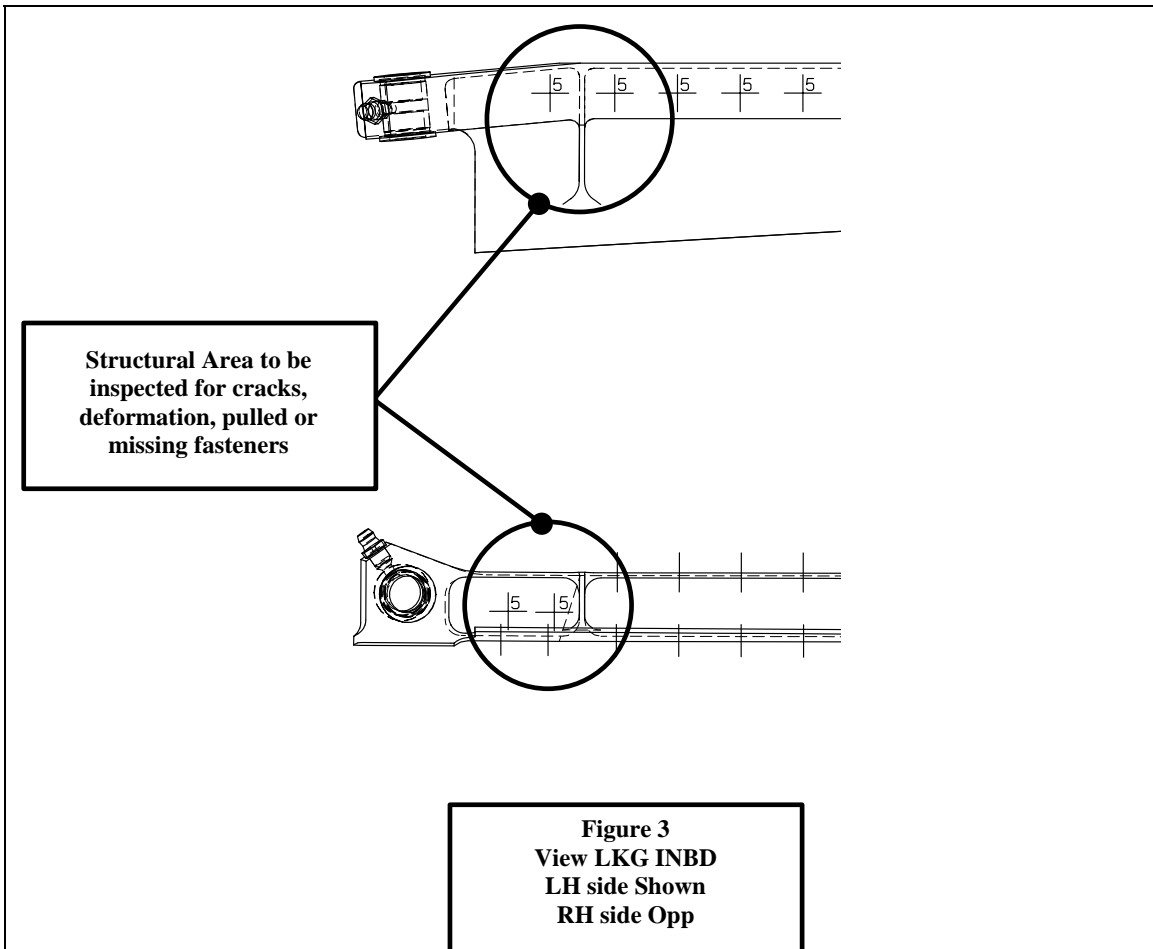
(4) Inspect the forward member, P/N CC670-10570, and aft member, P/N CC670-10571, of the MLG door lower panel, for cracking or deformation, or pulled or missing fasteners, in accordance with Figure 3 of this AD. Figures 1 through 3 of this AD follow.
