**[Docket No. 99-CE-85-AD; Amendment 39-12917; AD 2002-21-11]**

### **Airworthiness Directives; EXTRA Flugzeugbau GmbH Model EA-300S Airplanes**

## **2002-21-11 Extra Flugzeugbau GmbH:** Amendment 39-12917; Docket No. 99-CE-85-AD.

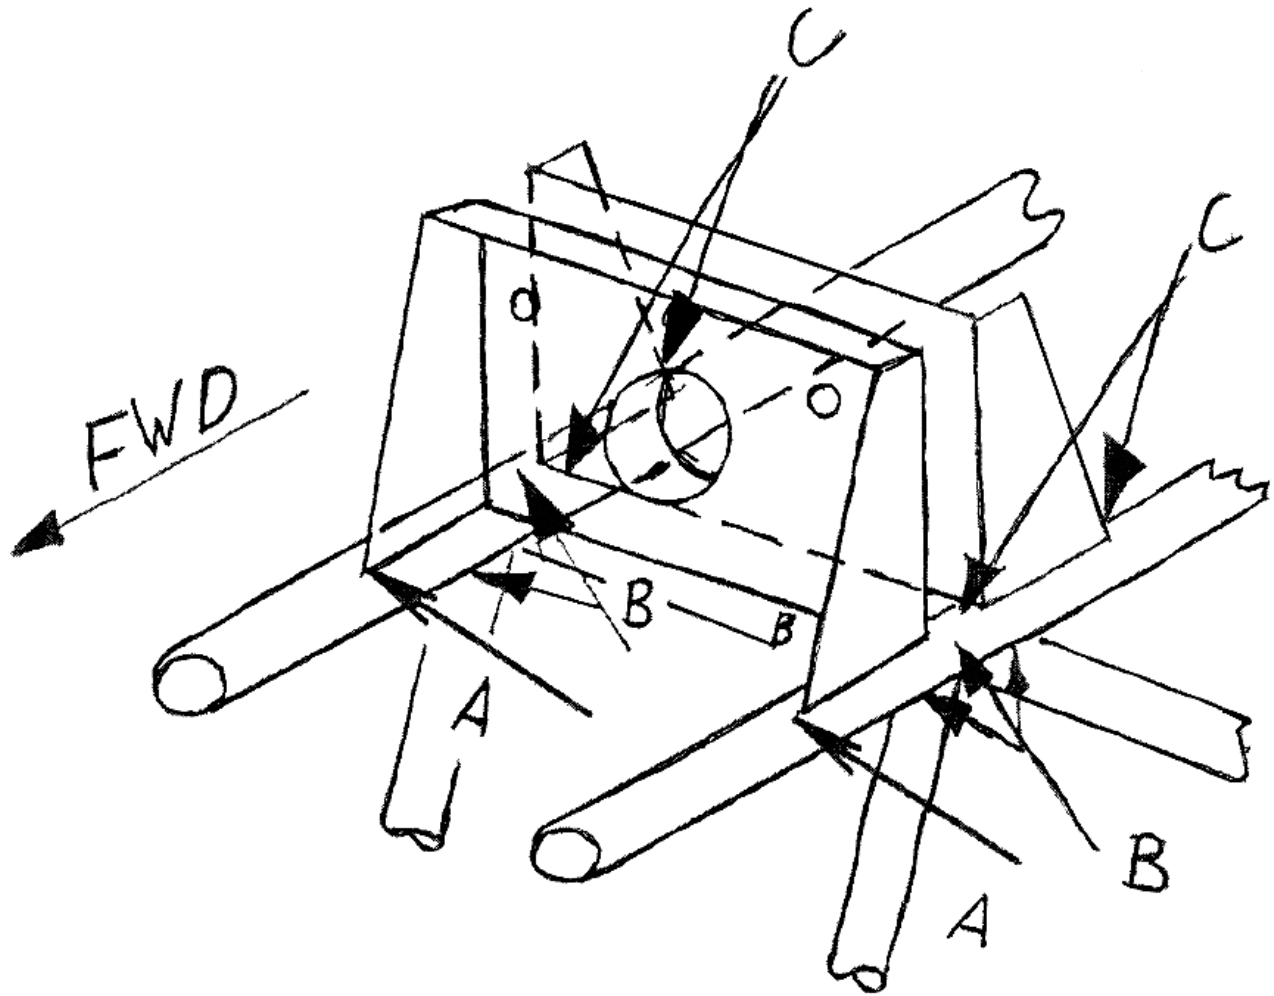
<b>Actions</b>	<b>Compliance</b>	<b>Procedures</b>
(1) For all affected airplanes, inspect, using a fluorescent dye penetrant method, the upper longeron at the horizontal stabilizer attachment for cracks in the areas depicted in Figure 1 of this AD.	Upon accumulating 250 hours time-in-service (TIS) or within the next 50 hours TIS after December 17, 2002 (the effective date of this AD), whichever occurs later.	In accordance with Part I of Extra Service Bulletin No. 300-2-95 (pages 2-6 at Issue: C, dated July 15, 1998; and pages 1 and 7 through 11 at Issue: D, dated January 30, 2001). No further action is required by this paragraph if the modification is already accomplished in accordance with Part II of Extra Service Bulletin No. 300-2-95 (all pages at Issue: C, dated July 15, stabilizer 1998).

<p>(3) For all affected airplanes, if any crack is found during the inspection required by this AD and the cracks(s) is (are) in Area A or Area B as depicted in Figure 1 of this AD, accomplish the following:</p> <p>(i) Repair and modify the upper longeron at the horizontal stabilizer attachment; and</p> <p>(ii) Weld the cracks tight during repair.</p>	<p>Prior to further flight after the inspection where any crack is found in Area A or Area B as depicted in Figure 1 of this AD.</p>	<p>In accordance with Part II of Extra Service Bulletin No. 300-2-95, Issue: D, dated January 30, 2001. No further action is required by this paragraph if already accomplished in accordance with Part II of Extra Service Bulletin No. 300-2-95 (all pages at Issue: C, dated July 15, 1998).</p>
<p>(4) For all affected airplanes, if any crack is found during the inspection and the crack(s) is (are) in Area C as depicted in Figure 1 of this AD, accomplish the following:</p> <p>(i) Obtain a repair scheme from the manufacturer;</p> <p>(ii) Incorporate this repair scheme; and</p> <p>(iii) Accomplish any follow-up actions as directed by the FAA.</p>	<p>Prior to further flight after the inspection where any crack is found.</p>	<p>In accordance with a repair scheme obtained from EXTRA Flugzeugbau GmbH, Flugplatz Dinslaken, D-46569 Hünxe, Federal Republic of Germany; telephone: (0 28 58) 91 37-00; facsimile: (0 28 58) 91 37-30. Obtain this repair scheme through the FAA at the address specified in paragraph (g) of this AD.</p>

(2) For all affected airplanes, if no crack(s) is (are) found during the inspection required by this AD, modify the upper longeron at the horizontal stabilizer attachment.	Prior to further flight after the inspection required by paragraph (d)(1) of this AD.	In accordance with Part II of Extra Service Bulletin No. 300-2-95 (pages 2-6 at Issue: C, dated July 15, 1998; and pages 1 and 7 through 11 at Issue: D, dated January 30, 2001). No further action is required by this paragraph if already accomplished in accordance with Part II of Extra Service Bulletin No. 300-2-95 (all pages at Issue: C, dated July 15, 1998).
