CF34 TURBOFAN (AIRLINE SERVICE)

GE Aircraft Engines

ALERT SERVICE BULLETIN

ENGINE - Fan Rotor Assembly (72-21-00) - Fan Disk Bore Tactile and Visual Inspection

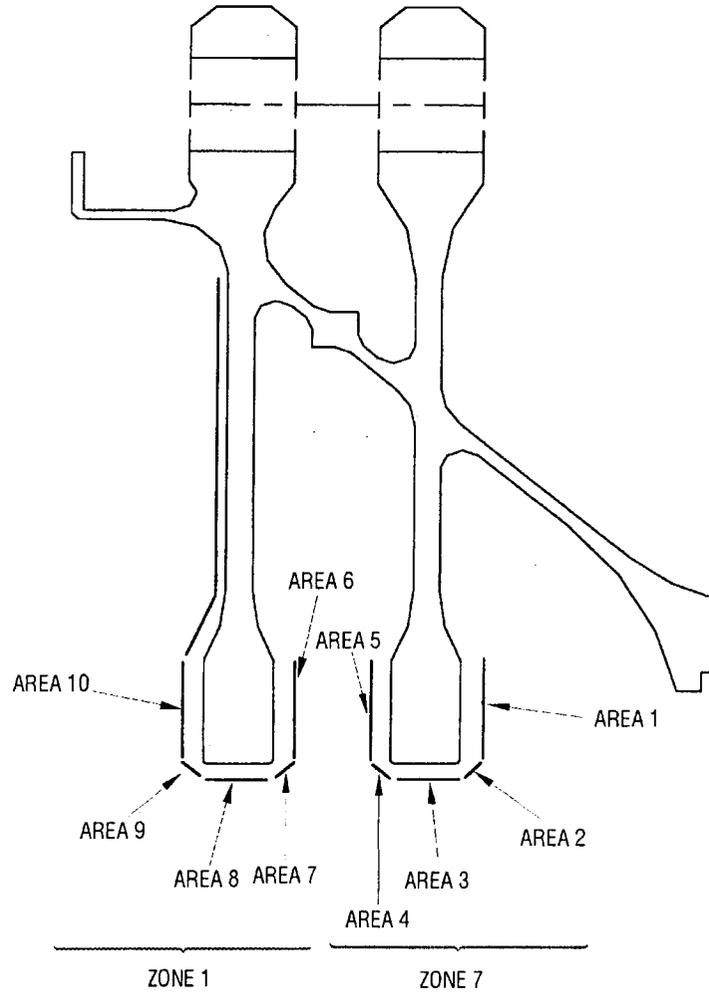
Bore Inspection Areas
Figure 1

NOTE 2: This Alert Service Bulletin is only for the inspection of zones 1 and 7 of the fan disk as defined in figure 1. Therefore, it is not required to remove the disk, fan blades, or fan blade pins to accomplish this inspection.

- Aft Bore Aft Corner (Area 2)
 - Aft Bore Inner Diameter (Area 3)
 - Aft Bore Forward Corner (Area 4)
 - Forward Bore Aft Corner (Area 7)
 - Forward Bore Inner Diameter (Area 8)

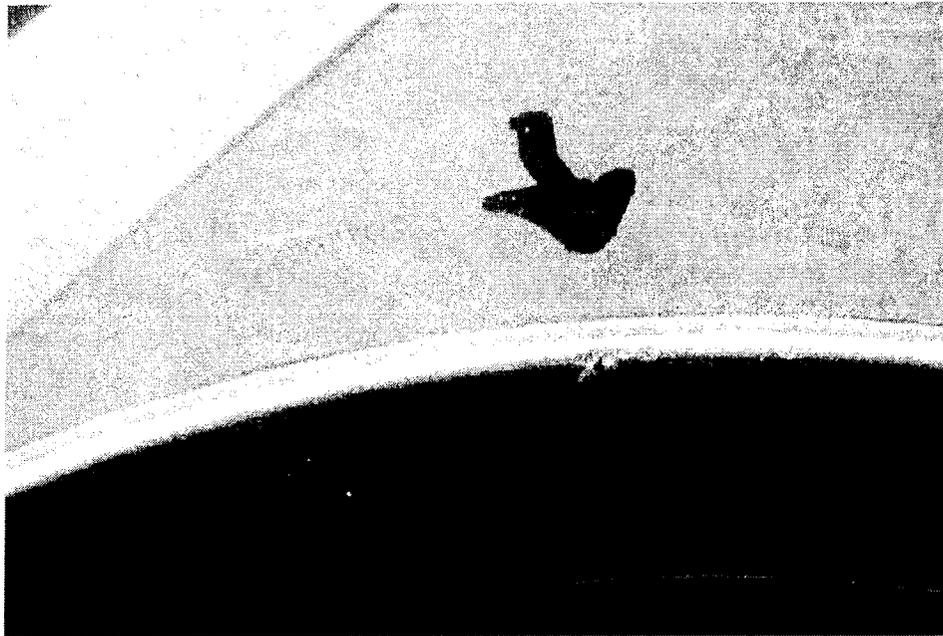
Detail of Arc-out on the Rim
Figure 2

1. ARC-OUTS CAN BE, BUT ARE NOT ALWAYS, DISCOLORED AREAS ON THE SURFACE OF THE DISK.
2. ARC-OUTS ARE OFTEN, BUT NOT ALWAYS, RAISED AREAS OF METAL ON THE SURFACE.

- (f) If arc-out indications are found, use the instructions in SEI-782 (72-00-21, REMOVAL AND INSTALLATION) and replace the fan disk with a new or serviceable fan disk.
- (g) If indications are found that are determined to not be arc-outs, refer to SEI-782 (72-00-21, INSPECTION).
- (h) Report all inspection results to Mike Harris in GE Product Support Engineering (michael.harris@ge.com) and your applicable Customer Support Manager.

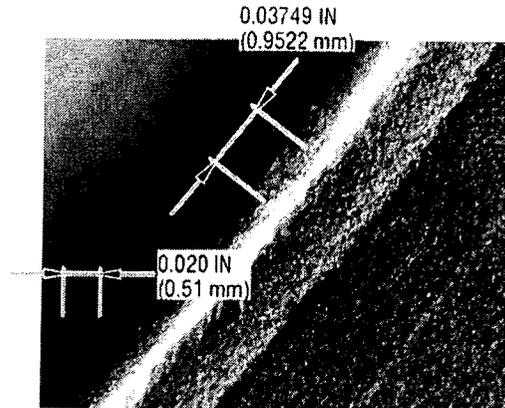
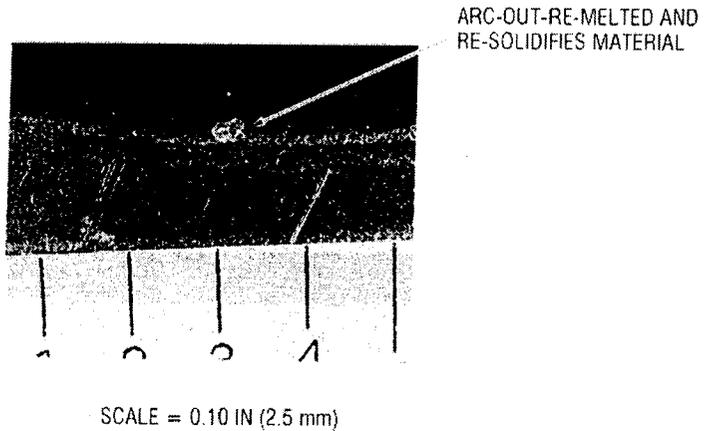
Detail of Arc-out at the Bore
Figure 3

NOTE:
ARC OUTS MAY BE SMALLER IN SIZE.

EXAMPLE OF AN ARC OUT

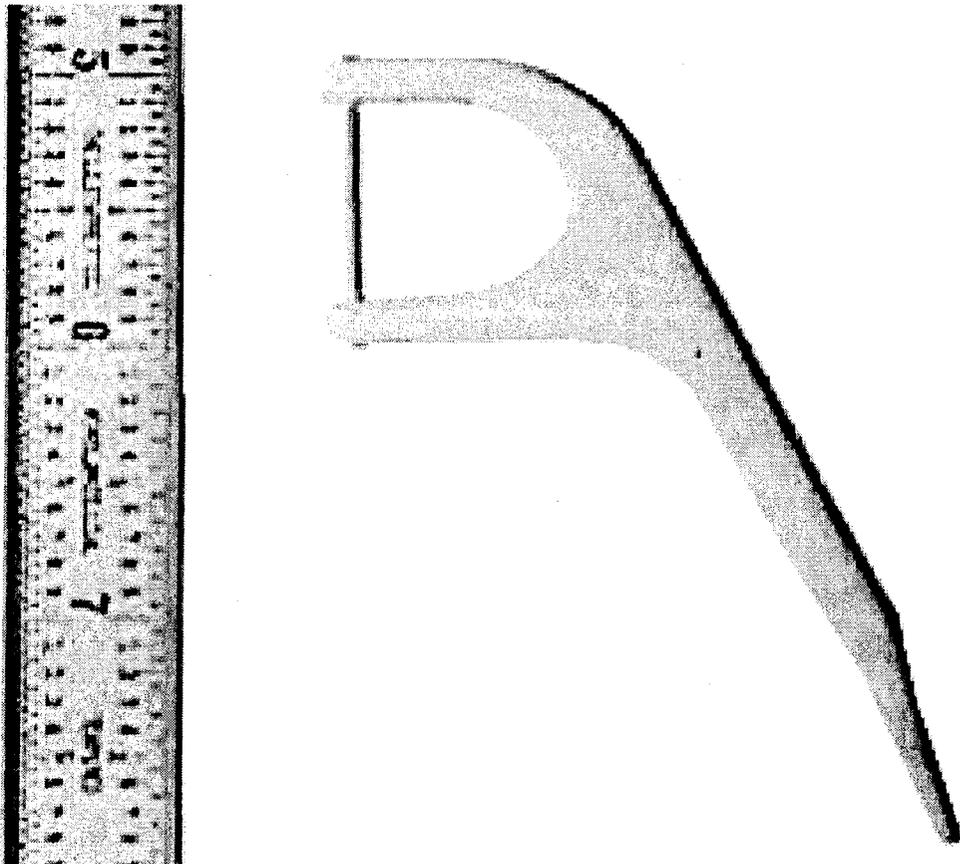
Inspection Tools for Checking Arc-out
Figure 4

- (c) Do a tactile inspection of the disk bores in zones 1 and 7 for indications.
- 1 Put your finger or a commercially available tactile inspection tool (figure 4) on one area listed below, starting with the aft bore aft corner (Area 2). Slowly rotate the fan for a total of two full rotations with finger or tool in contact with the area. Repeat the tactile inspection for each area of zones 1 and 7 listed below.

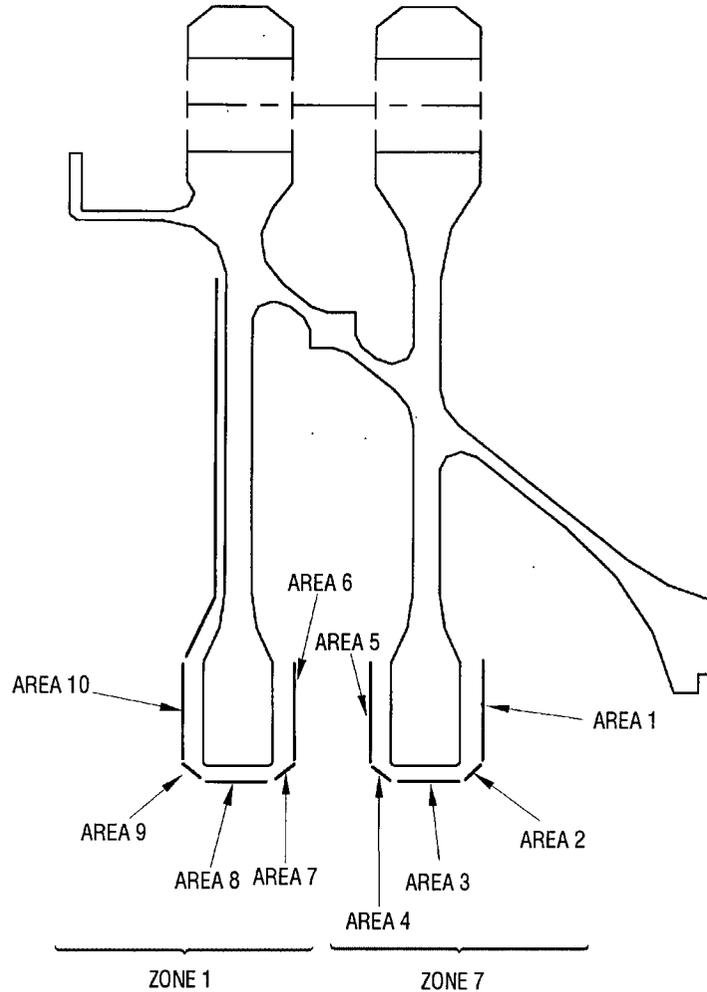
**Bore Inspection Areas
Figure 1**

NOTE 2: This Alert Service Bulletin is only for the inspection of zones 1 and 7 of the fan disk as defined in figure 1. Therefore, it is not required to remove the disk, fan blades, or fan blade pins to accomplish this inspection.

- Aft Bore Aft Corner (Area 2)
- Aft Bore Inner Diameter (Area 3)
- Aft Bore Forward Corner (Area 4)
- Forward Bore Aft Corner (Area 7)
- Forward Bore Inner Diameter (Area 8)
- Forward Bore Forward Corner (Area 9)

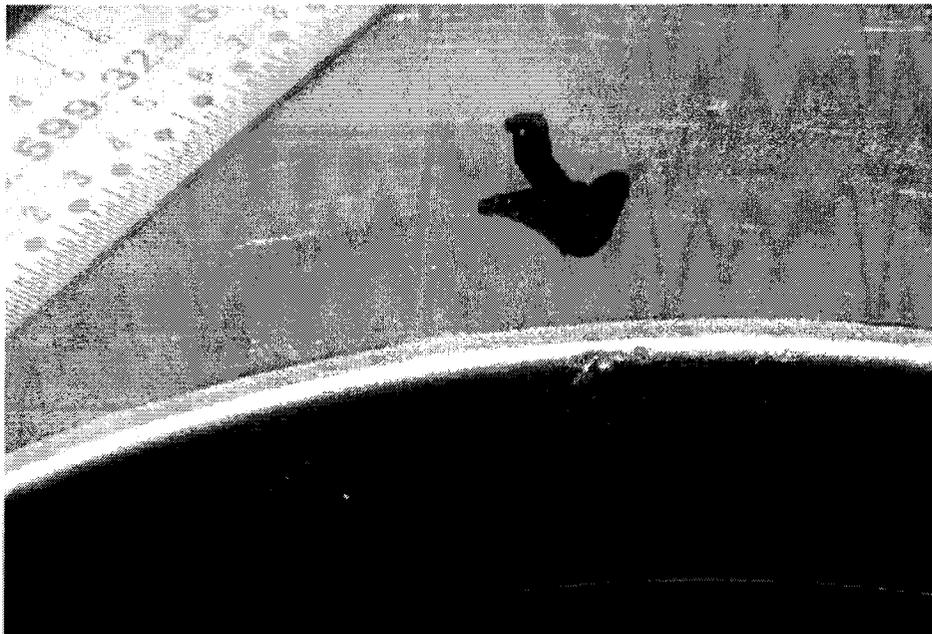
Detail of Arc-out on the Rim
Figure 2

1. ARC-OUTS CAN BE, BUT ARE NOT ALWAYS, DISCOLORED AREAS ON THE SURFACE OF THE DISK.
2. ARC-OUTS ARE OFTEN, BUT NOT ALWAYS, RAISED AREAS OF METAL ON THE SURFACE.

Scrap all fan disks that do not pass the inspection as defined by this Alert Service Bulletin.

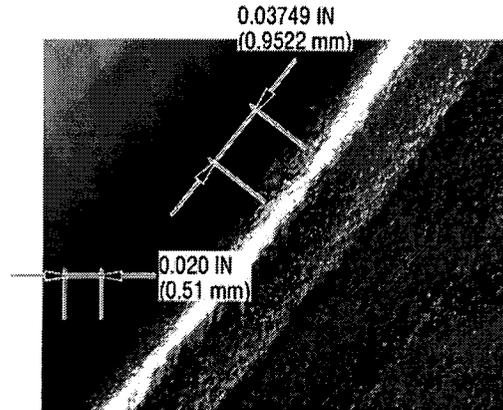
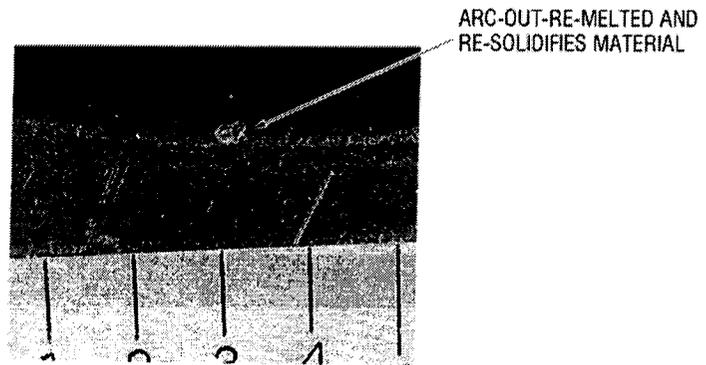
Detail of Arc-out at the Bore
Figure 3

NOTE:
ARC OUTS MAY BE SMALLER IN SIZE.

EXAMPLE OF AN ARC OUT

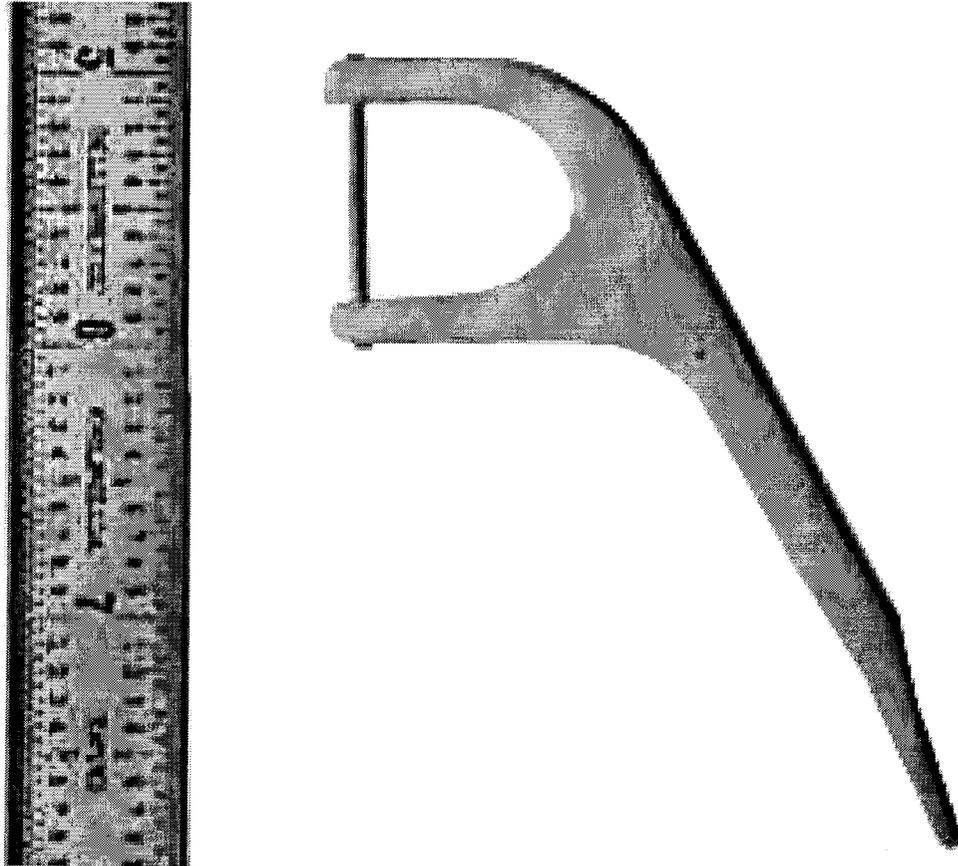
Inspection Tools for Checking Arc-out
Figure 4

- (b) Clean the fan disk bores zones 1 and 7 (figure 1) with isopropyl alcohol or acetone, or equivalent, and wipes. Make sure that all dirt is removed from the fan disk bores zones 1 and 7. Allow the disk to dry.
- (c) Do a tactile inspection of the disk bores in zones 1 and 7 for indications.
 - 1 Put your finger or a commercially available tactile inspection tool (figure 4) on one area listed below, starting with the aft bore aft corner (Area 2). Slowly rotate the fan for a total of two full rotations with finger or tool in contact with the area. Repeat the tactile inspection for each area of zones 1 and 7 listed below.
