[Docket No. FAA-2004-18850; Directorate Identifier 2004-SW-19-AD; Amendment 39-13771; AD 2004-16-15]

Airworthiness Directives; Eurocopter France Model AS-365N2, AS 365 N3, EC 155B, EC155B1, SA-365N and N1, and SA-366G1 Helicopters

2004-16-15 Eurocopter France: Amendment 39-13771. Docket No. FAA-2004-18850; Directorate Identifier 2004-SW-19-AD.

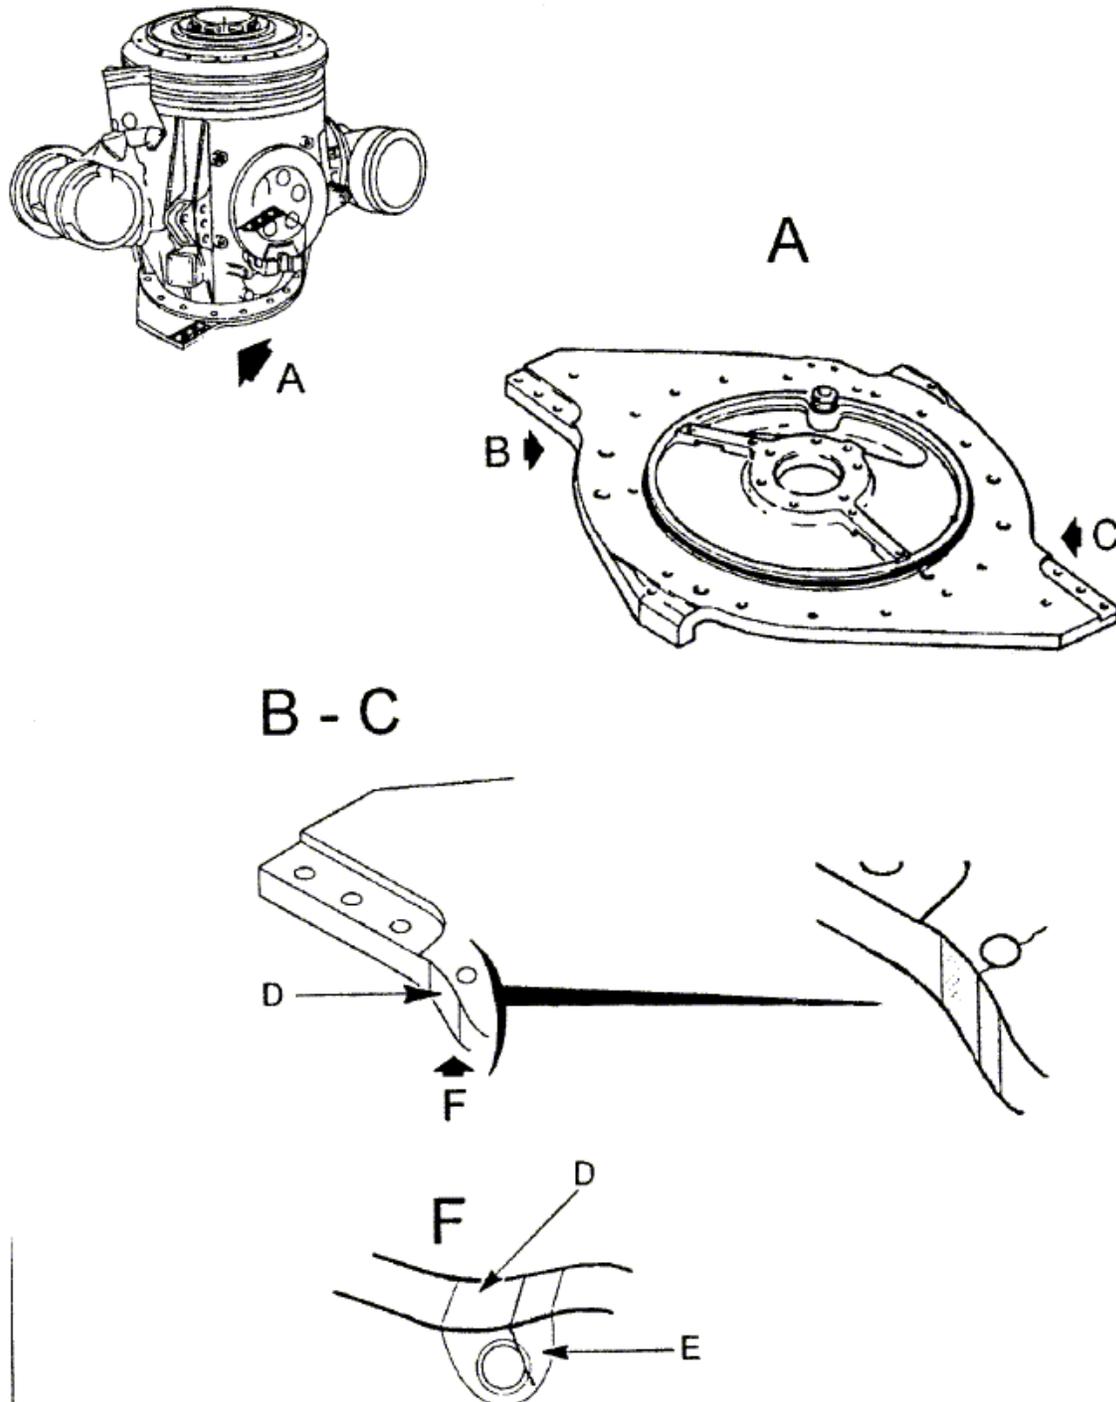
Figure 1

To detect a crack in the MGB base plate and prevent failure of a MGB attachment point to the frame, which could result in severe vibration and subsequent loss of control of the helicopter:

(a) Before the initial inspection at the time indicated in the compliance table, strip the paint from area "D" on both sides ("B" and "C") of the MGB base plate as depicted in Figure 1.

(b) At the times indicated in the compliance table, inspect area "D" of the MGB base plate for a crack using a 10x or higher magnifying glass.

(c) If a crack is found in a MGB base plate, remove and replace the MGB with an airworthy MGB before further flight.
