AIRWORTHINESS DIRECTIVE

AD #: 2012-03-52

Emergency Airworthiness Directive (AD) 2012-03-52 is sent to owners and operators of Mooney Aviation Company, Inc. (Mooney) Models M20TN and M20R airplanes.

2012-03-52 **Mooney Aviation Company, Inc. (Mooney)**: Directorate Identifier 2012-CE-005-AD.

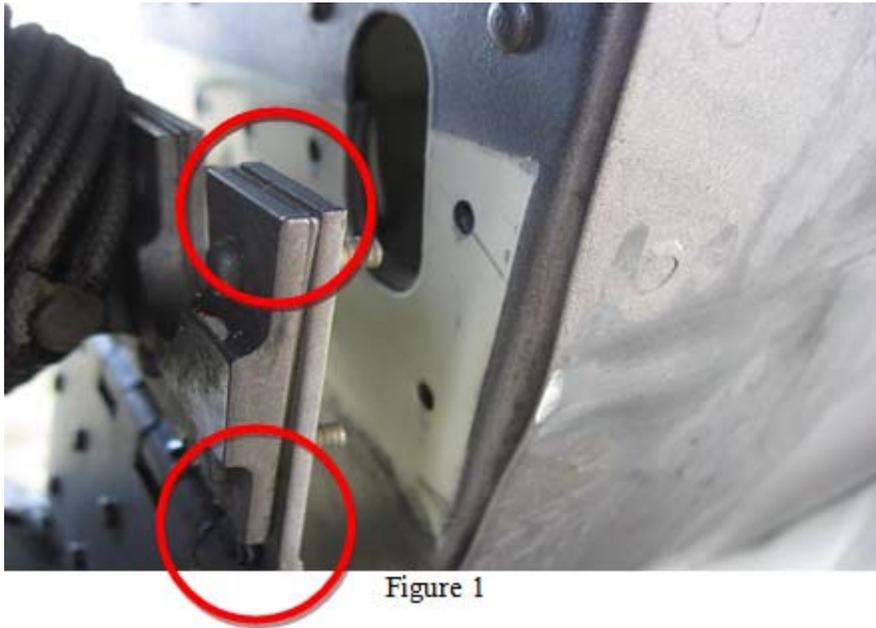
Figure 1

This aircraft was immediately inspected, and all 10 swaged collars that hold the tail trim assembly together had become unattached.

Mooney inspected several other aircraft and found that on one airplane the filler plate was incorrectly installed. The filler plate was not correctly installed between the aft side of the hinge and the bulkhead. Instead, the filler plate was located on the forward side of the hinge between the hinge and trim fitting. It was then noted the incident aircraft had the same issue, as shown in the upper circle of figure 1.

Because the hinge has a lip on the bottom, on the side toward the bulkhead (as shown in the bottom circle of figure 1), if the filler plate is not installed correctly, the hinge will not fit flush against the bulkhead, the Huck Bolt fasteners will not fit perpendicular to the bulkhead, and the collars will not swage properly. The condition also causes excessive tension pre-load on the Huck Bolts.

The incident aircraft was manufactured in 2008. Mooney has determined the incorrect installation was a manufacturing quality escape during production.

Before further flight after receipt of this emergency AD, inspect the trim fitting, hinge, and filler plate of the tail pitch trim assembly for correct positioning and proper attachment; and also inspect that the Huck Bolt fasteners are properly secured following Mooney Aviation Company, Inc. Service Bulletin No. M20-313, dated February 7, 2012.

If during the inspection required in paragraph (g) of this AD you find incorrect positioning or improper attachment of the trim fitting, hinge, and filler plate of the tail pitch trim assembly; and/or you find loose or improperly installed Huck Bolt fasteners, before further flight, contact Mooney for FAA-approved repair instructions and perform the repair. Use the contact information found in paragraph (m)(2) of this AD.
