# EMERGENCY AIRWORTHINESS DIRECTIVE

**AD #: 2007-05-51**

**2007-05-51 MD Helicopters Inc. (MDHI): Directorate Identifier 2007-SW-05-AD.**

Applicability: Model MD600N helicopters, with a lateral mixer output link assembly (mixer link), part number (P/N) 600N7636-1, -3, -9, or -11 installed, certificated in any category.

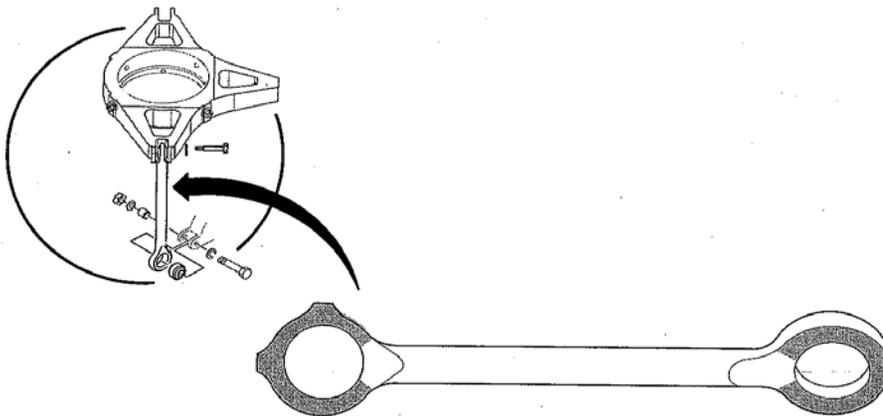
Figure 1

This Emergency Airworthiness Directive (AD) is prompted by the discovery of a cracked lateral mixer output link assembly (mixer link), part number (P/N) 600N7636-1, on an in-service MDHI Model MD600N helicopter. Cracks were also found on two additional mixer links, P/N 600N7636-3, which were being held as spares. The cracks on all three mixer links run through the bearing end area of the mixer link and emanate from staking marks in the mixer link. Cracks in the mixer link, if not detected, could result in failure of the mixer link and subsequent loss of control of the helicopter.

(1) Remove each mixer link and visually inspect, with a bright light and a 10x or higher magnifying glass, the shaded areas around the bearing bore for any crack as depicted in the following Figure 1:

(2) Perform an eddy current inspection of each mixer link in the bearing end areas.

(3) Replace any cracked mixer link with an airworthy mixer link on which an eddy current inspection has been performed.
