[Docket No. 2002-SW-15-AD; Amendment 39-12817; AD 2002-14-17]

Airworthiness Directives; Eurocopter Deutschland GmbH Model EC135 Helicopters

AD 2002-14-17 Eurocopter Deutschland GMBH: Amendment 39-12817. Docket No. 2002-SW-15-AD. Supersedes AD 99-12-01, Amendment 39-11217, Docket No. 99-SW-38-AD.

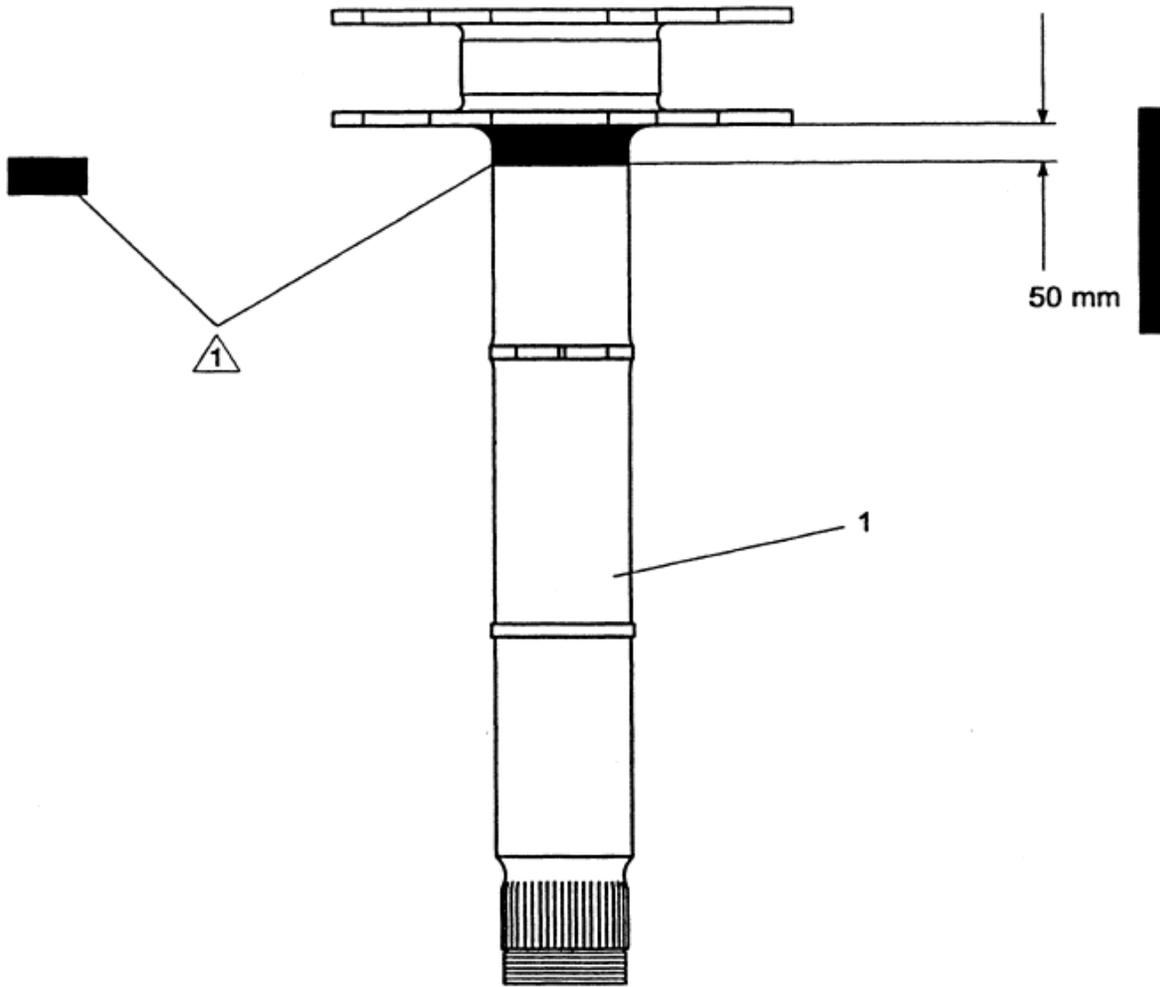
Crack inspection on main rotor hub-shaft
Figure 1

(a) Before further flight, clean and visually inspect the shaft for cracks in the area as shown in the following Figure 1:

⚠ Inspect marked area i.a.w. crack inspection procedure described.

1 Main Rotor Hub-Shaft

(b) Within 10 hours time-in-service (TIS) after accomplishing the visual inspection required by paragraph (a) of this AD, clean and dye-penetrant inspect the shaft for cracks in the area as shown in Figure 1 of this AD.

(c) Thereafter, visually inspect the shaft for cracks in accordance with paragraph (a) of this AD at intervals not to exceed 15 hours TIS, or dye-penetrant inspect the shaft for cracks in accordance with paragraph (b) of this AD at intervals not to exceed 100 hours TIS.

(d) If a crack is discovered during any shaft inspections, remove the shaft and replace it with an airworthy shaft.
