**[Docket No. FAA-2013-0695; Directorate Identifier 2011-NM-264-AD; Amendment 39-17726; AD 2014-01-03]**

#### **Airworthiness Directives; Saab AB, Saab Aerosystems Airplanes**

**ACTION:** Final rule.

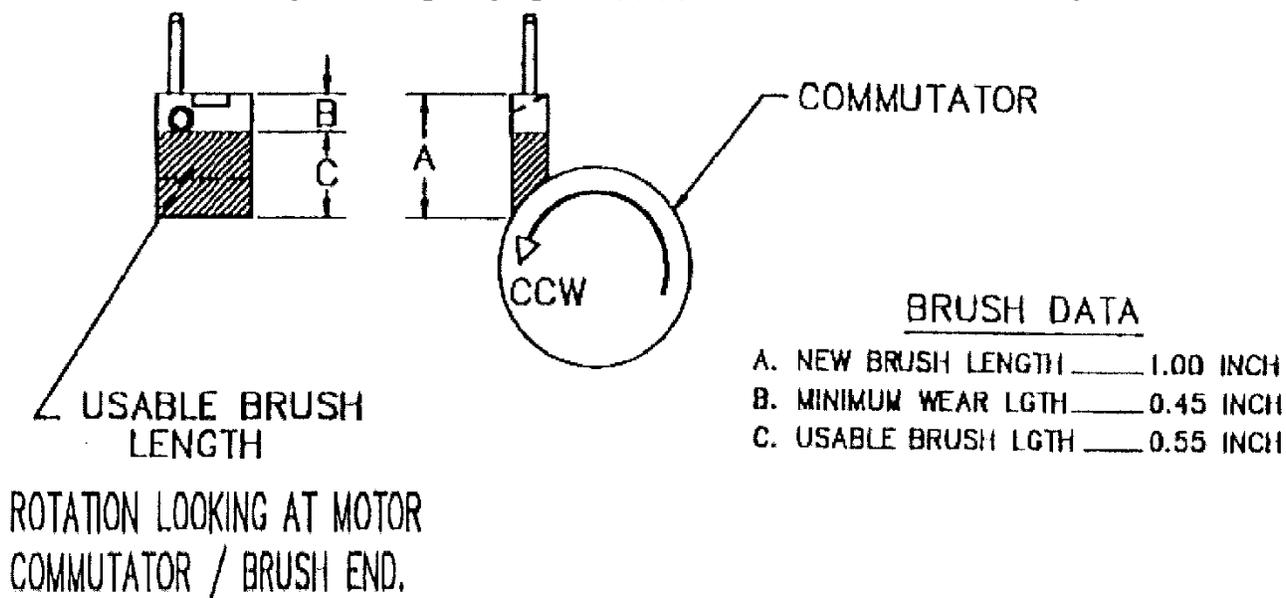
Figure 1 to paragraph (m)(4)(vii) of this AD – Measuring the Brush

- (vi) Lift brush spring and remove brush with wire hook or scribe.
  - (vii) Measure each brush as shown in figure below and record values.

(viii) Using the brush with the shortest measured length, calculate the wear by subtracting the measured value from 1.000 inch.

(11) Install each new brush set by lifting brush springs, sliding brush into holder (with brush leading edge in direction of motor rotation) and lightly releasing the brush spring on the brush. (See Figure 1 to paragraph (m)(4)(vii) of this AD.) CAUTION: Do not allow brush spring to strike hard into place or damage to brush may result.

(ix) Replace brushes in accordance with the instructions specified in paragraphs (j)(9) through (j)(23) of this AD.
