[Docket No. FAA-2011-1115; Directorate Identifier 2010-SW-011-AD; Amendment 39-17017; AD 2012-08-01]

Airworthiness Directives; Sikorsky Aircraft Corporation Helicopters

ACTION: Final rule.

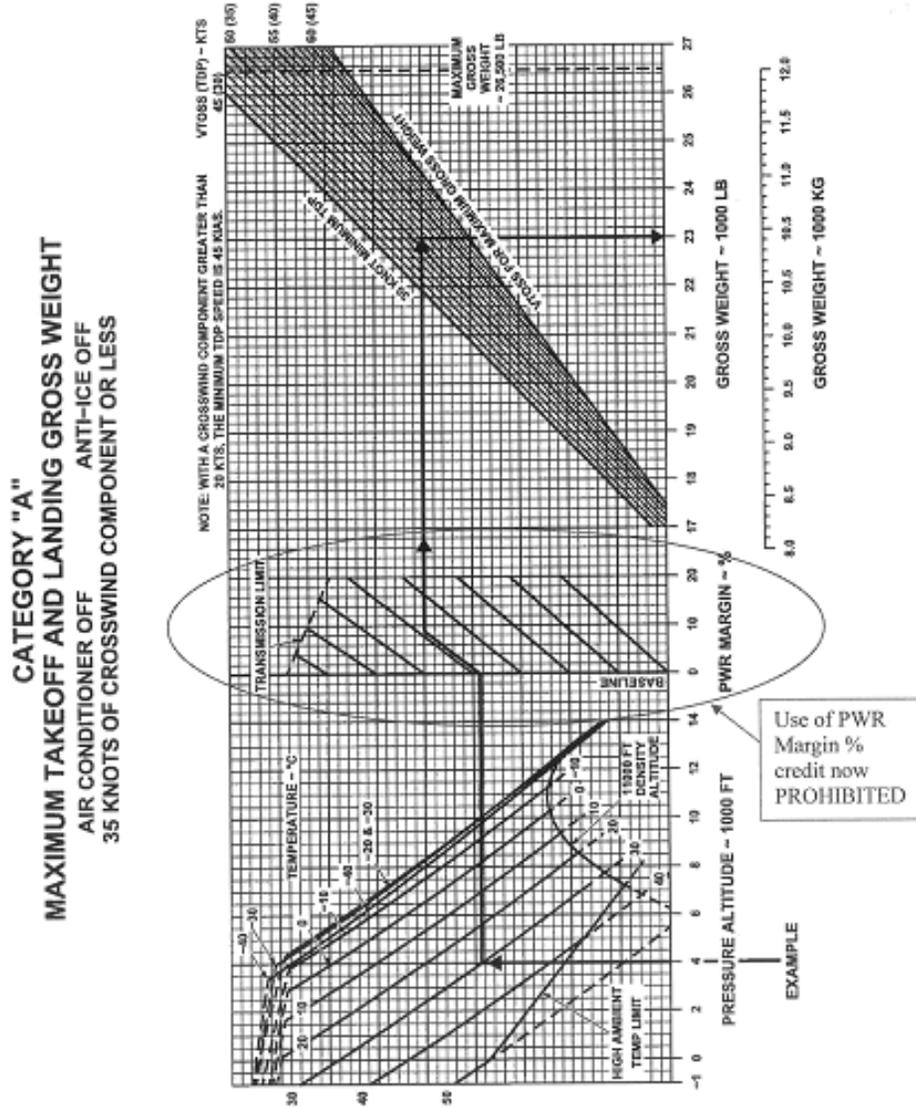
Figure 1: Cat 'A' Takeoff and Landing Gross Weight

(2) If the RFM already contains the revisions appropriate for your helicopter as listed in the following Table 1, all dated April 9, 2008, with the correct performance charts, without the performance credit as depicted in the circled area of Figure 1 of this AD, the operating limitation required by paragraph (1) of this AD does not need to be inserted into the RFM.

Note to paragraph (e)(2) of this AD: Previous RFM revisions allowed for the use of above-specification engine power margin as depicted in the circled area of Figure 1 of this AD.

(1) By making pen and ink changes, insert into the Operating Limitations section, Part 1, Section 1, Weight Limits, of Rotorcraft Flight Manuals (RFMs) SA S92A-RFM-002, -003, -004, -005, and -006 the following limitation "Performance credit for above specification engine power margin is prohibited."
