**[Docket No. FAA-2015-1937; Directorate Identifier 2014-SW-067-AD; Amendment 39-18171; AD 2015-11-08]**

#### **Airworthiness Directives; Agusta S.p.A. (Agusta) Helicopters**

**ACTION:** Final rule; request for comments.

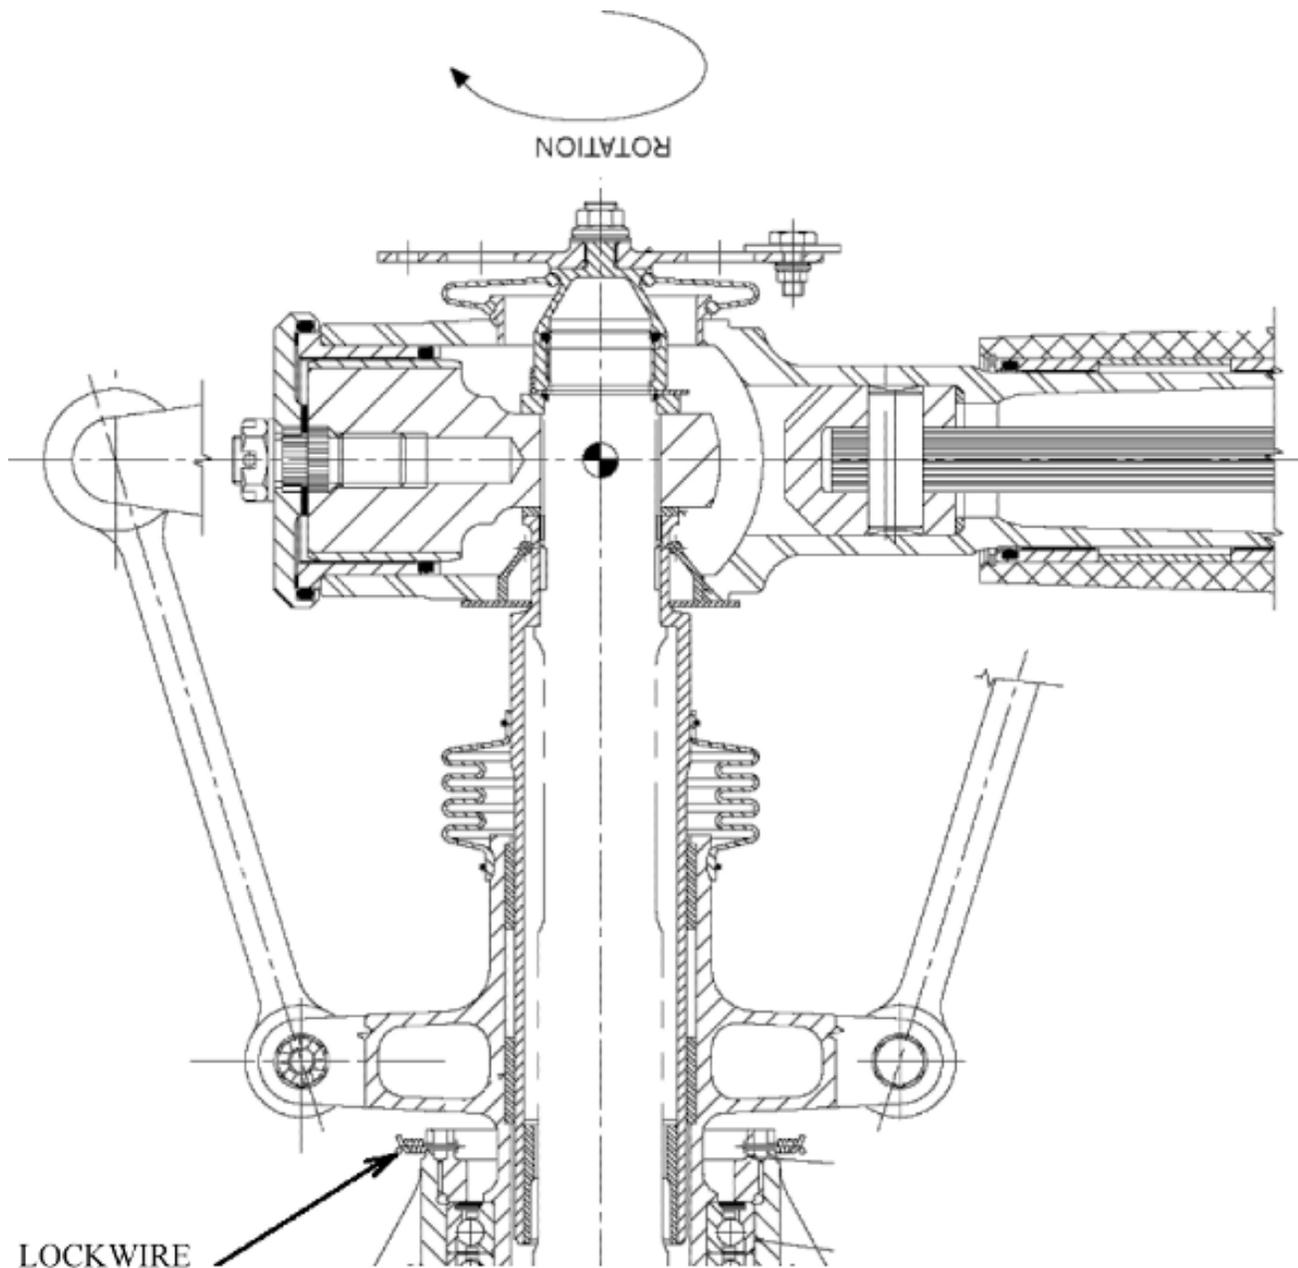
**Figure 1 of paragraph (f)(1)**

This AD defines the unsafe condition as a missing or broken lock wire securing the tail rotor (T/R) duplex bearing locking nut (locking nut). This condition could result in loosening of the locking nut, failure of the T/R, and subsequent loss of control of the helicopter.

(1) Within 24 hours and thereafter before the first flight of each day or at intervals not exceeding 24 hours, whichever occurs later, check each lock wire securing the T/R locking nut to the housing. The location of the housing wire is depicted in Figure 1 to paragraph (f)(1) of this AD.

(4) If one or both lock wires are missing or damaged, before further flight, remove and reassemble the housing and slider group of the T/R rotating controls.
