[Docket No. FAA-2012-0008; Directorate Identifier 2011-NE-43-AD; Amendment 39-17115; AD 2012-14-01]

Airworthiness Directives; Rolls-Royce Deutschland Ltd & Co KG Turbofan Engines

ACTION: Final rule.

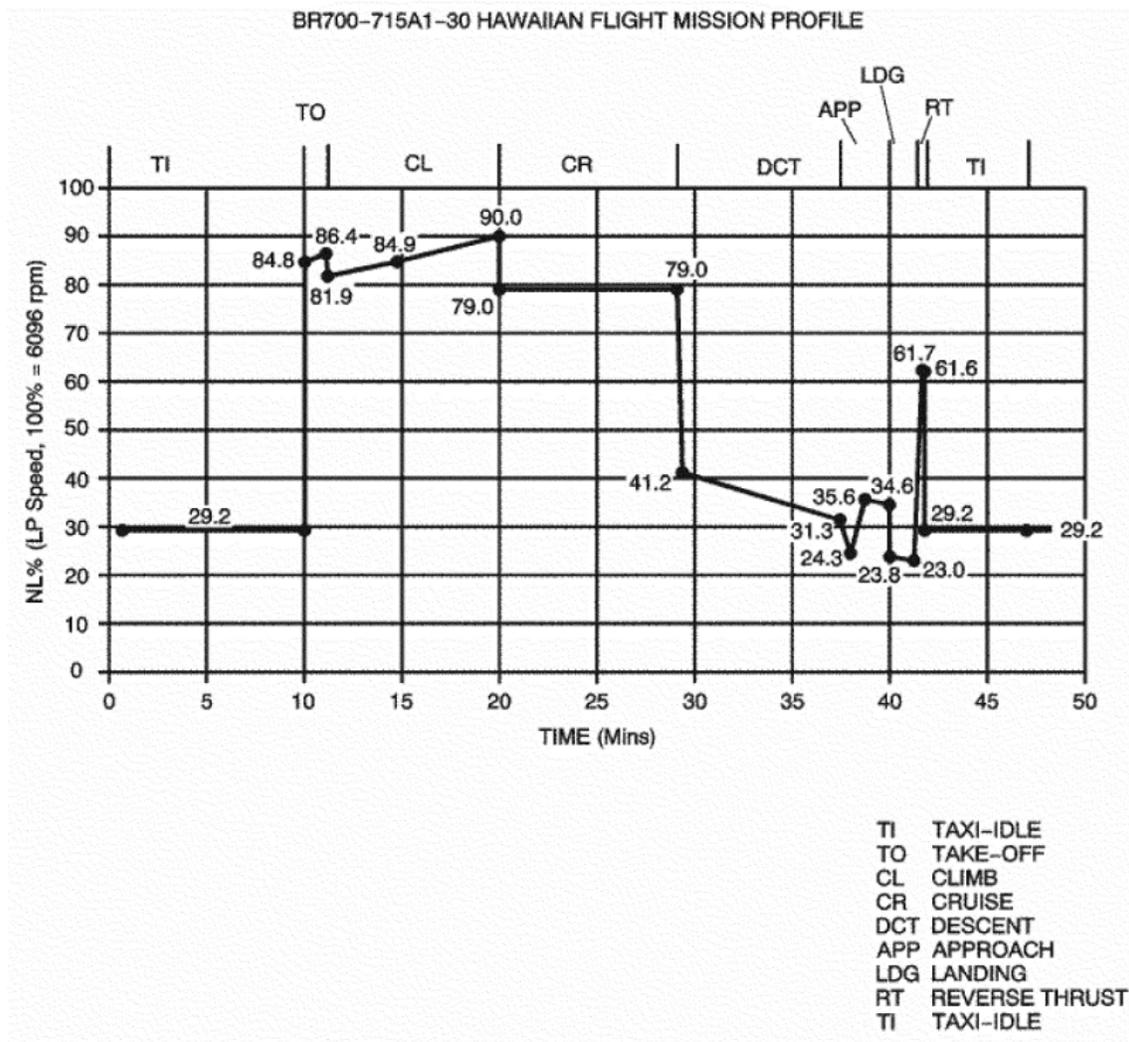
Figure 1 to paragraph (f)(2)

(2) The Hawaiian Flight Mission referenced in Table 1 to paragraph (e) is shown in Figure 1 to paragraph (f)(2):
