**[Docket No. 2002-NE-07-AD; Amendment 39-12760; AD 2002-10-14]**

### **Airworthiness Directives; Bombardier-Rotax GmbH 914 F Series Reciprocating Engines**

**2002-10-14 Bombardier-Rotax GmbH:** Amendment 39-12760. Docket No. 2002-NE-07-AD.

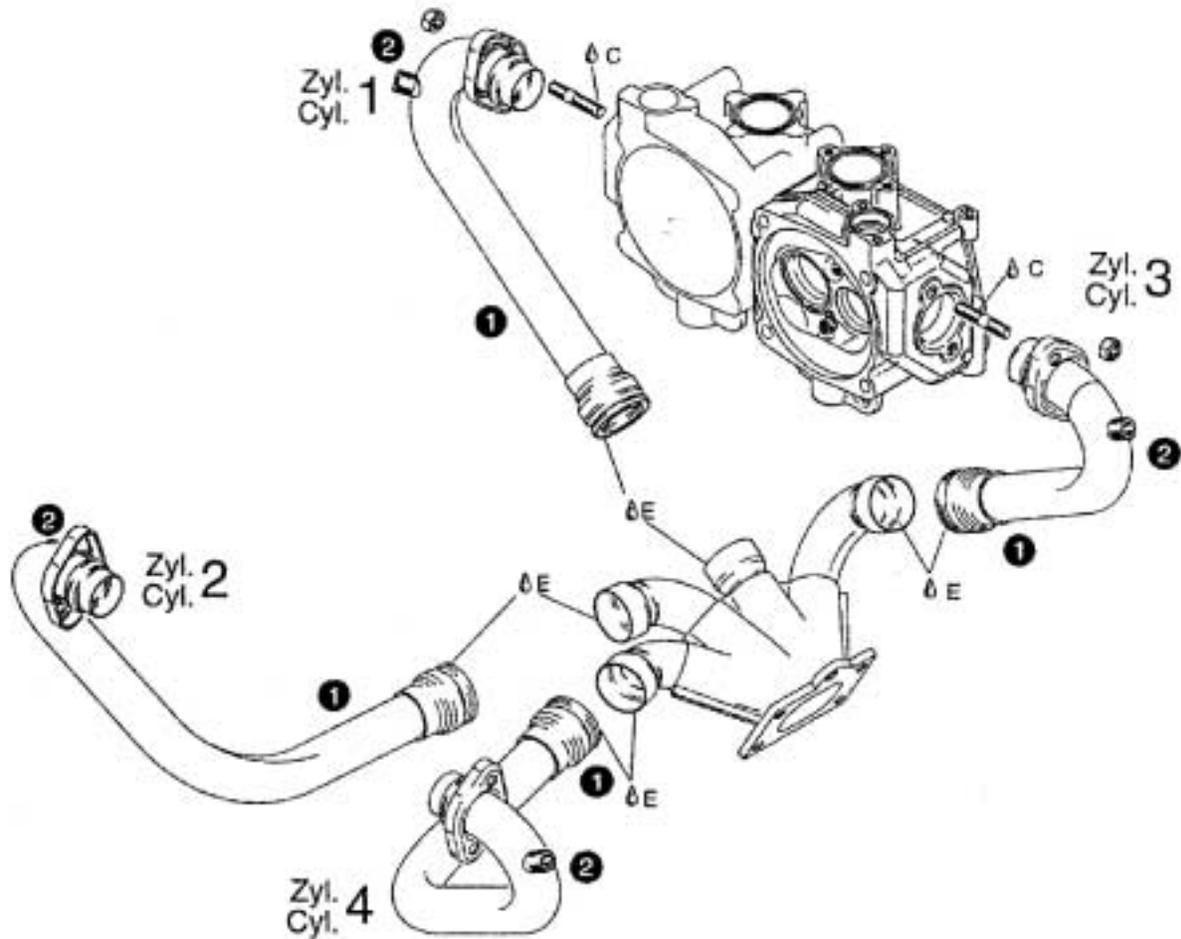
**Figure 1**

**SUPPLEMENTARY INFORMATION:** Austro Control, which is the airworthiness authority for Austria, recently notified the FAA that an unsafe condition may exist on Bombardier-Rotax GmbH 914 F series reciprocating engines. Austro Control advises that cracks found in exhaust bend assemblies, which are located between the cylinder heads and exhaust manifold assembly have been detected in service. Bombardier-Rotax GmbH is continuing to evaluate the unsafe condition and may implement a design change as terminating action.

(a) Within 50 hours time-in-service (TIS) after the effective date of this AD, visually inspect the exhaust bend assemblies (item 1, Figure 1, of this AD), located between the cylinder heads and exhaust manifold assembly, for exterior traces of smoke, cracks, and damage, especially around the exhaust gas temperature (EGT) bosses (item 2). Replace any exhaust bend assembly found cracked. Figure 1 follows:

- 1) Exhaust Bend Assembly
- 2) EGT Boss

(b) Thereafter, inspect the exhaust bend assemblies every additional 50 hours TIS. Replace any exhaust manifold assembly found cracked.

(c) If any exhaust bend assembly is replaced, perform a ground test run and exhaust leakage test.
