**[Docket No. FAA-2008-1207; Directorate Identifier 2007-NE-47-AD; Amendment 39-15880; AD 2009-08-07]**

#### **Airworthiness Directives; Honeywell International Inc. ALF502L-2 and ALF502L-2C Turbofan Engines**

**ACTION:** Final rule.

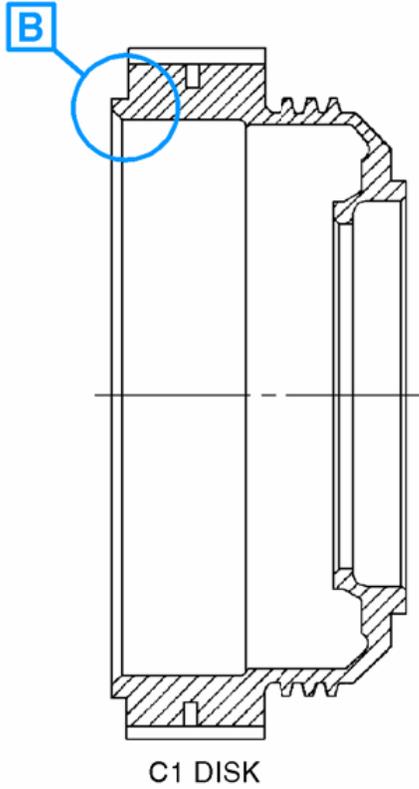
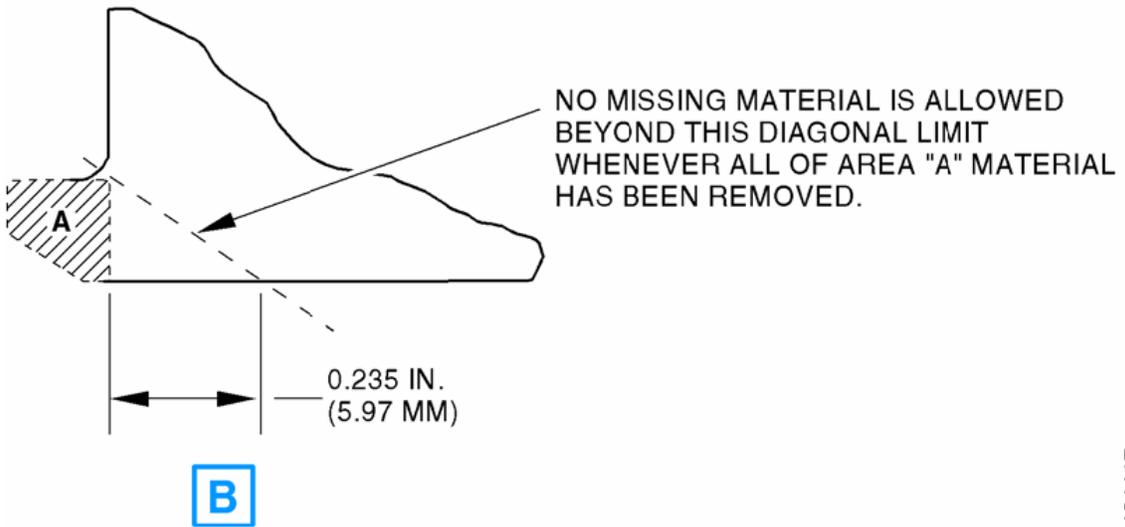
Limits for Removed Balance Material, Disc Forward Flange  
Figure 1 (Sheet 1 of 2)

(d) This AD results from reports of discs found with excessive material removed from the balancing locations of the disc. We are issuing this AD to prevent the discs from fracturing before reaching the currently published life limit. A disc fracture could result in an uncontained failure of the disc and damage to the airplane.

(f) For discs with 5,000 or more cycles-since-new on the effective date of this AD, perform a dimensional inspection of the HPC first stage disc to determine if excessive disc balance material was removed. See the following Figure 1 for limits.

(g) Replace the disc if excessive disc balance material was removed. See limits in Figure 1 of this AD.

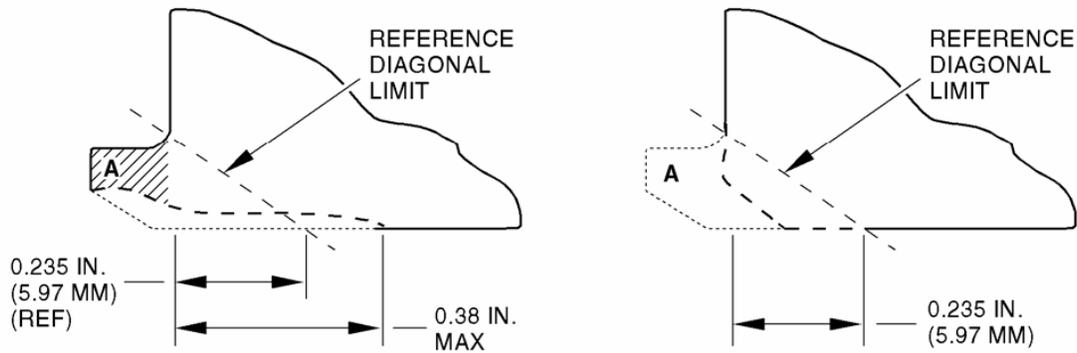
Limits for Removed Balance Material, Disc Forward Flange  
Figure 1 (Sheet 2 of 2)

EXAMPLES OF ACCEPTABLE REMOVED MATERIAL CONDITION

Any remaining Area 'A' lip material is sufficient to permit axial material removal up to 0.38 inch (0.97 mm) limit. Surface shall have a smooth contour and 0.020 inch (0.51 mm) minimum blend radius.

Removal of all Area 'A' material is permitted when axial material removal is less than 0.235 inch (5.97 mm) diagonal limit. Surface shall have a smooth contour and 0.020 inch (0.51 mm) minimum blend radius.

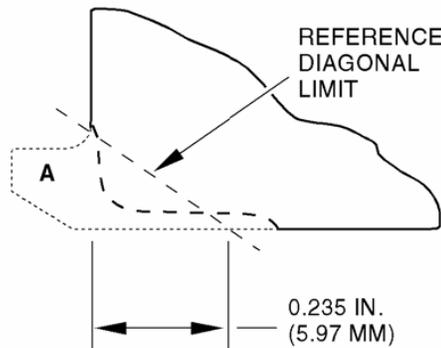
EXAMPLE OF UNACCEPTABLE REMOVED MATERIAL CONDITION

No Area 'A' material remaining and 0.235 inch (5.97 mm) diagonal limit is exceeded.
