[Docket No. 2003-SW-21-AD; Amendment 39-13424; AD 2004-01-10]

### **Airworthiness Directives; Eurocopter Deutschland Model MBB-BK-117 A-1, A-3, A-4, B-1, B-2, and C-1 Helicopters**

**2004-01-10 Eurocopter Deutschland:** Amendment 39-13424. Docket No. 2003-SW-21-AD.

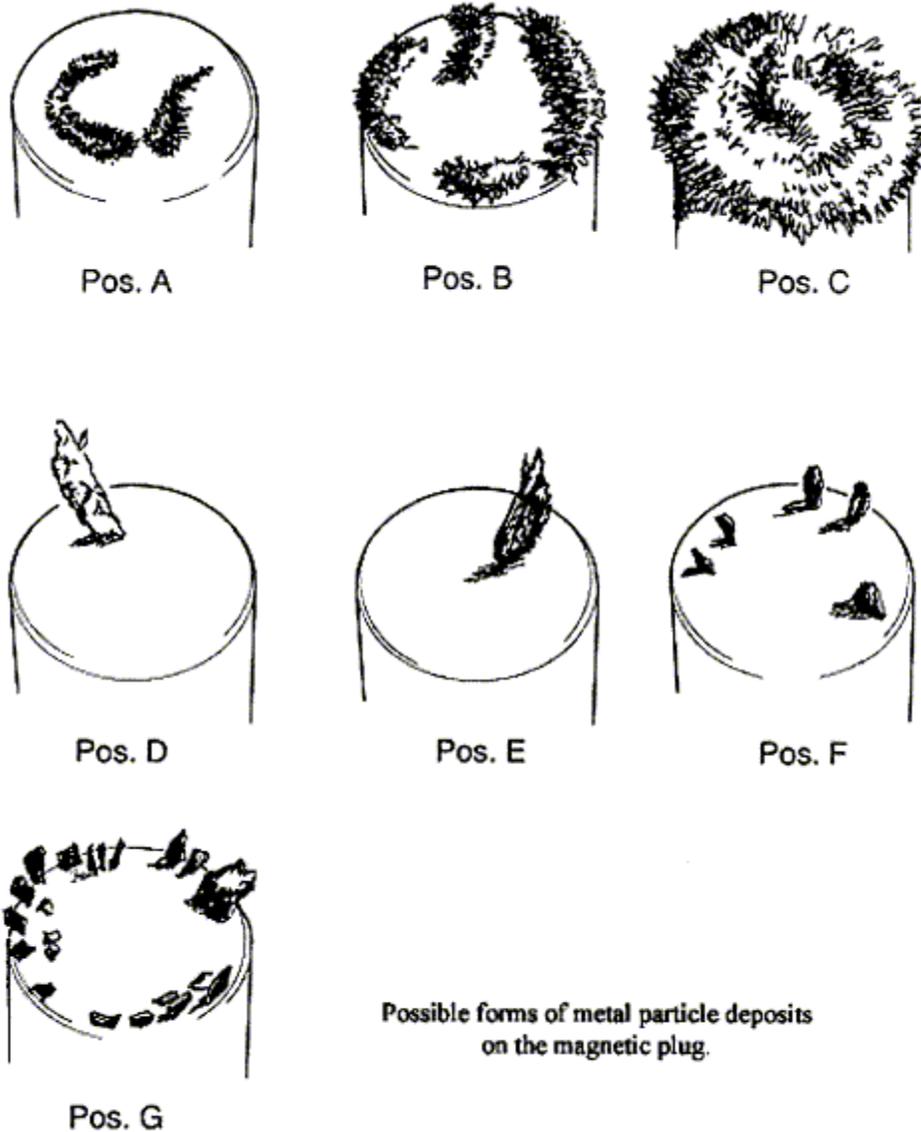
**Figure 1**

(a) Until you do paragraph (b) of this AD, before the first flight of each day, inspect the magnetic plugs of the TR transmission and INT gearbox for metal particles deposits by reference to Figure 1 of this AD.

(1) If you find a small amount of fine fuzz as shown in "Pos. A" of Figure 1 of this AD, clean the magnetic plug and reinstall it after ensuring that the O-ring is correctly positioned and there is no other damage.

(2) If you find an amount of fuzz as depicted in "Pos. B" or "Pos. C" or metal chip(s) as depicted in "Pos. D" through "Pos. G" or a combination of both fuzz and chips, do paragraph (b) of this AD.

(b) No later than February 23, 2004, replace bearing, P/N 4639310006 with S/N 3246 through 3598, with an airworthy bearing or replace the affected TR transmission or INT gearbox with an airworthy TR transmission and INT gearbox that does not contain the affected bearing.
