[Docket No. FAA-2005-22481; Directorate Identifier 2004-NM-176-AD; Amendment 39-14647; AD 2006-12-21]

Airworthiness Directives; Bombardier Model CL-600-2B19 (Regional Jet Series 100 & 440) Airplanes

2006-12-21 Bombardier, Inc. (Formerly Canadair): Amendment 39-14647. Docket No. FAA-2005-22481; Directorate Identifier 2004-NM-176-AD.

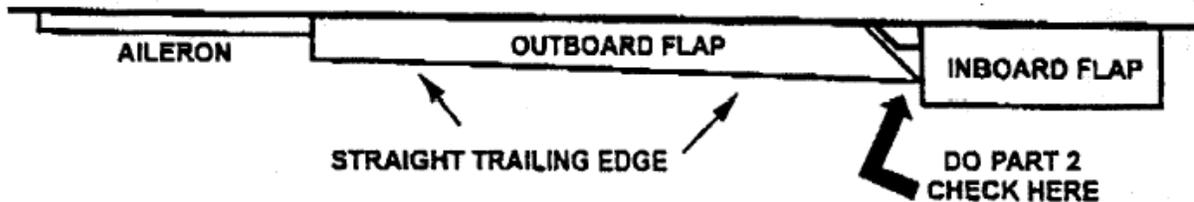
Figure 1. Normal/Abnormal Outboard flap Configuration in Take-off Position”

1. NORMAL

A normal outboard flap has a straight trailing edge, and the inboard corner is slightly above (i.e. higher) than the inboard flap.

2. ABNORMAL

The following are indications of an outboard flap with a twist, skew or abnormal deformation:

- Noticeable curve in the trailing edge
- Buckled top or bottom surface
- Higher than normal position of the inboard trailing edge corner

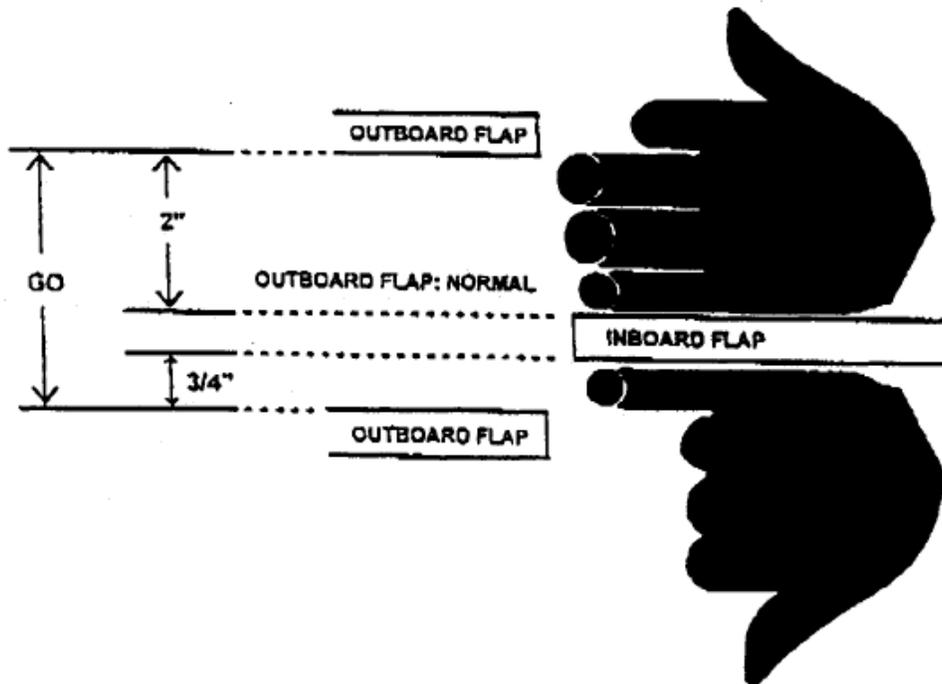
1. FLAPS AT 8 DEGREES

OUTBOARD FLAP GO/NO-GO CRITERIA IN TAKE-OFF POSITION

If the outboard flap position is outside the "GO" range as shown below further flight is prohibited.

Whenever the outboard flap position indicator is outside the "GO" range as shown in Figure 2, or whenever directed to do so by the Maintenance Procedure above, perform the following procedures:
