[Docket No. FAA-2011-0939; Directorate Identifier 2010-SW-067-AD; Amendment 39 16798; AD 2011-18-16]

Airworthiness Directives; Eurocopter France (Eurocopter) Model AS332C, AS332L, AS332L1, and AS332L2 Helicopters

2011-18-16 Eurocopter France: Amendment 39-16798; Docket No. FAA 2011-0939; Directorate Identifier 2010-SW-067-AD.

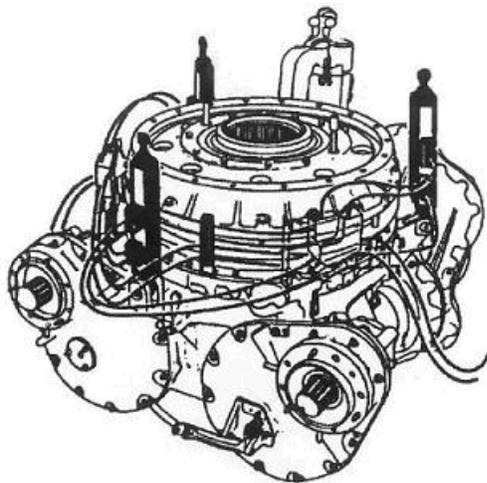
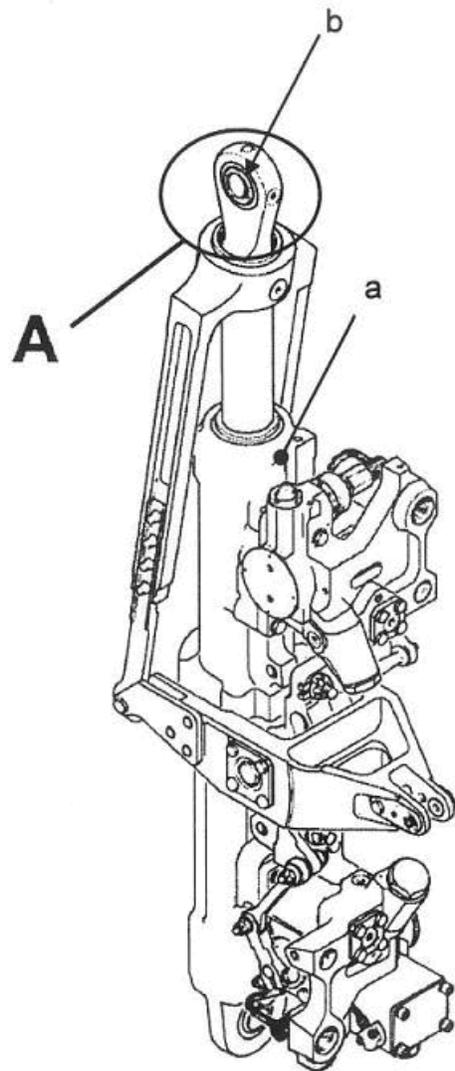
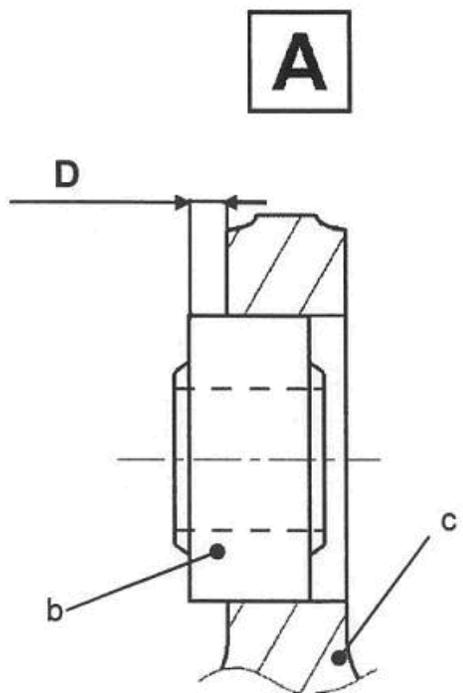
To prevent failure of the upper end fitting ball joints of the main rotor servocontrols, failure of the upper end fittings, and loss of control of the helicopter, do the following:

(a) Within 15 hours time-in-service (TIS), unless accomplished previously, using a feeler gage, measure the lateral play between the outer ring of the ball joint and each of the two faces of the upper end fitting as depicted in Figure 1 of this AD.

(b) If the lateral play is greater than or equal to 1 millimeter (MM) (0.04 inch) and the servocontrol has accumulated 825 or more hours TIS, before further flight, replace it with an airworthy servocontrol.

(c) If the lateral play is greater than or equal to 1 mm (0.04 inch) and the servocontrol has accumulated less than 825 hours TIS, on or before the servocontrol accumulates 825 hours TIS, replace it with an airworthy servocontrol.

(d) If the lateral play is less than 1 mm (0.04 inch), at intervals not to exceed 300 hours TIS, repeat the inspection required by paragraph (a) of this AD. At each 300 hour TIS interval inspection, if the lateral play is greater than or equal to 1 mm (0.04 inch), within 525 hours TIS, replace the servocontrol with an airworthy servocontrol.
