[Docket No. FAA-2004-18850; Directorate Identifier 2004-SW-19-AD; Amendment 39-14694; AD 2004-16-15 R1]

Airworthiness Directives; Eurocopter France Model AS-365N2, AS 365 N3, EC 155B, EC155B1, SA-365N, N1, and SA-366G1 Helicopters

AIRWORTHINESS DIRECTIVE

2004-16-15 R1 Eurocopter France: Amendment 39-14694. Docket No. FAA-2004-18850; Directorate Identifier 2004-SW-19-AD. Revises AD 2004-16-15, Amendment 39-13771.

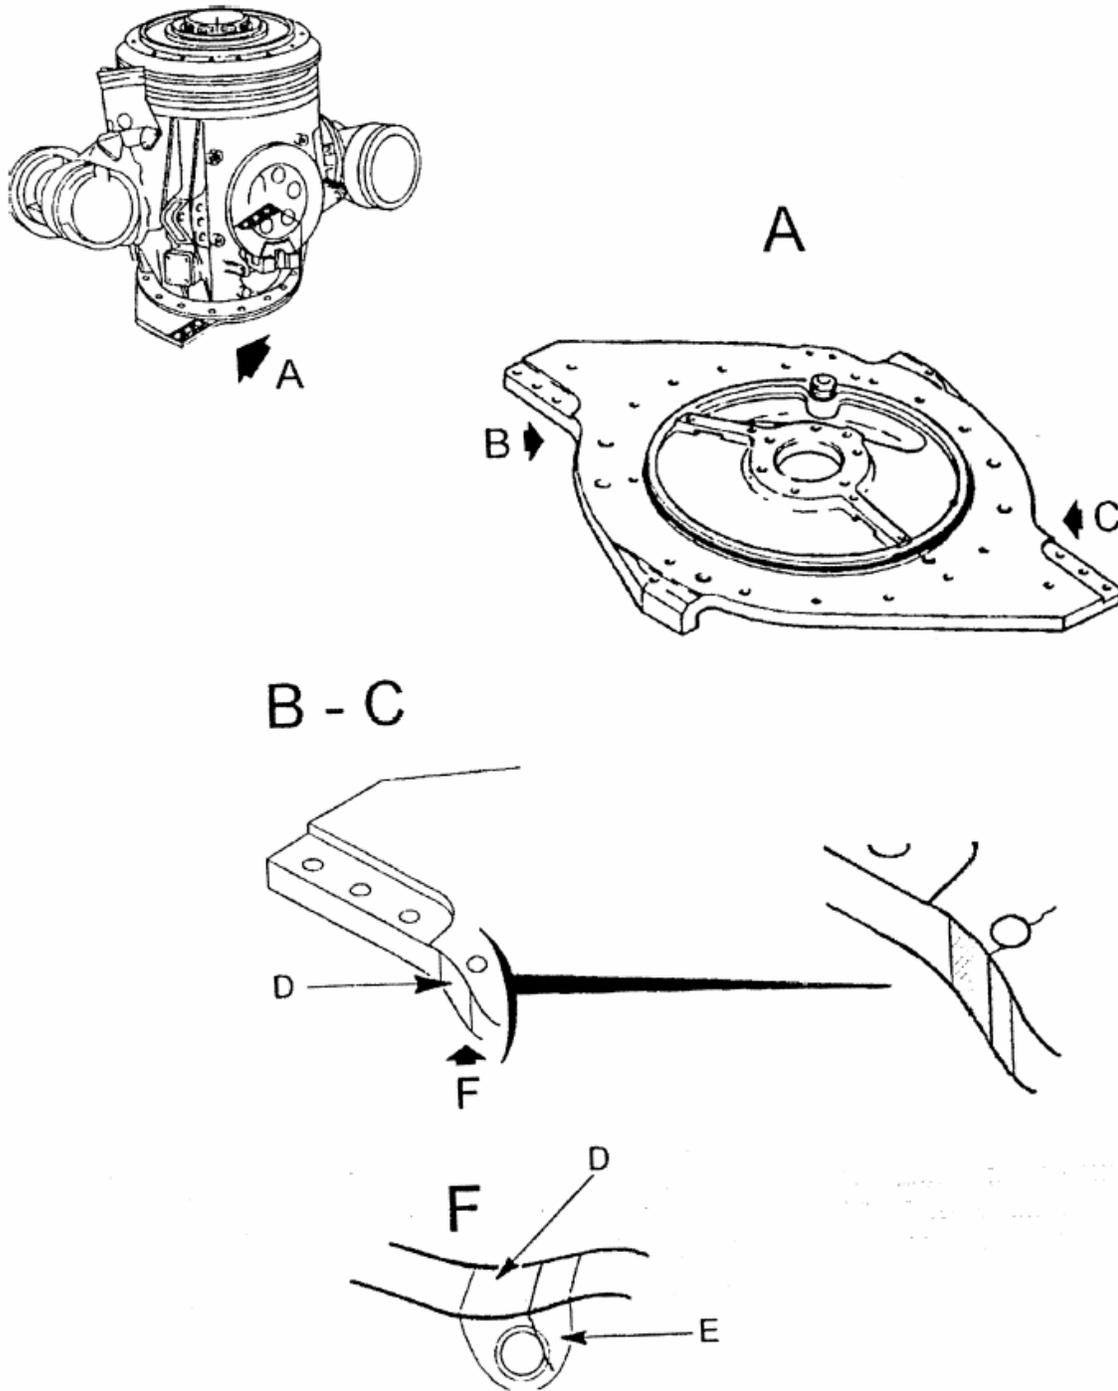
crack in the MGB base plate, part number (P/N) 366A32-1062-03 or P/N 366A32-1062-06, close to the attachment hole using a 10x or higher magnifying glass. Stripping paint from the inspection area is also required, but only before the initial inspection. That action was prompted by the discovery of a crack in the MGB base plate of an MGB installed in a Model AS-365 N2 helicopter. The crack was located very close to the attachment points of one of the laminated pads, and it propagated to the inside of the MGB base plate and then continued into the MGB casing. That condition, if not detected, could result in failure of one of the MGB attachment points to the frame, which could result in severe vibration and subsequent loss of control of the helicopter.

(a) Before the initial inspection at the time indicated in the compliance table of this AD, strip the paint from area "D" on both sides ("B" and "C") of the MGB base plate as depicted in Figure 1 of this AD.

(b) At the times indicated in the compliance table, inspect area "D" of the MGB base plate for a crack using a 10x or higher magnifying glass. Area "D" to be inspected is depicted in Figure 1 of this AD.

(c) If a crack is found in a MGB base plate, remove and replace the MGB with an airworthy MGB before further flight.
