**FEDERAL AVIATION ADMINISTRATION
AIRWORTHINESS DIRECTIVES**

LARGE AIRCRAFT

BIWEEKLY 2012-05

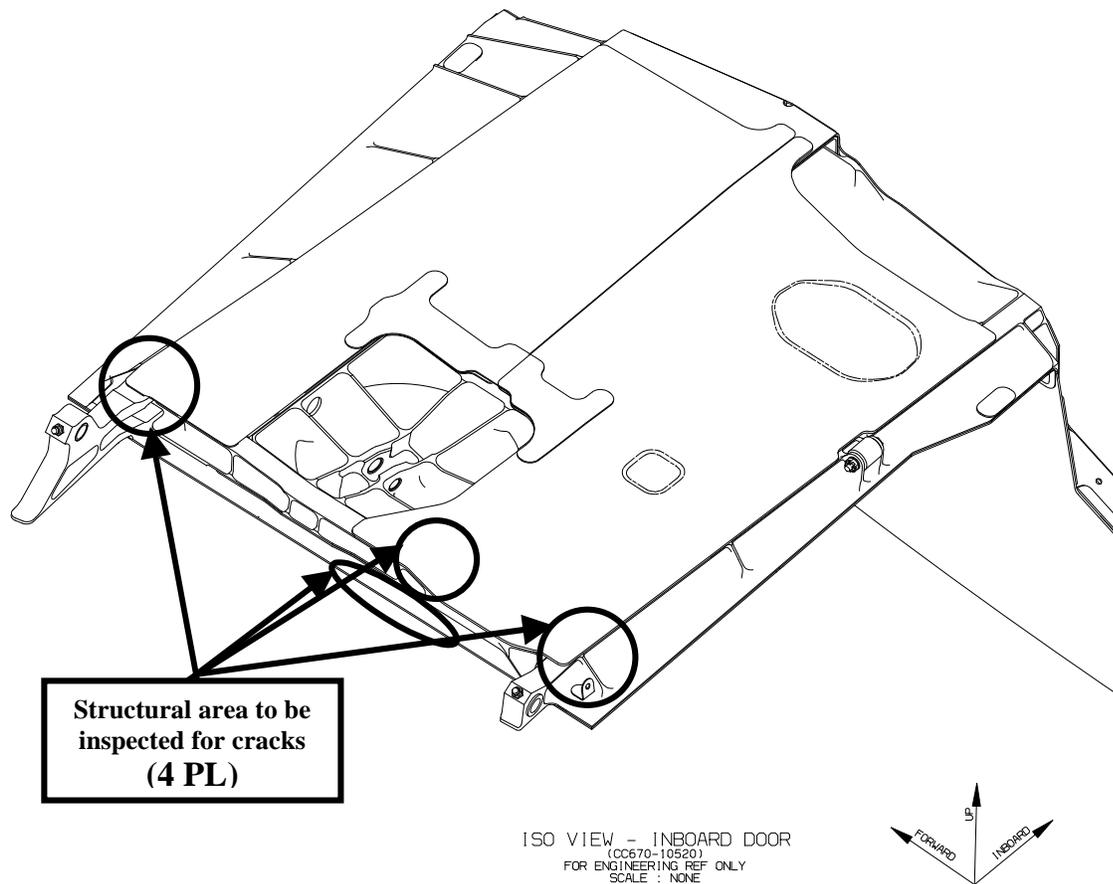
Figure 1
LH side shown
RH side opposite

(1) Inspect the cross member, P/N CC670-10572, of the MLG door lower panel for cracking or deformation, in accordance with Figure 2 of this AD.

(2) Inspect the inner skin, P/N CC670-10577, of the MLG door lower panel at the cross member (P/N CC670-10572) for cracking or deformation, or pulled or missing fasteners, in accordance with Figure 2 of this AD.

(3) Inspect the outer skin, P/N CC670-10574, of the MLG door lower panel at the cross member (P/N CC670-10572) for cracking or deformation, or pulled or missing fasteners, in accordance with Figure 2 of this AD.

(4) Inspect the forward member, P/N CC670-10570, and aft member, P/N CC670-10571, of the MLG door lower panel for cracking or deformation, or pulled or missing fasteners, in accordance with Figure 3 of this AD. Figures 1 through 3 of this AD follow.

If any cracking or deformation, or pulled or missing fastener, as applicable, is found during any inspection done in accordance with paragraph (h) or (i) of this AD: Before further flight, accomplish paragraph (j)(1), (j)(2), or (j)(3) of this AD.

(1) Repair the damage in accordance with a method approved by either the Manager, New York Aircraft Certification Office (ACO), FAA; or Transport Canada Civil Aviation (TCCA) (or its delegated agent); and accomplish repetitive inspections in accordance with a method and at a repetitive interval approved by same.

(2) Replace the lower panel assembly, P/N CC670-10520, of the affected MLG door with a new or serviceable lower panel assembly having the same P/N, according to a method approved by either the Manager, New York ACO, FAA; or TCCA (or its delegated agent). Repeat the inspections specified in paragraph (h) of this AD at intervals not to exceed 100 flight cycles.
