**FEDERAL AVIATION ADMINISTRATION  
AIRWORTHINESS DIRECTIVES**

**SMALL AIRPLANES, ROTORCRAFT, GLIDERS,  
BALLOONS, & AIRSHIPS**

**BIWEEKLY 2013-08**

*4/8/2013 - 4/21/2013*

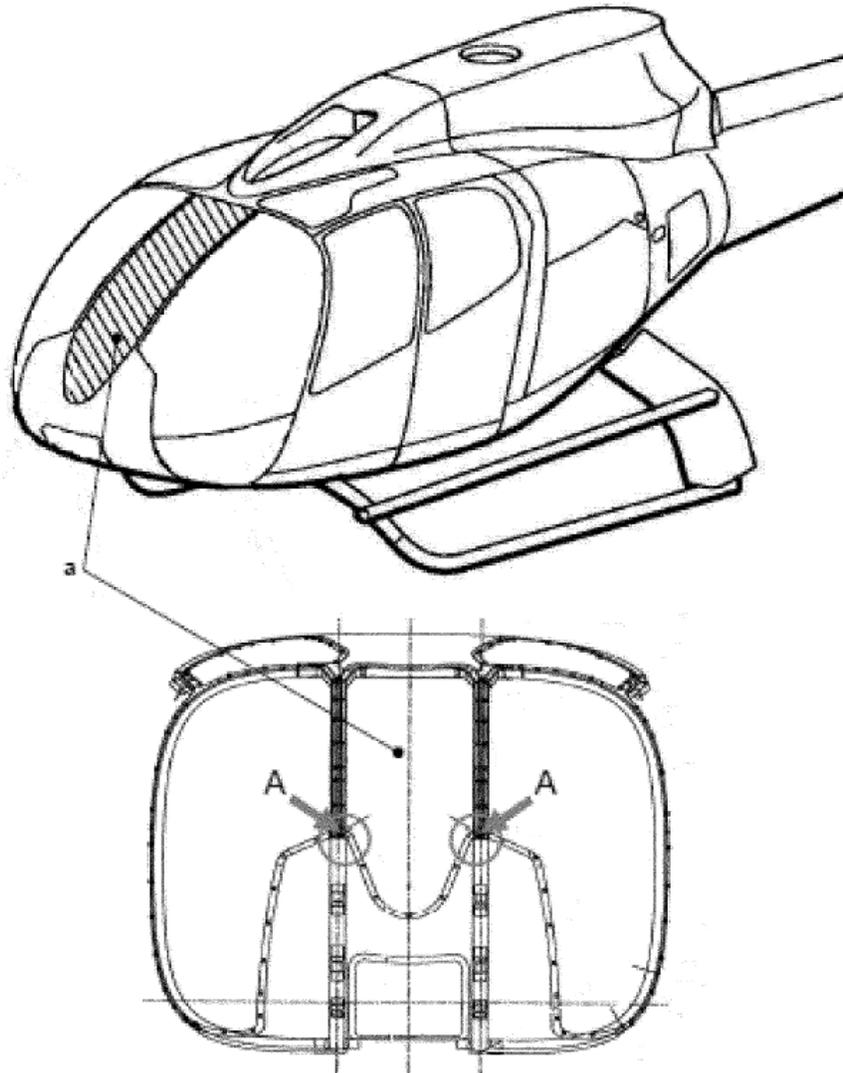
**Figure 1 to Paragraph (e)(1)**

This AD defines the unsafe condition as a crack in the blending radii of the center windscreen, which could lead to failure of the center windscreen, injury to the flight crew, and subsequent loss of control of the helicopter.

(1) Until the center windscreen is replaced with center windscreen P/N 350A25-9045-20, before each flight, visually check the center windscreen for a crack in the area of the blending radii where the front-lower part of the center windscreen joins the front fuselage as depicted in Figure 1 to paragraph (e)(1) of this AD. This visual check may be performed by the owner/operator (pilot) holding at least a private pilot certificate, and must be entered into the aircraft records showing compliance with this AD in accordance with Title 14 Code of Federal Regulations (14 CFR) 43.9 (a)(1)-(4) and 14 CFR 91.417(a)(2)(v). The record must be maintained as required by 14 CFR 91.417, 121.380, or 135.439.

(2) If there is a crack or if a pilot indicates that the center windscreen distorted during flight, before further flight, replace the center windscreen with an airworthy center windscreen, P/N 350A25-9045-20, in accordance with the Accomplishment Instructions, paragraphs 2.B.2.b. through 2.B.2.b.4., of Eurocopter Service Bulletin No. 56-003, Revision 0, dated November 16, 2010.

(3) Within 12 months, replace the center windscreen with an airworthy center windscreen, P/N 350A25-9045-20, in accordance with the instructions contained in paragraph (e)(2) of this AD.
