**FEDERAL AVIATION ADMINISTRATION
AIRWORTHINESS DIRECTIVES**

**LARGE AIRCRAFT
BIWEEKLY 2015-09**

4/20/2015 - 5/3/2015

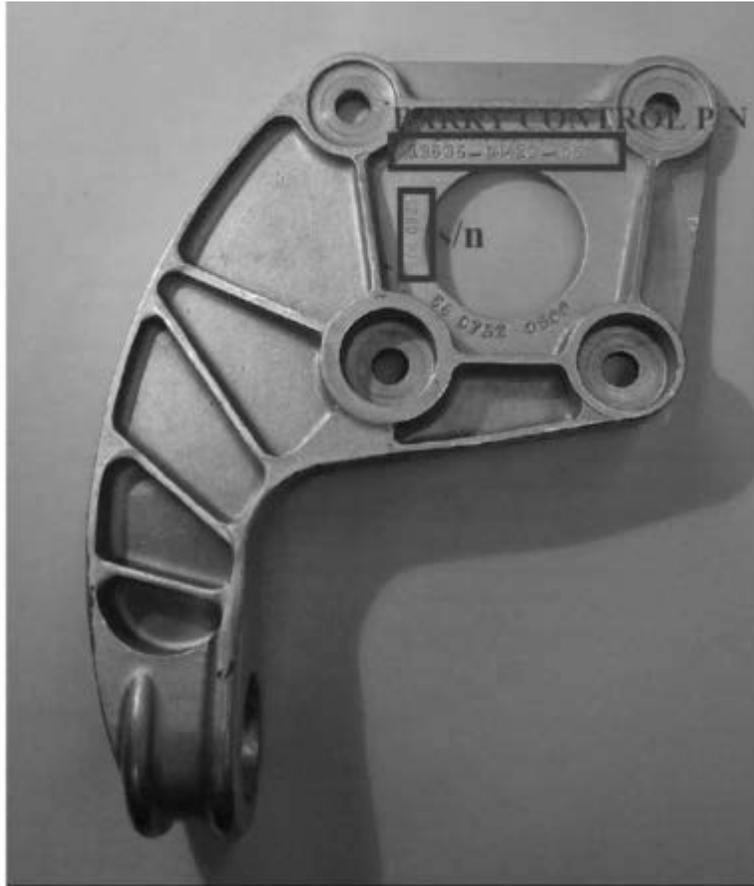
Figure 1 to paragraph (g)(1) of this AD - Location of Fitting Part Number and Serial Number

(1) Identify the serial number (S/N) of the part number (P/N) S54210394200 (Barry Control P/N 94423-05) LH and right-hand (RH) shock mount pick-up fittings installed on both engine nacelles. Figure 1 to paragraph (g)(1) of this AD identifies the fitting part number and serial number locations.

(2) If the serial number of the LH shock mount pick-up fitting, identified during any inspection required by paragraph (g)(1) of this AD, is lower than 2451 or is unreadable, and no crack has been found during any inspection required by paragraphs (g)(2) and (g)(3) of this AD: Within 6 months after the inspection required by paragraph (g)(2) of this AD, replace the LH shock mount pick-up fitting P/N S54210394200 with a serviceable LH shock mount pick-up fitting having a serial number equal to or higher than 2451, in accordance with a method approved by the Manager, International Branch, ANM-116, Transport Airplane Directorate, FAA; or EASA; or ATR-GIE Avions de Transport Régional's EASA DOA.

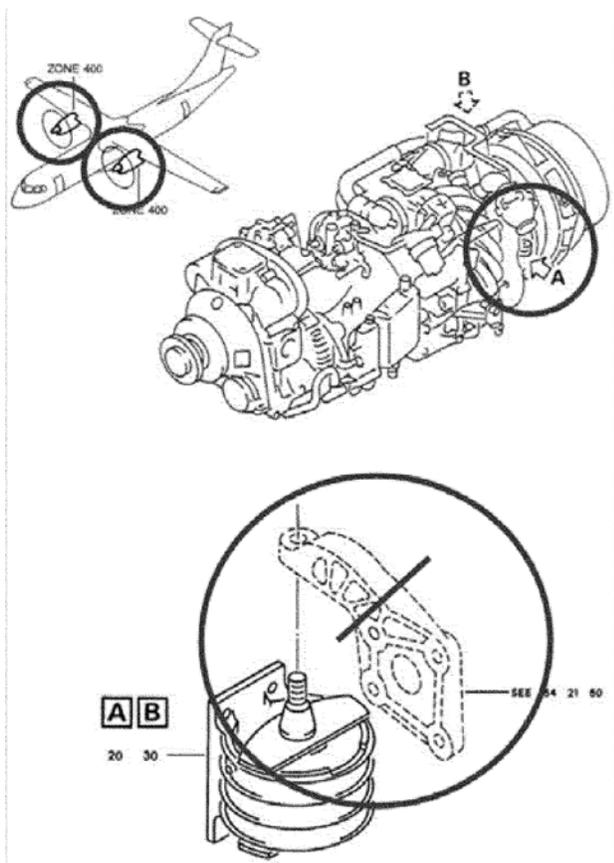
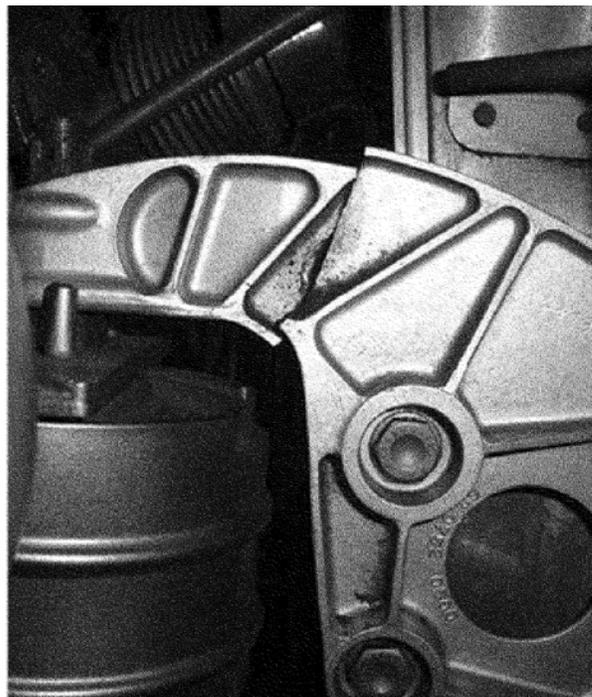
Figure 2 to Paragraph (g)(2) of this AD - Shock Mount Pick-up Fitting

This AD was prompted by reports of several cases of engine shock mount pick-up fittings with cracks or failure on the engine left-hand (LH) aft side attachment. We are issuing this AD to detect and correct an aft side attachment pick up fitting failure associated with a cone bolt failure that could reduce the structural integrity of the concerned engine nacelle, and possibly result in detachment of the engine and consequent reduced control of the airplane.

(2) Do a detailed inspection of both LH and RH aft side isolator pick-up fittings on both engines to detect cracks, in accordance with paragraph 004.1 of ATR ATR72 Aircraft Maintenance Manual (AMM) Job Instruction Card (JIC) 54-11-61 DVI 10000, dated March 1, 2012. Refer to figure 2 to paragraph (g)(2) of this AD for potential crack location.

(1) If any crack is found during any inspection required by paragraphs (g)(2) and (g)(3) of this AD: Before further flight, repair in accordance with a method approved by the Manager, International

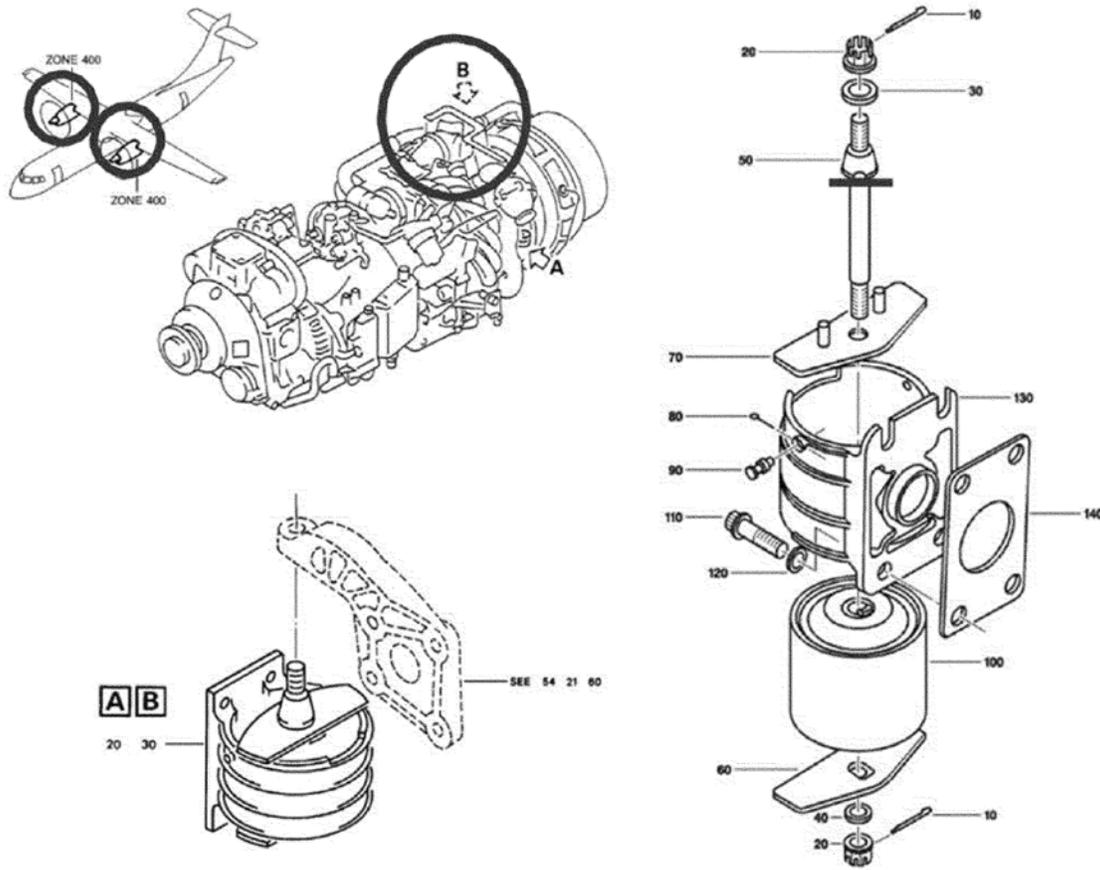
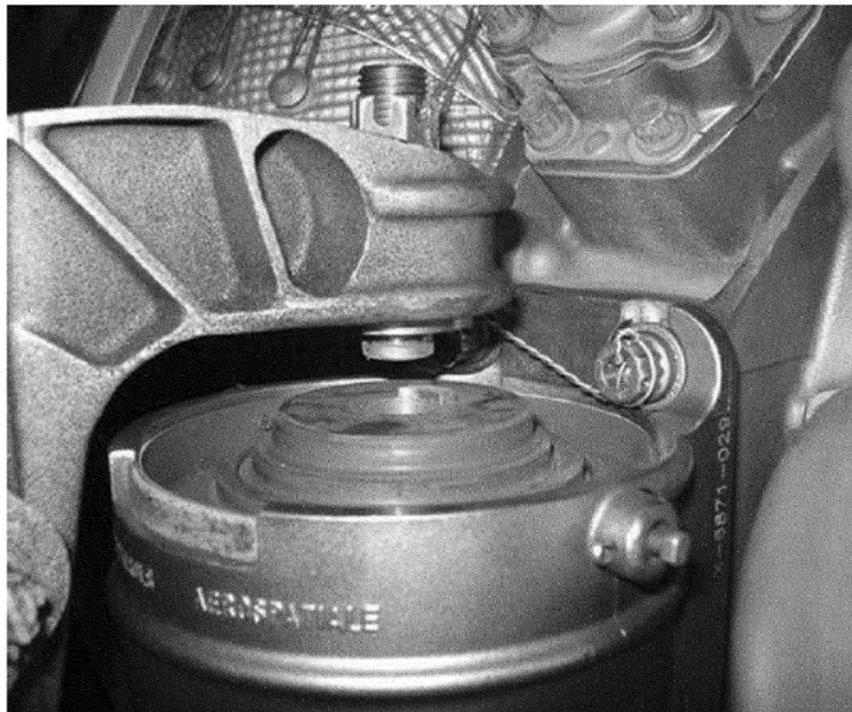
Figure 3 to paragraph (g)(3) of this AD - Shock Mount Cone Bolt

(3) Do a detailed inspection of both LH and RH aft shock mount cone bolts on both engines to detect cracks, in accordance with paragraph 006.3.A. of ATR ATR72 AMM JIC 71-20-00 DVI 10000. Refer to figure 3 to paragraph (g)(3) of this AD for potential crack location.
