**FEDERAL AVIATION ADMINISTRATION
AIRWORTHINESS DIRECTIVES**

**SMALL AIRPLANES, ROTORCRAFT, GLIDERS,
BALLOONS, & AIRSHIPS**

BIWEEKLY 2014-16

7/28/2014 - 8/10/2014

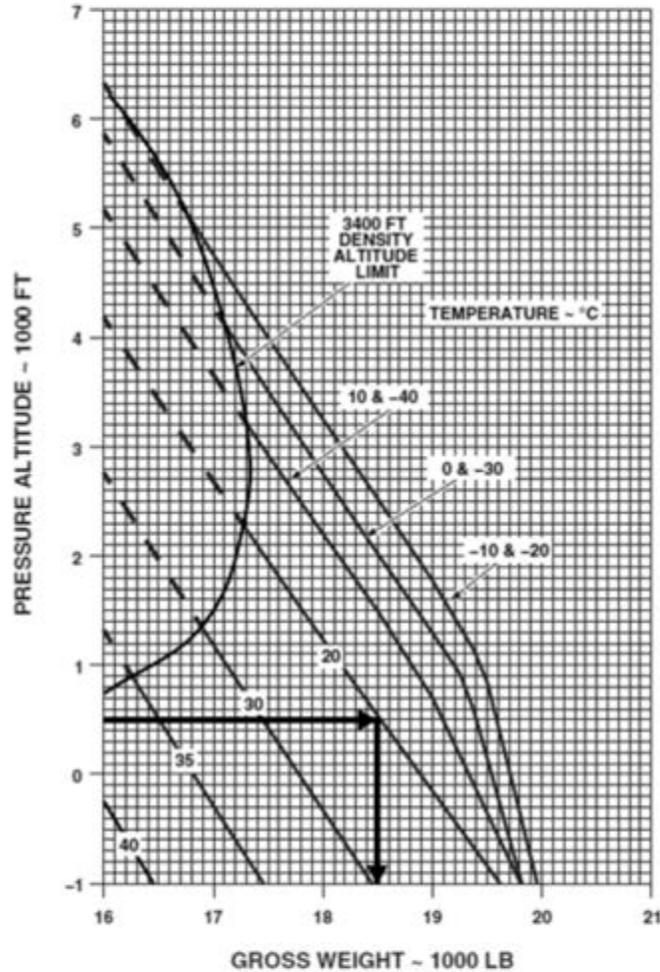
(iii) Add the following and insert Figure 1 to Paragraph (e)(3)(iii) of this AD: "HOIST" Maximum gross weight for Human External Cargo, which requires category 'A' performance capabilities, is limited to the gross weight determined in accordance with the following Figure 1 to Paragraph (e)(3)(iii) of this AD for your altitude and temperature with the air-conditioner, anti-ice, and bleed air turned off.

Note 1 to paragraph (e)(3)(iii) of this AD: Figure 1 to Paragraph (e)(3)(iii) of this AD becomes Figure 1-2A when inserted in the "Weight Limits" section of your RFM.

NOTE 1: THIS CHART DEPICTS THE GROSS WEIGHT, PRESSURE ALTITUDE, TEMPERATURE COMBINATION WHERE OEI HOGE CAPABILITY EXISTS USING 30 SECOND OEI POWER WITH A 60 SHP MARGIN.

NOTE 2: 15 FT OF GROUND CLEARANCE IS ASSURED IN THE EVENT OF AN ENGINE FAILURE AT 20 TO 80 FT AGL.
