**FEDERAL AVIATION ADMINISTRATION
AIRWORTHINESS DIRECTIVES**

**LARGE AIRCRAFT
BIWEEKLY 2013-10**

5/6/2013 - 5/19/2013

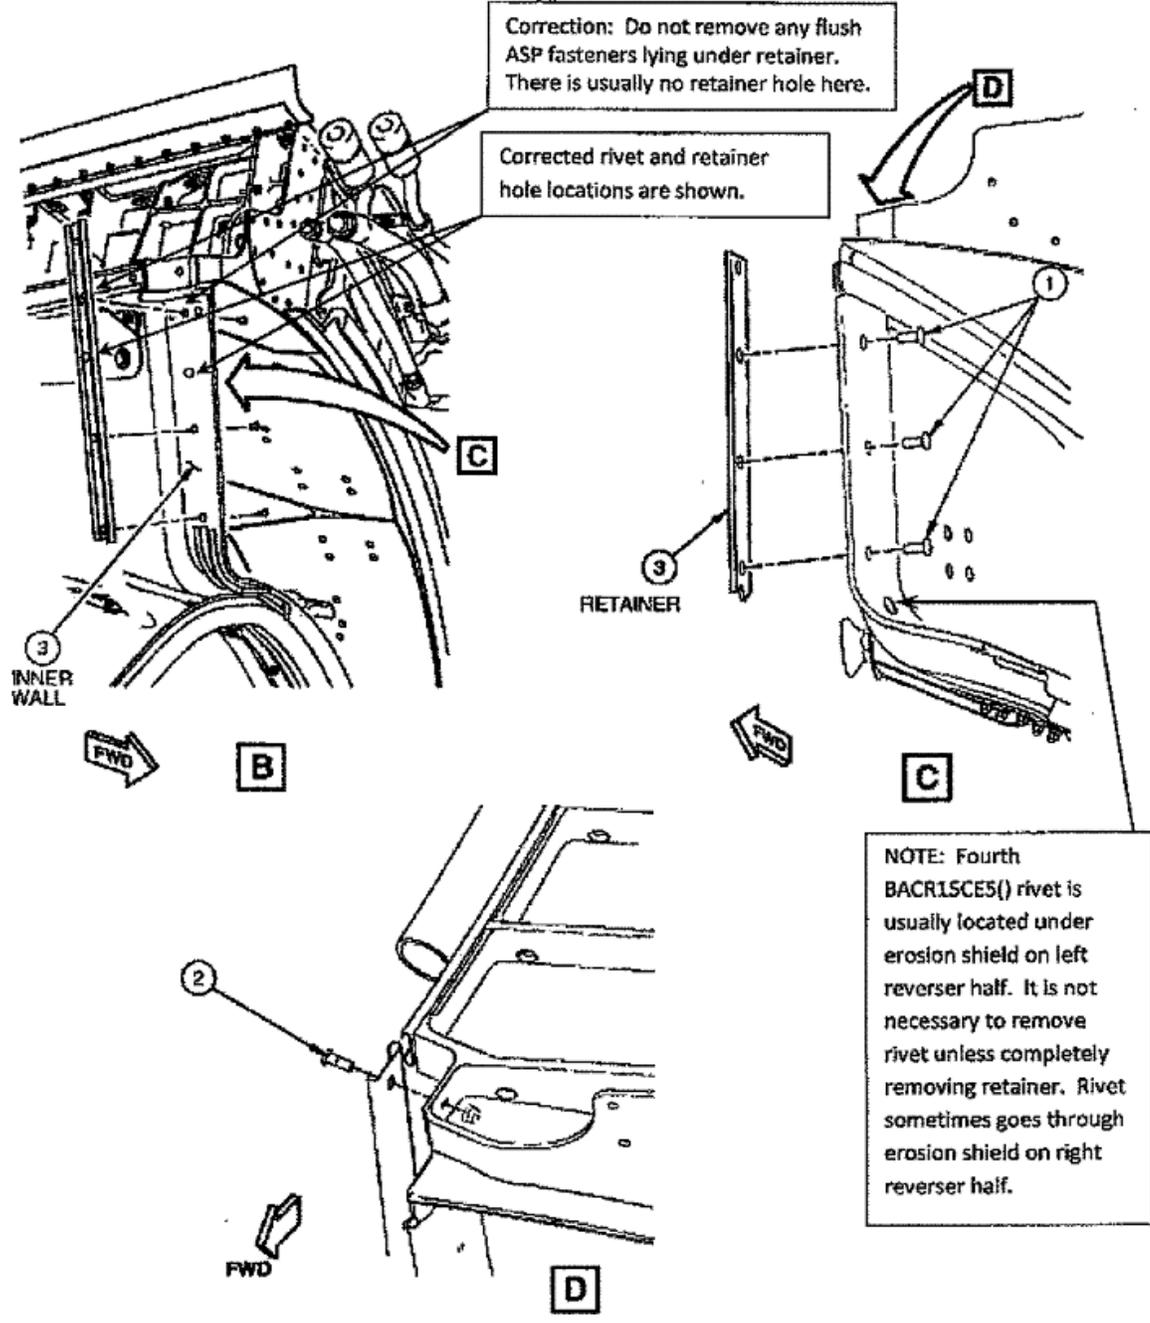
Figure 1, Fastener Removal of the Retainer Support on the Left Thrust Reverser Half

This AD was prompted by reports of damaged upper fire seals on the forward edge of the thrust reversers. We are issuing this AD to detect and correct damage to the fire seals, which could allow airflow into the engine fire zone and could ultimately degrade the ability to extinguish an engine fire.

Within 36 months after the effective date of this AD: Do a one-time general visual inspection of the left and right thrust reverser halves of each engine for damage to the upper fire seal, for stiffness of the upper fire seal, and for missing vent holes as applicable, in accordance with paragraph 3.B. of the Accomplishment Instructions of Boeing Special Attention Service Bulletin 737-78-1086, Revision 1, dated May 15, 2012, except as required by paragraph (h) of this AD.

(1) If, during the inspection required by paragraph (g) of this AD, no upper fire seal damage is found, and the fire seal has the correct stiffness: Before further flight, drill vent holes if they are missing, and install a new bracket behind the upper fire seal retainer, in accordance with paragraph 3.B. of the Accomplishment Instructions of Boeing Special Attention Service Bulletin 737-78-1086, Revision 1, dated May 15, 2012.

(2) If, during the inspection required by paragraph (g) of this AD, upper fire seal damage or insufficient fire seal stiffness is found: Before further flight, install a new upper fire seal, drill vent

holes if they are missing, and install a new bracket behind the upper fire seal retainer, in accordance with paragraph 3.B. of the Accomplishment Instructions of Boeing Special Attention Service Bulletin 737-78-1086, Revision 1, dated May 15, 2012, except as required by paragraph (h) of this AD.

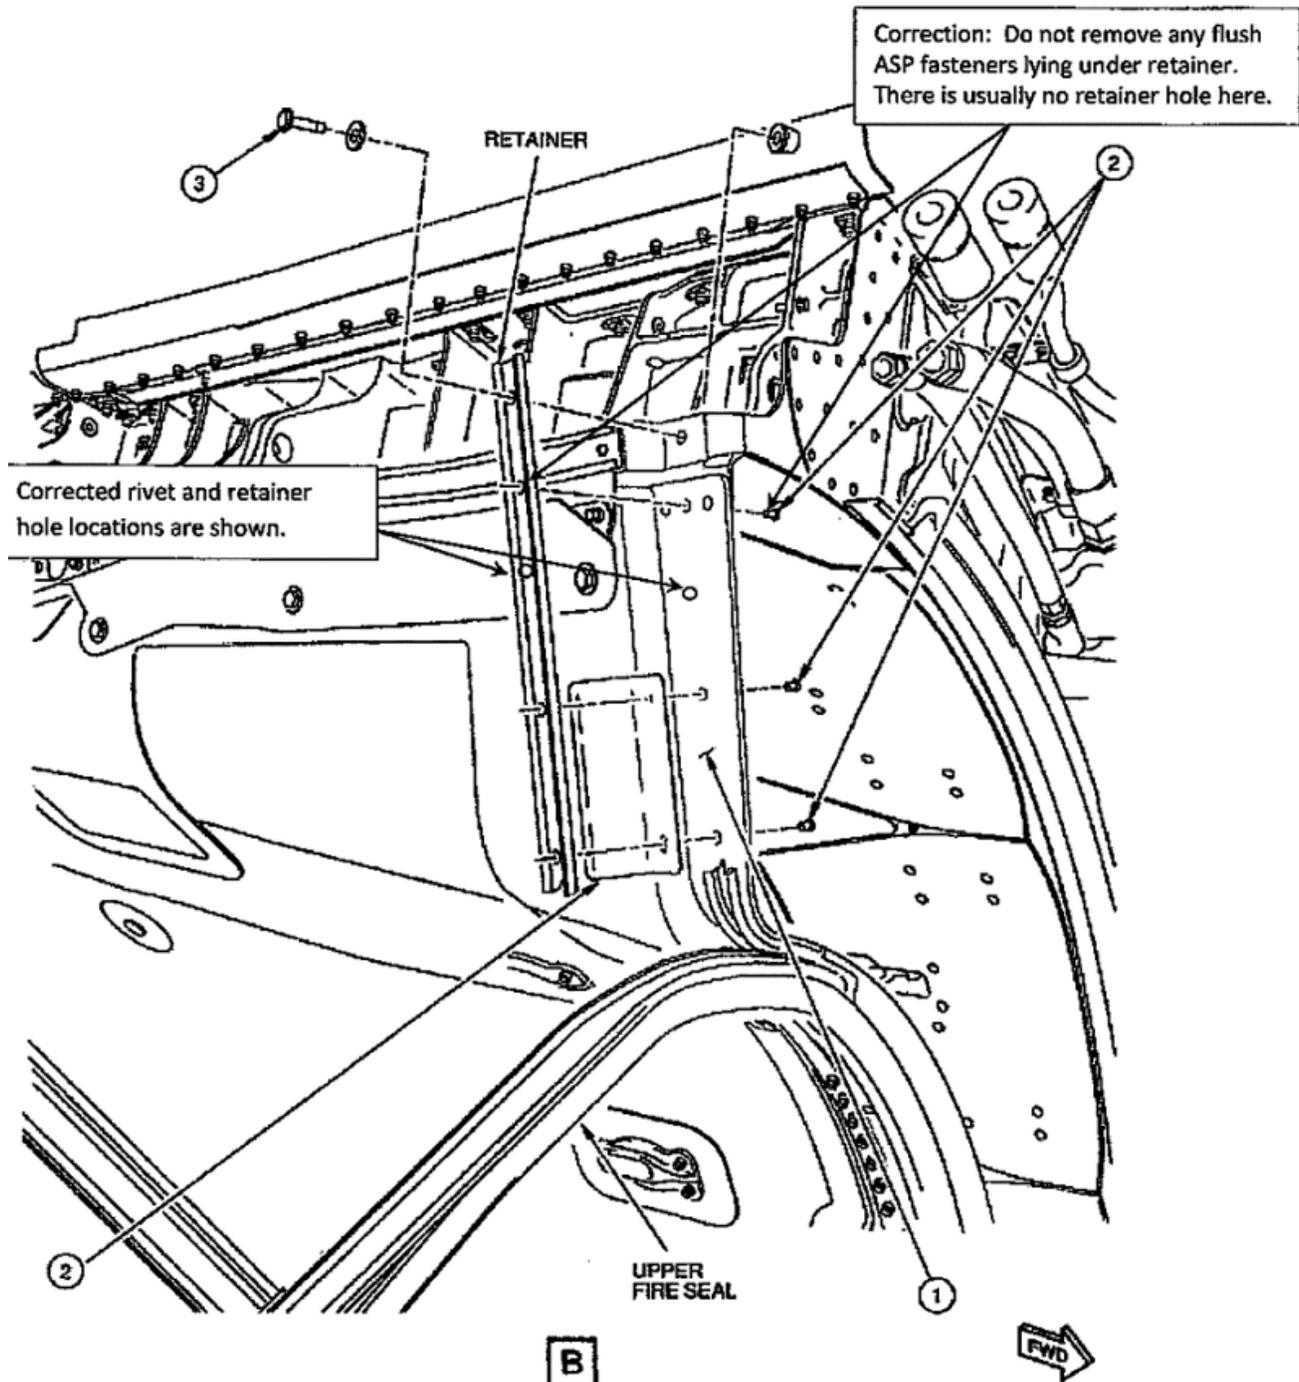
Figure 2, Installation of the New Bracket behind the Retainer Support on the Left Thrust Reverser Half

(3) Figures 2 and 4 of this AD, titled "Installation of the New Bracket behind the Retainer Support on the Left (Right) Thrust Reverser Half," have View B showing the top rivet hole. That rivet hole is actually below the row of three ASP fasteners. The figures in this AD point to the correct information for those rivet holes.
