**FEDERAL AVIATION ADMINISTRATION
AIRWORTHINESS DIRECTIVES**

BIWEEKLY 2012-21

AD #: 2012-21-51

This emergency airworthiness directive (EAD) No. 2012-21-51 is being sent to owners and operators of Eurocopter France (Eurocopter) Model AS350B3 helicopters.

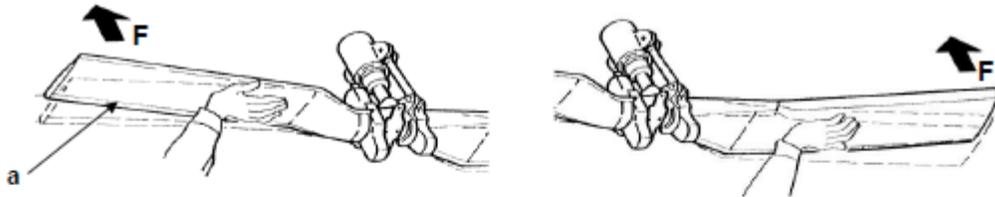
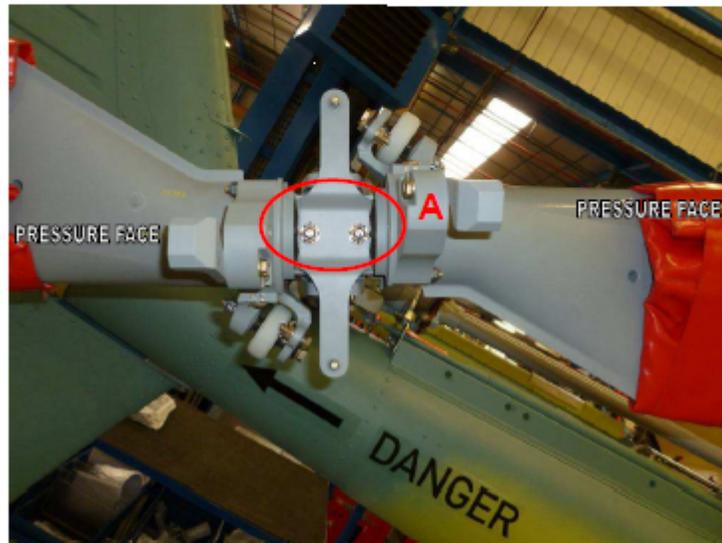
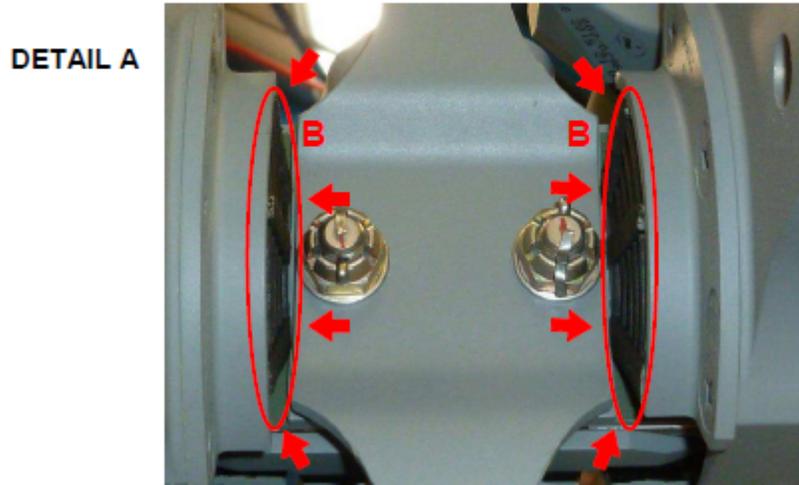
Figure 5 to paragraphs (e)(3)(ii) and (e)(3)(iii)

(iii) While maintaining the load, check all the visible faces of the bearings (front and side faces) in area B of DETAIL A of Figure 5 to paragraphs (e)(3)(i) and (e)(3)(iii) of this EAD for separation between the elastomer and metal parts, a crack in the elastomer, or an extrusion (see example in Figure 6 to paragraph (e)(3)(iii) of this EAD).

(5) If there is an extrusion on any bearing, before further flight, replace the four bearings with airworthy bearings.

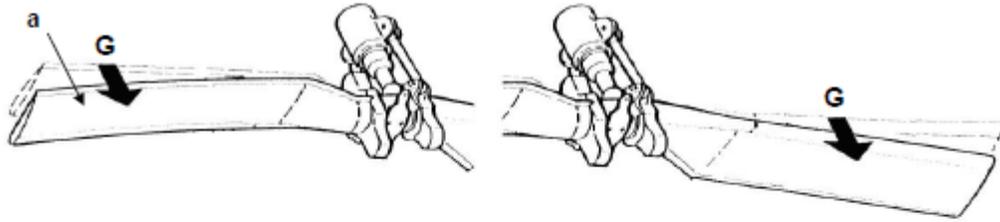
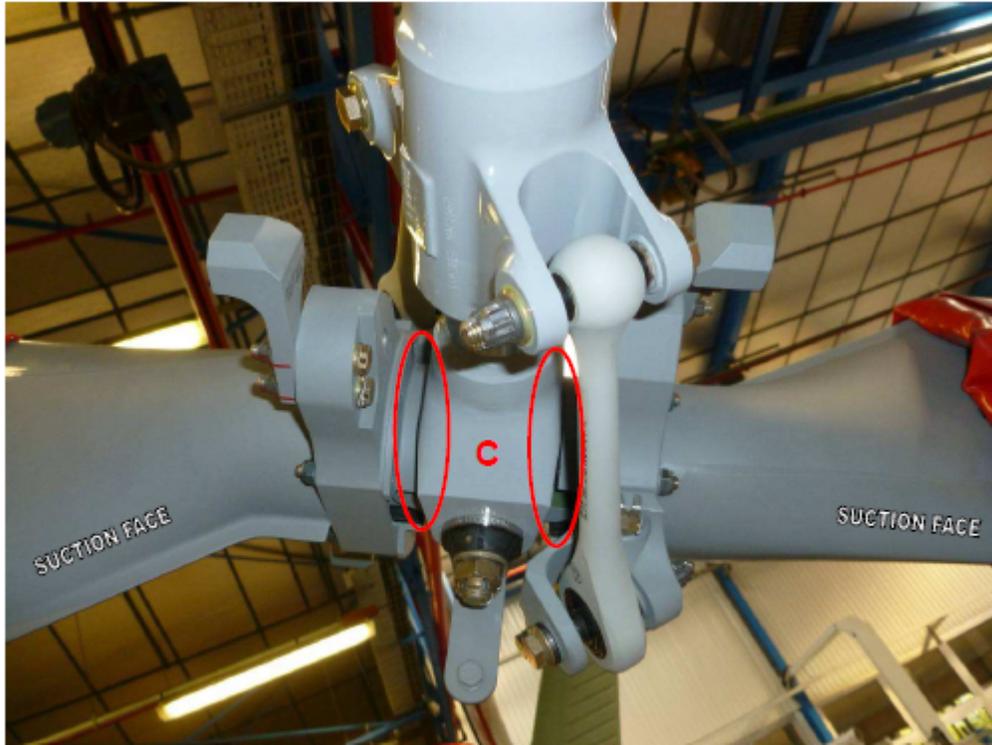
(vi) While maintaining the load, check visible faces of Area C as shown in Figure 7 to paragraphs (e)(3)(v) and (e)(3)(vi) of this EAD for any extrusion.

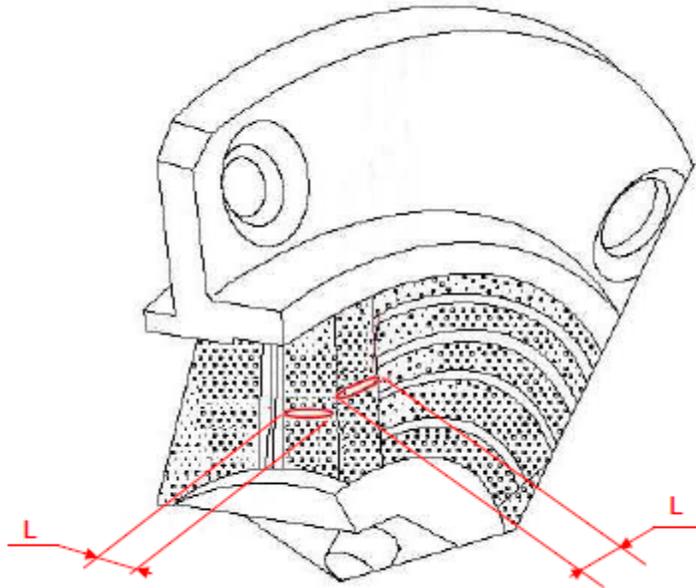
Figure 8 to paragraph (e)(6)

(6) If there is a separation or a crack on the pressure side bearing, measure the separation or the crack. If the separation or crack is greater than 5 millimeters (.196 inches) as indicated by dimension “L” in Figure 8 to paragraph (e)(6), before further flight, replace the four bearings with airworthy bearings.
