**[Docket No. FAA-2012-0060; Directorate Identifier 2012-NE-02-AD; Amendment 39-17123; AD 2012-14-09]**

#### **Airworthiness Directives; Pratt & Whitney (P&W) Division Turbofan Engines**

**ACTION:** Final rule.

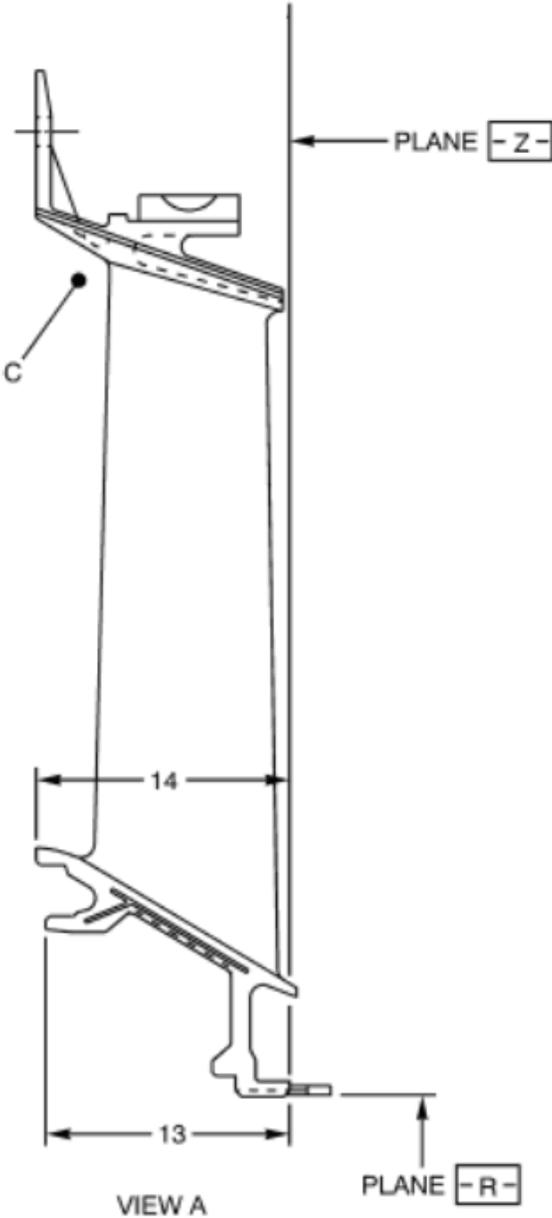
Figure 1 to Paragraph (e) - Determination of Vane Eligibility

(iii) Dimensionally examine index 13 through index 34 of the LPT 3rd stage vane cluster assembly. Use Table 2 to paragraph (e) of this AD and Figure 1, Figure 2, and Figure 3 to paragraph (e) of this AD to determine whether the vane is eligible for installation.

<b>Inspect:</b>	<b>Eligible for Installation Limits:</b>
13	1.820 – 1.830 inches (46.23 – 46.48 mm)
14	1.920 – 1.930 inches (48.77 – 49.02 mm)
15	3.200 inches (81.280 mm) Basic
16	0.900 inch (22.860 mm) Basic
17	0.365 inch (9.271 mm) Basic
18	0.350 inch (8.890 mm) Basic
19	0.160 inch (4.064 mm) Basic
20	0.772 inch (19.609 mm) Basic
21	72° Basic
22	22.382 inch (568.503 mm) Radius – Origin on Plane S Basic
23	21.052 inch (534.721 mm) Radius – Origin on Plane S, concentric with Index 8 Basic
24	Angle from Plane S to Plane SL 3° 4' 37" Basic
25	Angle from Plane S to Plane SM 6° 9' 14" Basic
26	90° Basic for typical airfoil section
27 Distance from rear foot outer diameter surface to airfoil section along Planes S, SL, and SM.  For Section B-B: For Section E-E: For Section J-J:	  5.241 inches (133.121 mm) 3.181 inches (80.797 mm) 1.935 inches (49.149 mm)
28 Airfoil chord at Section J-J (1.935 inches (49.149 mm) from rear foot outer diameter surface at Planes S, SL, and SM)  At Section E-E (3.181 inches (80.797 mm) from rear foot outer diameter surface at Planes S, SL, and SM)	 1.346 inches (34.188 mm) minimum  1.314 inches (33.376 mm) minimum

At Section B-B (5.241 inches (133.121 mm) from rear foot outer diameter surface at Planes S, SL, and SM)	1.188 inches (30.175 mm) minimum
29 Airfoil thickness at Section J-J (1.935 inches (49.149 mm) from rear foot outer diameter surface at Planes S, SL, and SM)	0.239 inch (6.071 mm) minimum
At Section E-E (3.181 inches (80.797 mm) from rear foot outer diameter surface at Planes S, SL, and SM)	0.183 inch (4.648 mm) minimum
At Section B-B (5.241 inches (133.121 mm) from rear foot outer diameter surface at Planes S, SL, and SM)	0.139 inch (3.531 mm) minimum
30 Distance to trailing edge measurement	0.062 inch (1.575 mm)
31 Airfoil trailing edge thickness	0.030 inch (0.762 mm) minimum
32 Dimension	0.315 – 0.324 inch (8.001 – 8.230 mm) diameter
33 Dimension	6.785 – 6.795 inches (172.34 – 172.59 mm)
34 Dimension	0.692 – 0.714 inch (17.58 – 18.14 mm)

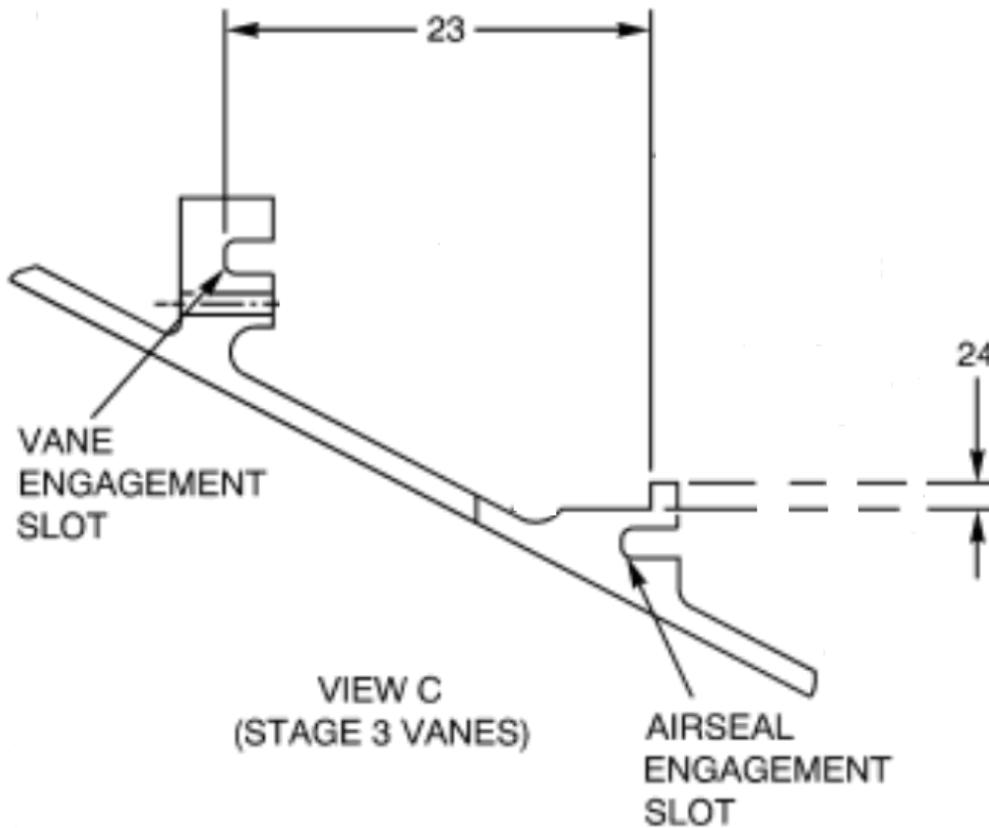
**Figure 4 to Paragraph (e) - Determination of Case Eligibility**

(iv) Dimensionally examine index 23 and index 24 of the vane engagement slots on the rear turbine case, where the 3rd stage vane is installed. Use Table 3 to paragraph (e) of this AD and Figure 4 to paragraph (e) of this AD to determine whether the case is eligible for installation.

<b>Inspect:</b>	<b>Eligible for Installation Limits</b>
23	1.875 inch (47.625 mm) minimum
24	0.097 inch (2.464 mm) minimum
