[Docket No. FAA-2013-0822; Directorate Identifier 2013-SW-004-AD; Amendment 39-17783; AD 2014-05-10]

Airworthiness Directives; Airbus Helicopters (Type Certificate Previously Held by Eurocopter France) (Airbus Helicopters)

2014-05-10 Airbus Helicopters (Type Certificate Previously Held By Eurocopter France):
Amendment 39-17783; Docket No. FAA-2013-0822; Directorate Identifier 2013-SW-004-AD.

This AD defines the unsafe condition as severe vibrations due to failure of laminated half-bearings (bearings). This condition could result in failure of the tail rotor and subsequent loss of control of the helicopter.

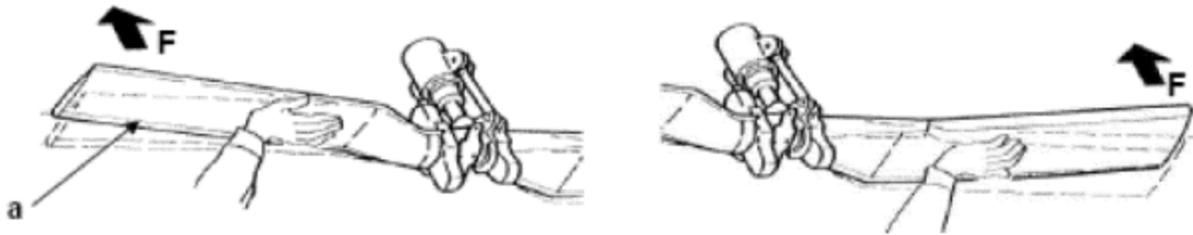
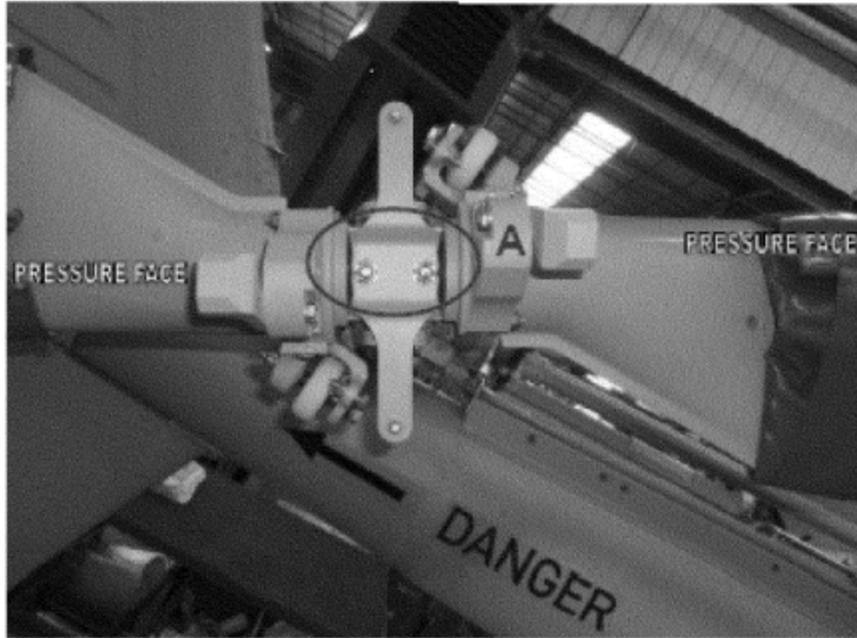
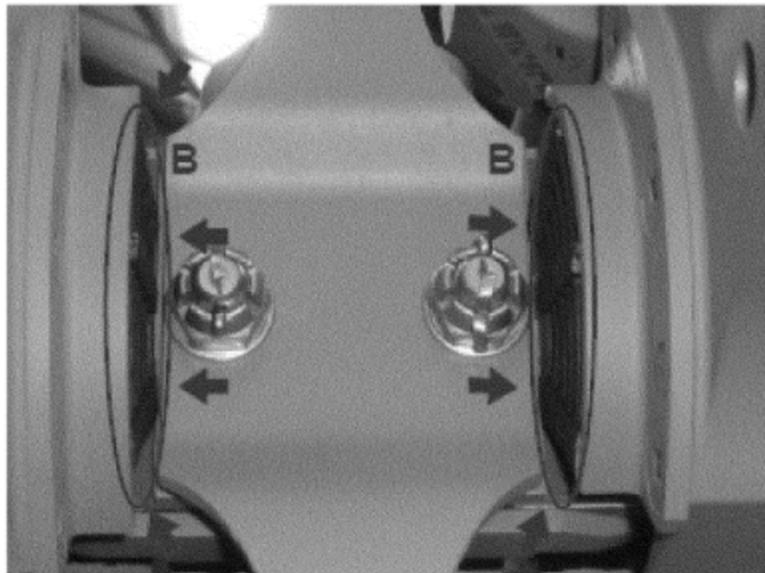
(C) While maintaining the load, check all the visible faces of the bearings (front and side faces) in area B of DETAIL A of Figure 3 to paragraph (f) of this AD for separation between the elastomer and metal parts, a crack in the elastomer, or an extrusion (see example in Figure 4 to paragraph (f) of this AD). A flashlight may be used to enhance the check.

(v) If there is an extrusion on any bearing, before further flight, replace the four bearings with airworthy bearings.

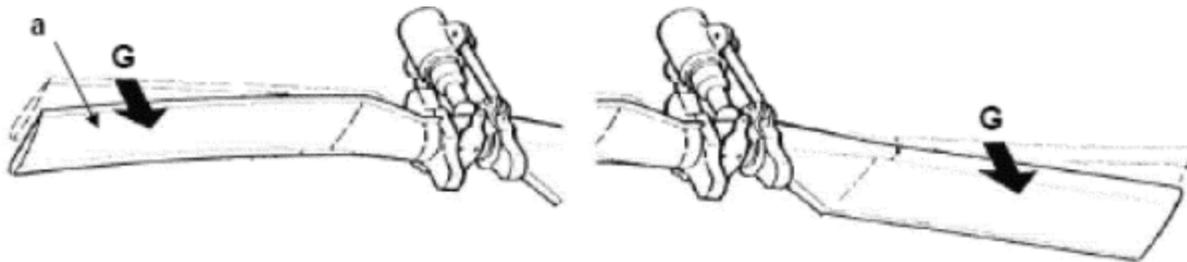
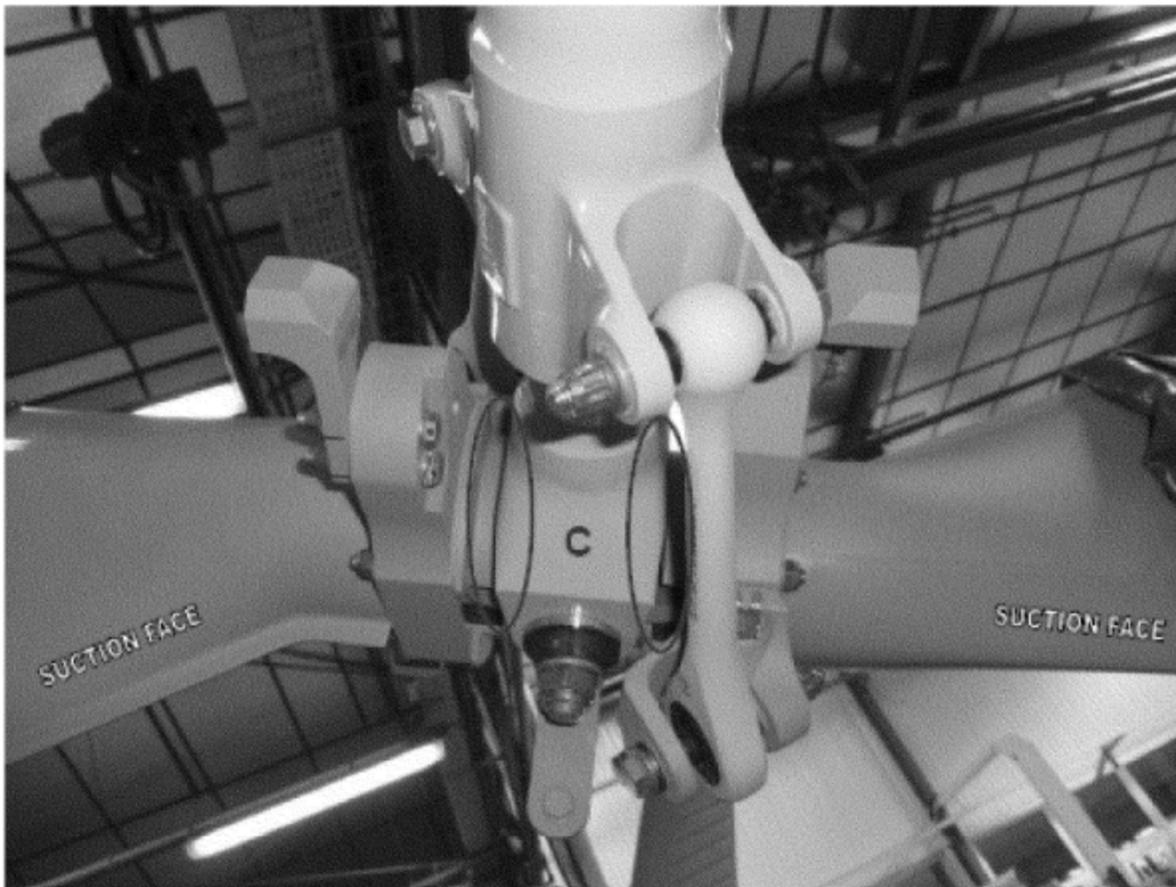
(F) While maintaining the load, check visible faces of Area C as shown in Figure 5 to paragraph (f) of this AD for any extrusion. A flashlight may be used to enhance the check.

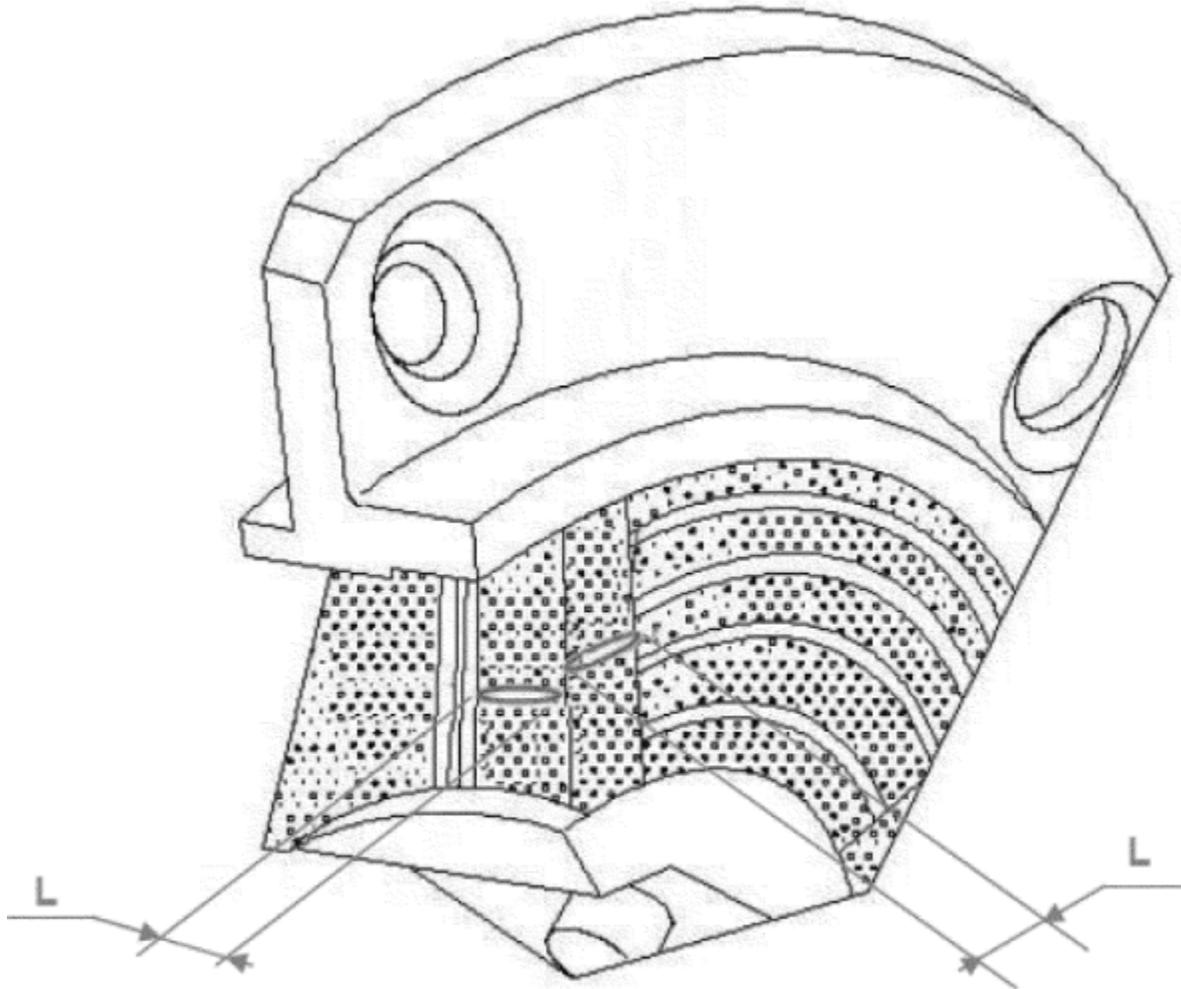
(vi) If there is a separation or a crack on the pressure side bearing, measure the separation or the crack. If the separation or crack is greater than 5 millimeters (.196 inches) as indicated by dimension "L" in Figure 6 to paragraph (f) of this AD, before further flight, replace the four bearings with airworthy bearings.
