**DATE: December 20, 2010**

**AD #: 2011-01-53**

Emergency airworthiness directive (AD) 2011-01-53 supersedes AD 2011-01-51, issued December 18, 2010, which was sent previously to all known U.S. owners/operators of PIAGGIO AERO INDUSTRIES S.p.A (Piaggio) Model PIAGGIO P-180 airplanes.

**2011-01-53** Piaggio Aero Industries S.p.A (Piaggio): Directorate Identifier 2010-CE-070-AD.

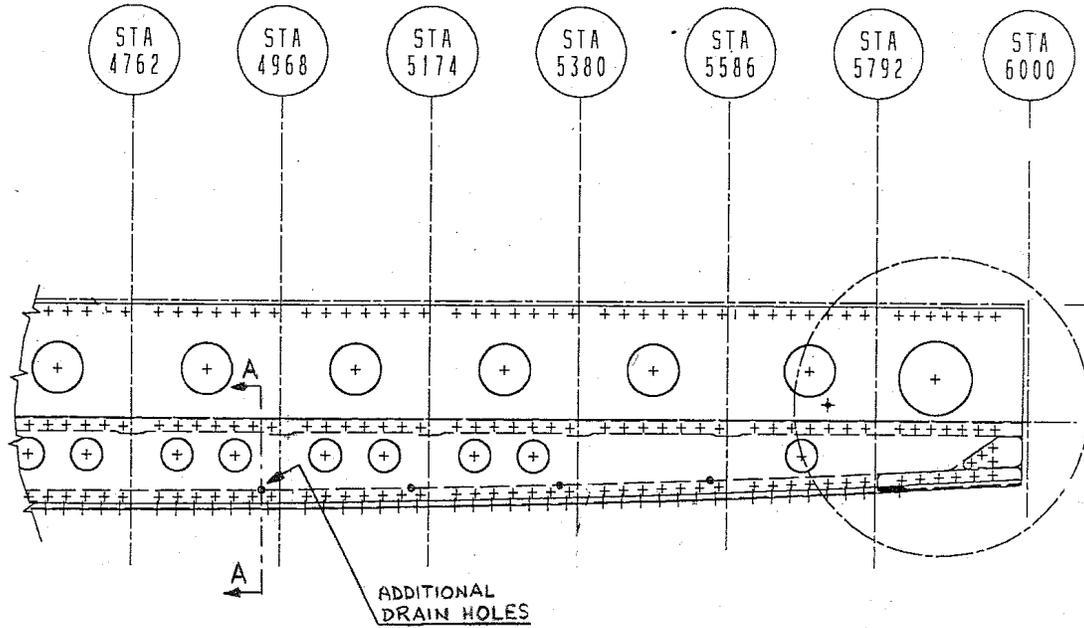
Figure 1. Additional drain holes on keel beam webs

- ii. If water is found in excess of item above (4-c-i), do step 5.
5. Add 6.3 mm draining holes as per attached figure 1 (additional drain holes on keel beam webs) connecting the lateral bays to the center ones or, as alternative, apply Piaggio Aero Industries Service Bulletin 80-0291. Then proceed with step 6.

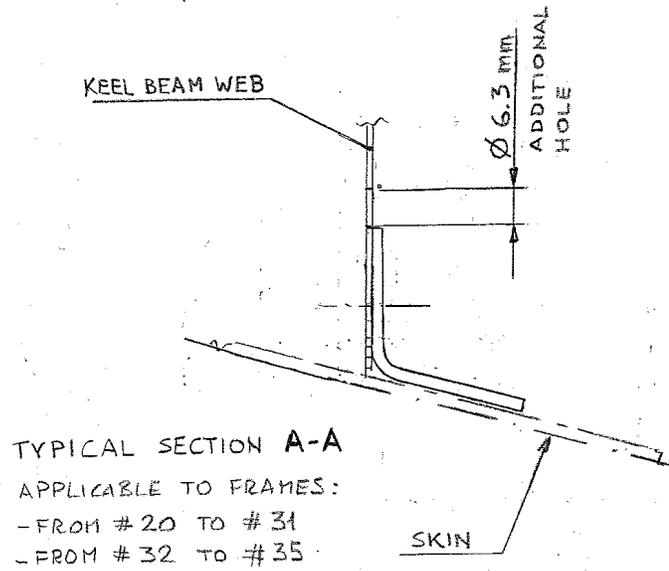
12. Test the valves and drain holes as described:
  - a. Place an adequate amount of water in each bay between FR 19 and FR 36 (See figure 2) to verify that the water is conveyed in the central bays and that it is drained. Use at least ½ gallon (approximately 2 liters).

NOTE: TAKE CARE NOT TO COME IN CONTACT WITH ELECTRICAL CONNECTORS WHILE POURING WATER.
  - b. A steady stream of water should be observed coming from the external drain holes. If not, the flapper valve does not drain properly. Cut off the rubber flap and replace the flapper valve at next A check. Take note of any cut rubber flap and its position.
