AIRWORTHINESS DIRECTIVE

AD #: 2011-01-51

2011-01-51 Piaggio Aero Industries S.p.A (Piaggio): Directorate Identifier 2010-CE-069-AD.

Appendix 1 to Emergency AD 2011-01-26
Functional Test of the Fuselage Drain Holes

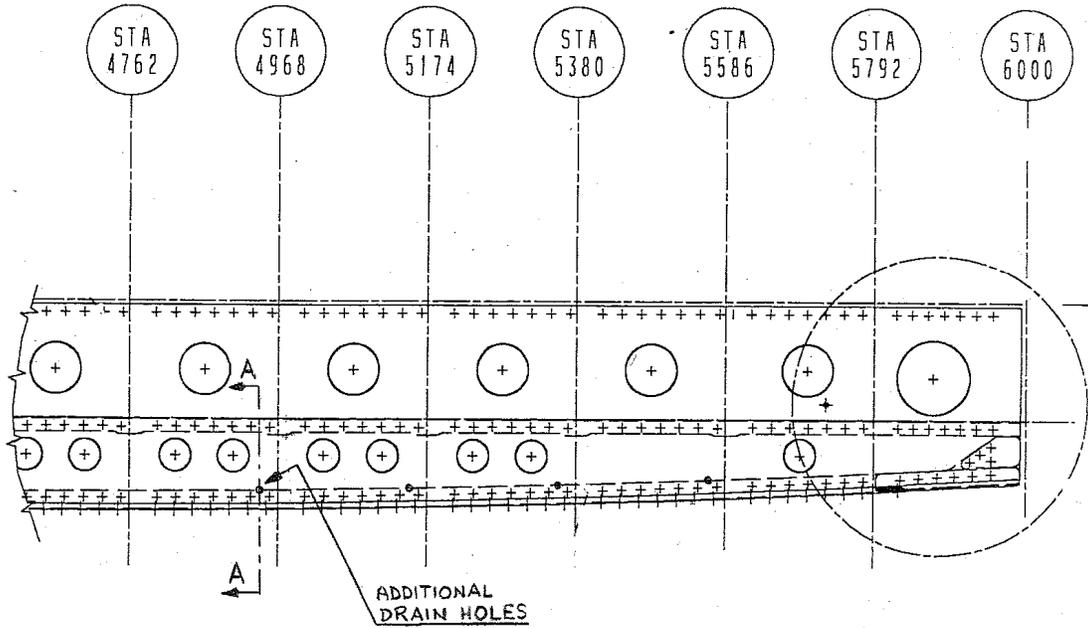
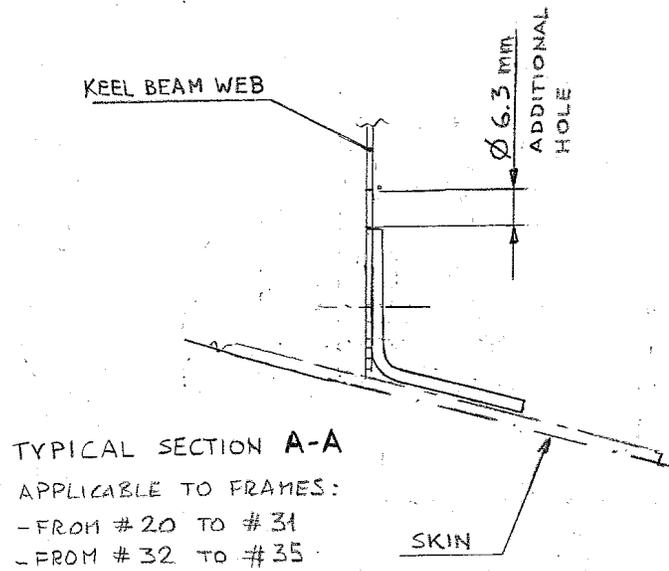
Fig 1 - Additional drain holes on keel beam webs

NOTE: BEFORE THAWING THE ICE, PUT A SUITABLE CONTAINER BELOW THE EXTERNAL DRAIN HOLES TO COLLECT THE FLUID.
 - c. Evaluate the amount of fluid collected:
 - i. If water is found only in the bottom of the belly (i.e., undrainable within the keel beams), go to step 6. Step 5 does not need to be accomplished at this time.
 - ii. If water is found in excess of item above (4-c-i), perform step 5
5. Add 6.3 mm draining holes as per attached figure 1 (Additional drain holes on keel beam webs) connecting the lateral bays to the center ones or, as alternative, apply Piaggio Aero Industries Service Bulletin 80-0291. Then proceed with step 6.
