DATE: May 18, 2012

AD #: 2012-10-53

2012-10-53 **EUROCOPTER DEUTSCHLAND GMBH (ECD)**: Directorate Identifier 2012-SW-049-AD.

This EAD defines the unsafe condition as a crack in the MRH shaft flange, which could result in failure of the MRH shaft and subsequent loss of control of the helicopter.

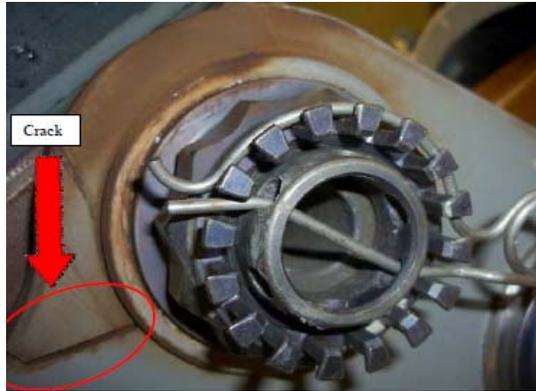
Figure 1

(1) Before further flight, and thereafter at intervals not to exceed 6 hours TIS, check the MRH shaft lower flange and the visible area of the MRH shaft upper flange for a crack. Figures 1 and 2 of this EAD are examples of cracks that have been discovered in the MRH shaft lower flange. The actions required by this paragraph may be performed by the owner/operator (pilot) holding at least a private pilot certificate, and must be entered into the aircraft records showing compliance with this EAD in accordance with 14 CFR §§ 43.9 (a)(1)-(4) and 14 CFR § 91.417(a)(2)(v). The record must be maintained as required by 14 CFR §§ 91.417, 121.380, or 135.439.

(3) If there is a crack in the upper or lower MRH shaft flange, before further flight, replace the MRH shaft.

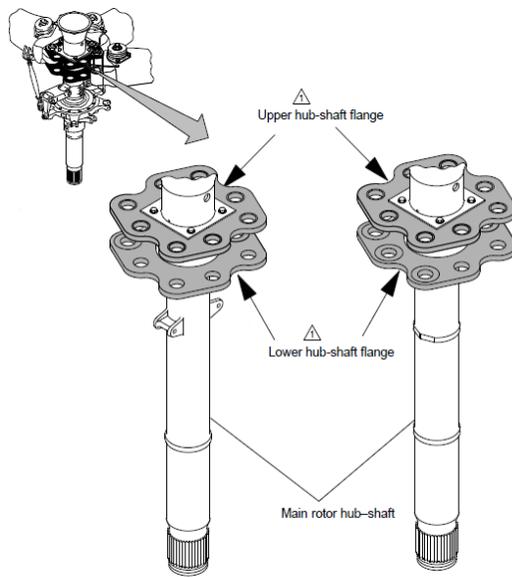
Figure 3

(ii) Clean the upper and lower MRH shaft flange as depicted in figure 3 of this EAD and visually inspect for a crack.

△ Check visible area of the upper and lower hub-shaft flange.

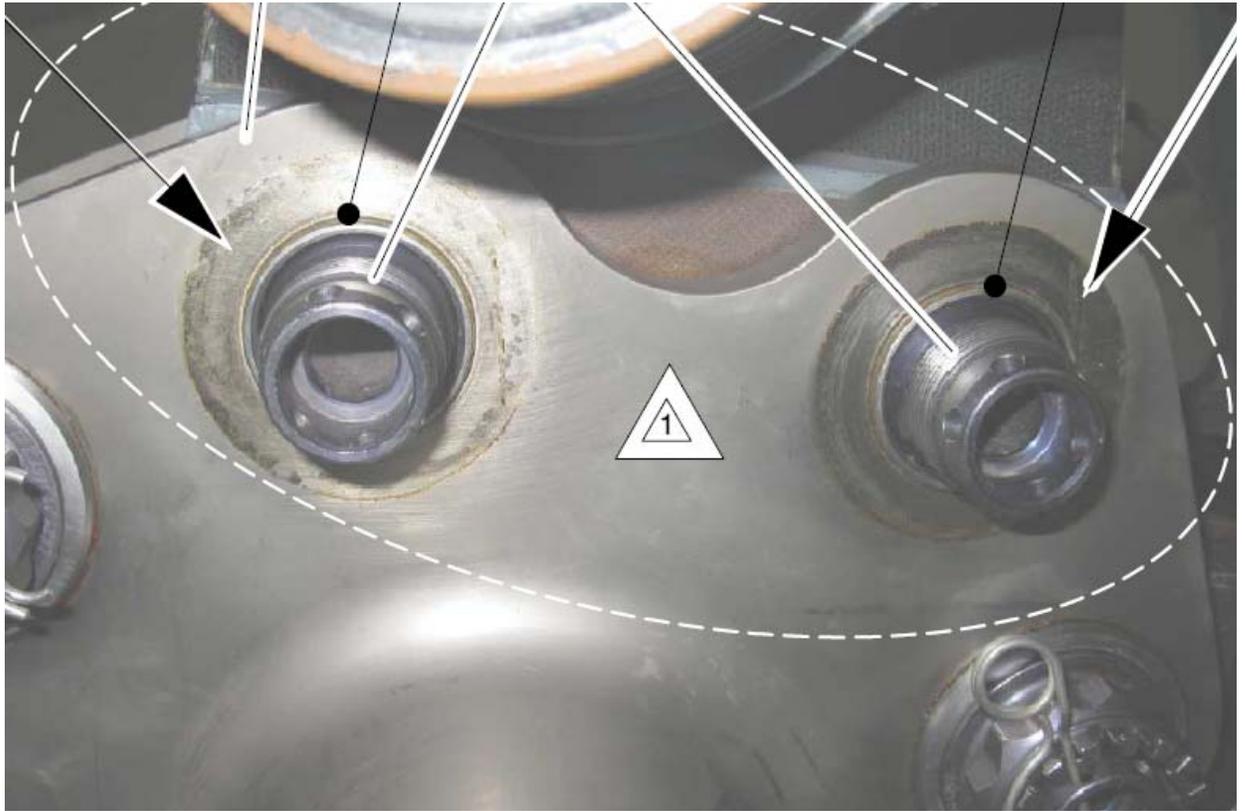
Figure 4

(v) Using a 10X or higher power magnification, inspect all lower MRH shaft flange blade bolt attachment areas for a crack as shown in figure 4 of this EAD.
