[Docket No. FAA-2012-0739; Directorate Identifier 2012-SW-044-AD; Amendment 39-17125; AD 2012-14-11]

Airworthiness Directives; Various Restricted Category Helicopters

SUMMARY: We are adopting a new airworthiness directive (AD) for Arrow Falcon Exporters, Inc. (AFE), Rotorcraft Development Corporation (RDC), and San Joaquin Helicopters (SJH) Model OH-58A, OH-58A+, and OH-58C helicopters to require inspecting the main rotor mast (mast) for a crack. This AD is prompted by two reported failures of the mast from corrosion-initiated fatigue cracking. The actions specified by this AD are intended to prevent failure of the mast and subsequent loss of control of the helicopter.

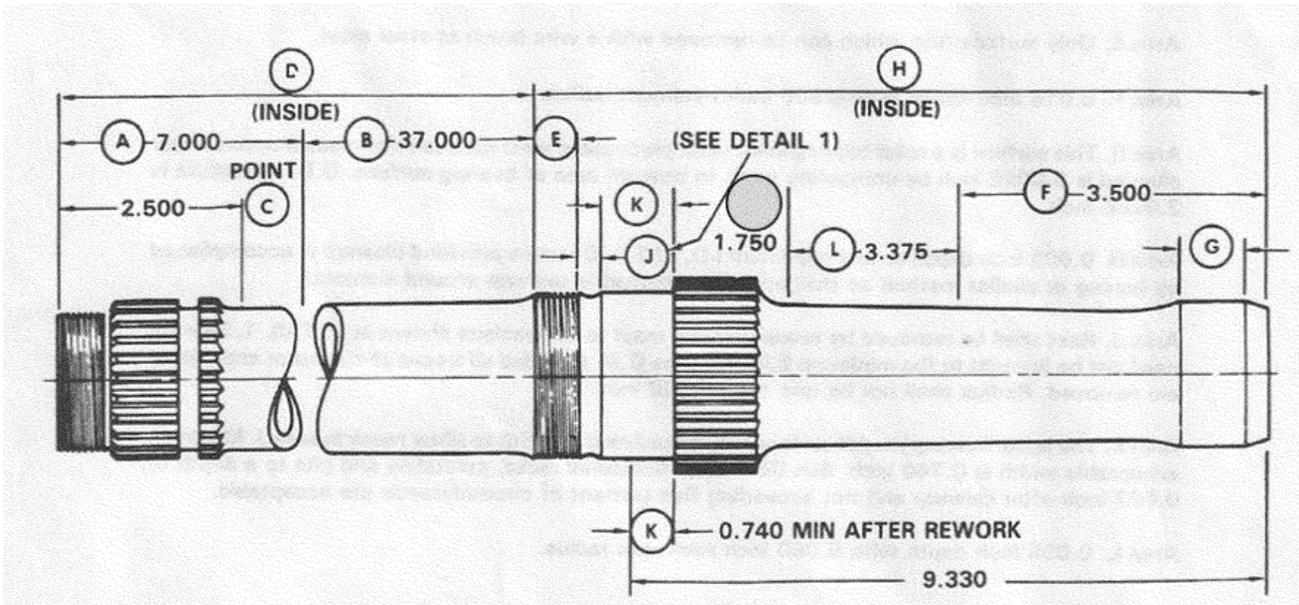
Figure 1 to Paragraph (e)

AFE reported two failures of a mast on an OH-58A+ and an OH-58C helicopter used in agricultural spraying operations. Investigation revealed that the mast failures were caused by fatigue cracking, which initiated from corrosion pitting found in the threaded section of the mast approximately 45 inches from the top of the mast. AFE issued Alert Service Bulletin: 2012-58-01, Revision 1, dated February 20, 2012 (ASB 2012-58-01), which specifies overhauling and inspecting the mast for any cracks, pitting, or corrosion by following the procedures in the latest revision of Aviation Unit and Intermediate Maintenance Manual TM55-1520-228-23. ASB 2012-58-01 further specifies replacing any mast with a crack, pitting, or corrosion beyond surface rust that is removed with a wire brush or steel wool in the threaded portion of the mast.

- (1) Within 30 days, unless accomplished previously within the last 12 months:
 - (i) Overhaul the main rotor mast assembly and magnetic particle inspect the mast; mast bearing nut; plate, mast and seal; and bearing liner for a crack.
 - (ii) Fluorescent penetrant inspect the locking plate for a crack.
 - (iii) Using a 10X or higher magnifying glass, inspect the threaded area of the mast as shown in area E of figure 1 to paragraph (e) of this AD for pitting, corrosion, or a crack. Remove any surface rust with a wire brush or steel wool.

(2) If there is a crack, pitting, or corrosion, before further flight, replace the mast with an airworthy mast.

(3) Within 10 days, report any findings of a crack, pitting, or corrosion to the address listed in paragraph (g)(1) of this AD. Include the number of hours TIS and calendar time since the last overhaul and inspection of the mast and the restricted category type of the helicopter.
