[Docket No. FAA-2015-8463; Directorate Identifier 2014-NM-226-AD; Amendment 39-18612; AD 2016-16-14]

Airworthiness Directives; Airbus Airplanes

ACTION: Final rule.

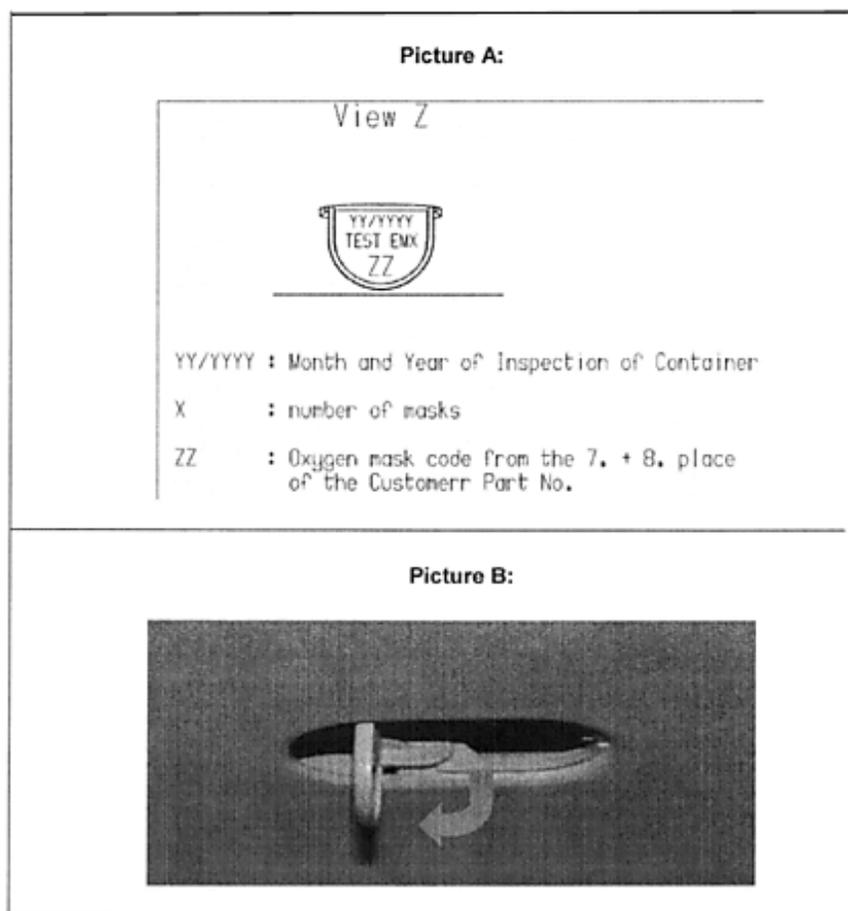
Figure 1 to Paragraph (l)(4) of this AD – Design A of the Passenger Oxygen Containers

(4) Airplanes on which the design of the passenger oxygen container is not Design A, as defined in figure 1 to paragraph (l)(4) of this AD, are excluded from the requirements of paragraph (i) of this AD for that passenger oxygen container.

Note 2 to paragraph (l)(4) of this AD: For "Design A," the placard on the passenger oxygen container test button is as described in "Picture A" in figure 1 to paragraph (l)(4) of this AD. The mask configuration ("ZZ" in "Picture A") is a number, and the test button is as shown in "Picture B."
