[Docket No. 2002-SW-25-AD; Amendment 39-13709; AD 2003-13-15 R1]

Airworthiness Directives; Schweizer Aircraft Corporation Model 269A, 269A-1, 269B, 269C, and TH-55A Helicopters

ACTION: Final rule.

2003-13-15 R1 Schweizer Aircraft Corporation: Amendment 39-13709. Docket No. 2002-SW-25-AD. Revises AD 2003-13-15, Amendment 39-13217, Docket No. 2002-SW-25-AD.

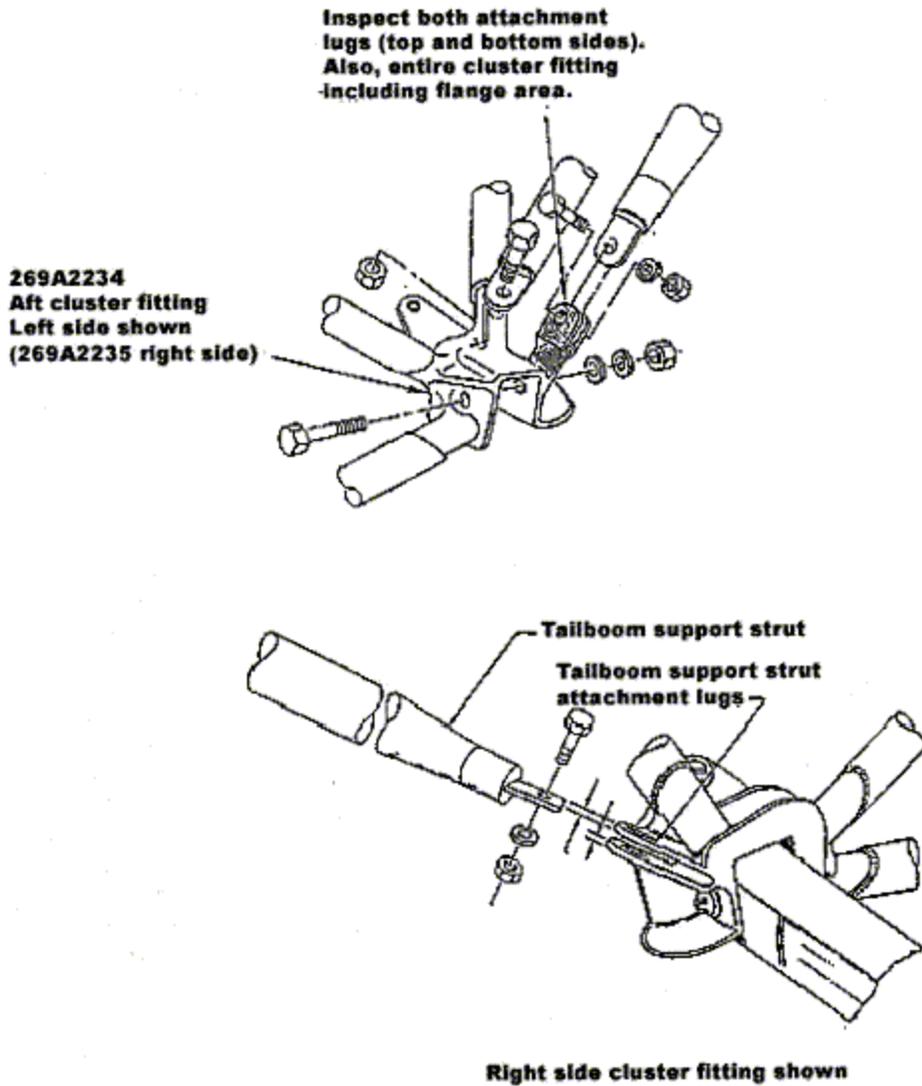
Figure 1

To prevent failure of a tailboom support strut or lug on a cluster fitting, which could cause rotation of a tailboom into the main rotor blades, and subsequent loss of control of the helicopter, accomplish the following:

(2) Dye-penetrant inspect the lugs on each cluster fitting. See the following Figure 1:

(3) If a crack is found, before further flight, replace the cracked cluster fitting with an airworthy cluster fitting.

(c) Within 150 hours TIS or 6 months, whichever occurs first, replace each cluster fitting, P/N 269A2234 and P/N 269A2235, with an airworthy cluster fitting or modify each cluster fitting, P/N 269A2234 and P/N 269A2235, with Kit, P/N SA-269K-106-1. Installing the kit is terminating action for the 50-hour TIS repetitive dye-penetrant inspection for these cluster fittings. Broken or cracked cluster fittings are not eligible for the kit modification.
