[Docket No. FAA-2005-22696; Directorate Identifier 2005-SW-22-AD; Amendment 39-14877; AD 2007-01-06]

Airworthiness Directives; Bell Helicopter Textron Canada Model 206A, B, L, L-1, L-3, and L-4 Helicopters

ACTION: Final rule.

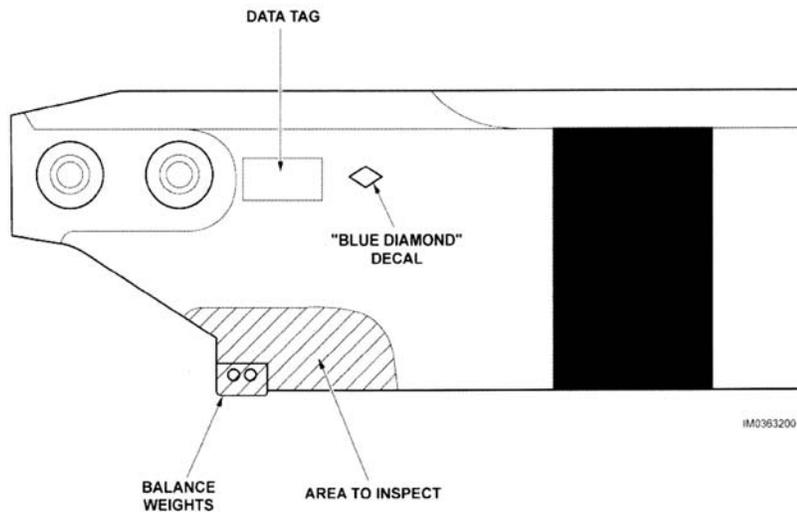
Figure 1. Tail rotor blade inspection.

Transport Canada, the airworthiness authority for Canada, notified the FAA that an unsafe condition may exist on these helicopter models. Transport Canada advises of three reports of skin cracks originating near the blade trailing edge balance weight. Two of the occurrences caused a loss of the weight and a strip of material along the trailing edge leading to an imbalance, which caused the fracture of three of the four tail rotor gearbox attachments. One of these occurrences resulted in the gearbox shifting that caused failure of the drive shaft and resulting loss of yaw control. Transport Canada issued AD No. CF-2004-05R1, dated June 28, 2004, to ensure the continued airworthiness of these helicopters in Canada.

(a) Before further flight, unless accomplished previously, and before installing any blade with a P/N and S/N listed in the applicability section of this AD, clean the blade. Using a 10X or higher magnifying glass, inspect both sides of each blade for a deformation, a crack, and a bent or deformed weight in the area shown in Figure 1 of this AD.

Note 1: Paint irregularities on the blade may indicate a crack.

(1) At intervals not to exceed 12 hours time-in-service (TIS), using a 10X or higher magnifying glass, inspect both sides of each blade for a deformation, a crack, and a bent or deformed weight in the area shown in Figure 1 of this AD, or

(2) Inspect and check both sides of each blade for a deformation, a crack, and a bent or deformed weight in the area shown in Figure 1 of this AD as follows:

(c) Before further flight, replace any blade that has a deformation, a crack, or a bent or deformed weight with an airworthy blade.

(d) On or before April 27, 2007, for any affected part-numbered blade with a S/N listed in the applicability section of this AD:

(1) Replace the blade with a blade that has a S/N other than one listed in the applicability section of this AD, or

(2) Replace the blade with a blade that has a S/N listed in the applicability section of this AD and also has a "V" suffix.
