**[Docket No. FAA-2015-3989; Directorate Identifier 2014-NM-250-AD; Amendment 39-18600; AD 2016-16-02]**

#### **Airworthiness Directives; Airbus Airplanes**

**SUMMARY:** We are adopting a new airworthiness directive (AD) for all Airbus Model A318, A319, A320, and A321 series airplanes. This AD was prompted by reports of premature aging of certain passenger chemical oxygen generators that resulted in the generators failing to activate. This AD requires an inspection to determine if certain passenger chemical oxygen generators are installed and replacement of affected passenger chemical oxygen generators. We are issuing this AD to prevent failure of the passenger chemical oxygen generator to activate and consequently not deliver oxygen during an emergency, possibly resulting in injury to the airplane occupants.

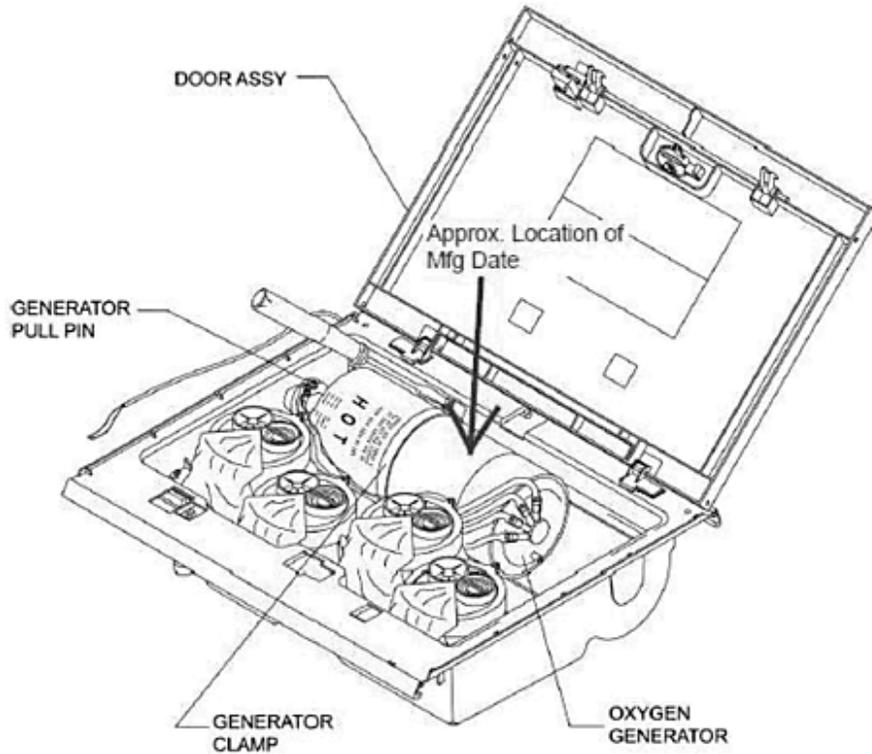
**Figure 1 to Paragraph (g) of this AD - Location of Date (MM-YY)**

Within 30 days after the effective date of this AD: Do a one-time inspection of passenger chemical oxygen generators, part numbers (P/N) 117042-02 (15 minutes (min)–2 masks), 117042-03 (15 min–3 masks), 117042-04 (15 min–4 masks), 117042-22 (22 min–2 masks), 117042-23 (22 min–3 masks), and 117042-24 (22 min–4 masks) to determine the date of manufacture as specified in Airbus Alert Operators Transmission (AOT) A35N006-14, dated December 10, 2014, including Appendix 1. Refer to figures 1 and 2 to paragraph (g) of this AD for the location of the date. A

review of airplane maintenance records is acceptable for the inspection required by this paragraph, provided the date of manufacture can be conclusively determined by that review.

If, during any inspection required by paragraph (g) of this AD, any passenger chemical oxygen generator having a date of manufacture in 1999, 2000, or 2001 is found: At the applicable time specified in paragraph (h)(1), (h)(2), or (h)(3) of this AD, remove and replace the affected passenger chemical oxygen generator with a serviceable unit, in accordance with Airbus AOT A35N006-14, dated December 10, 2014, including Appendix 1 (for 15-minute and 22-minute passenger chemical oxygen generators); or the Accomplishment Instructions of B/E Aerospace Service Bulletin 117042-35-001, Revision 004, dated October 13, 2015 (for 15-minute passenger chemical oxygen generators).
