[Docket No. FAA-2007-27343; Directorate Identifier 2007-SW-05-AD; Amendment 39-15030; AD 2007-05-51]

Airworthiness Directives; MD Helicopters Inc. (MDHI) Model MD600N Helicopters

2007-05-51 MD Helicopters Inc. (MDHI): Amendment 39-15030. Docket No. FAA-2007-27343; Directorate Identifier 2007-SW-05-AD.

Applicability: Model MD600N helicopters, with a lateral mixer output link assembly (mixer link), part number (P/N) 600N7636-1, -3, -9, or -11 installed, certificated in any category.

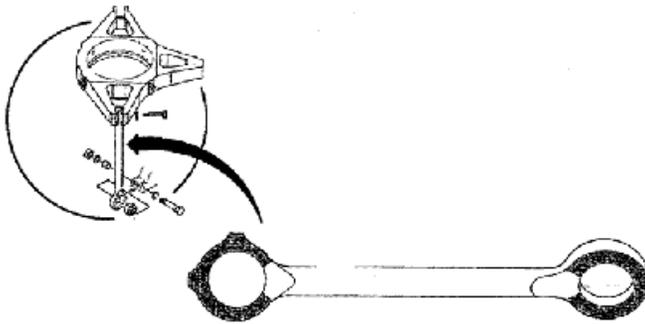
Figure 1

To detect a crack in the mixer link, which could result in failure of the mixer link and subsequent loss of control of the helicopter, accomplish the following:

(1) Remove each mixer link and visually inspect, with a bright light and a 10x or higher magnifying glass, the shaded areas around the bearing bore for any crack as depicted in the following Figure 1:

Bearings have been removed for clarity.

(2) Perform an eddy current inspection of each mixer link in the bearing end areas.

(3) Replace any cracked mixer link with an airworthy mixer link on which an eddy current inspection has been performed.
