[Docket No. 98-NM-300-AD; Amendment 39-14355; AD 2005-22-11]

Airworthiness Directives; Mitsubishi Model YS-11 Airplanes, and Model YS-11A-200, YS-11A-300, YS-11A-500, and YS-11A-600 Series Airplanes

ACTION: Final rule.

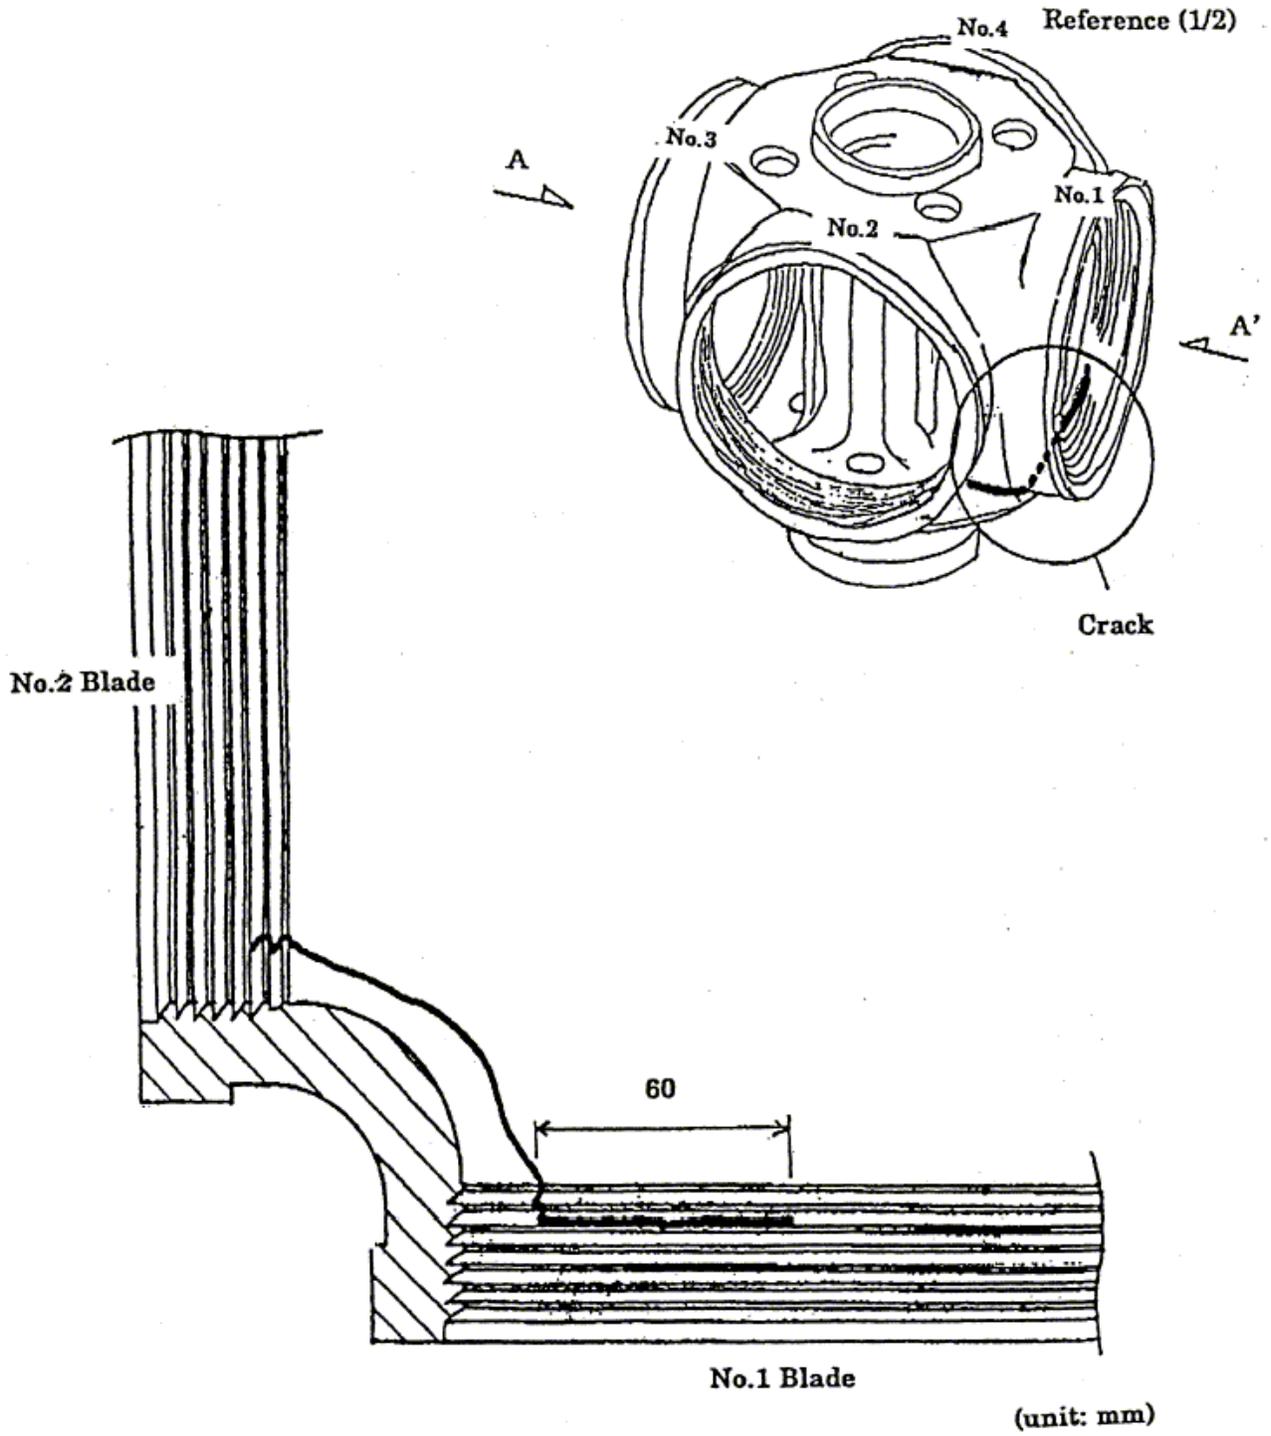
HUB CRACK - VIEW FROM TOP

To detect and correct fatigue cracking of the propeller hub, which could cause the loss of the propeller, accomplish the following:

(a) Within 25 flight hours or 30 days after the effective date of this AD, whichever occurs first, remove the spinner and perform a detailed inspection for cracking of the propeller hub in the crack area shown in Figure 1 of this AD.

(1) If no crack is found, repeat the actions required by paragraph (a) of this AD thereafter at intervals not to exceed 25 flight hours.

(2) If any crack is detected, prior to further flight, replace the hub with a new hub according to a method approved by either the Manager, Los Angeles Aircraft Certification Office (ACO), FAA; or the Japan Civil Aviation Bureau (JCAB) (or its delegated agent). Chapter 61 of the Nihon Aeroplane Manufacturing Company YS-11 and YS-11A Aircraft Maintenance Manuals is one approved method. Repeat the actions required by paragraph (a) of this AD thereafter at intervals not to exceed 25 flight hours.
