[Docket No. FAA-2013-0019; Directorate Identifier 2010-SW-051-AD; Amendment 39-17485; AD 2013-12-07]

Airworthiness Directives; Bell Helicopter Textron Canada Helicopters

ACTION: Final rule.

2013-12-07 Bell Helicopter Textron Canada (BHTC): Amendment 39-17485; Docket No. FAA-2013-0019; Directorate Identifier 2010-SW-051-AD.

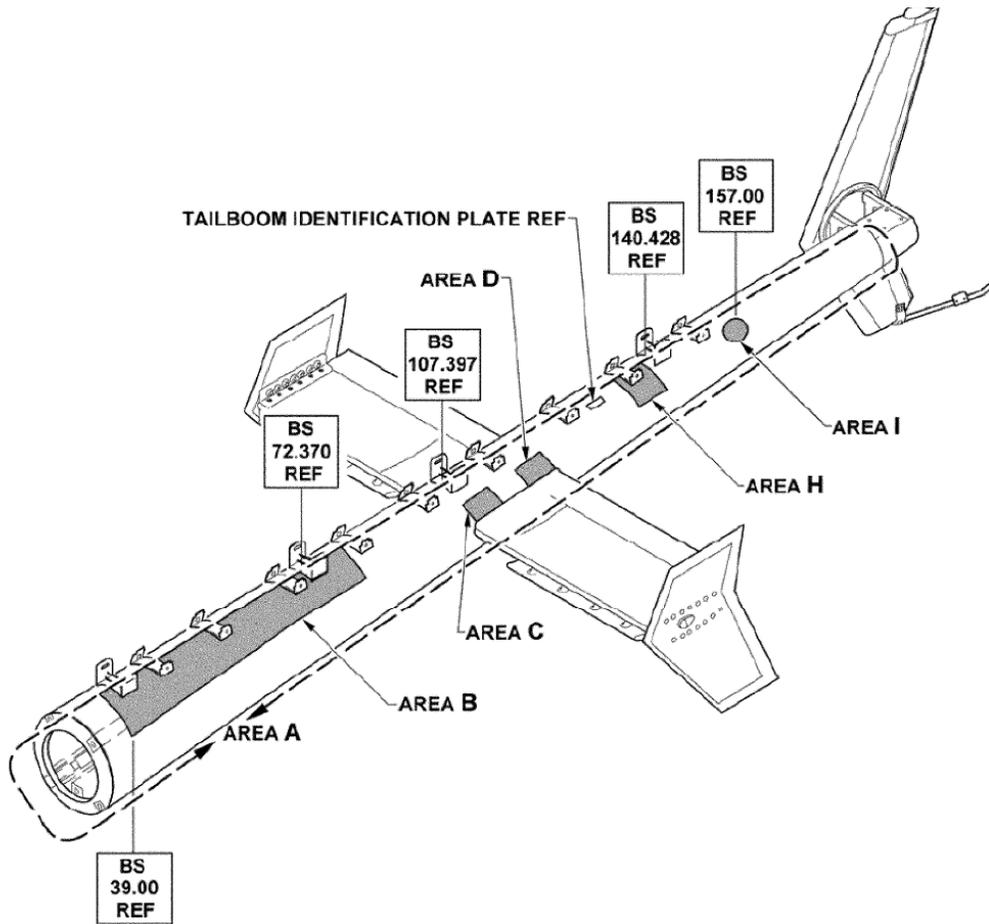
Figure 1 to Paragraph (e)

This AD defines the unsafe condition as high-stress-concentration areas in the tailboom skin that are at risk of cracking. This condition could result in a crack in the tailboom assembly, failure of the tailboom, and subsequent loss of helicopter control.

(A) Before the first flight of each day, visually check for a crack in the "C" and "D" areas depicted in Figures 1 and 2 to Paragraph (e) of this AD. The actions required by this paragraph may be performed by the owner/operator (pilot) holding at least a private pilot certificate, and must be entered into the aircraft records showing compliance with this AD in accordance with 14 CFR 43.9(a)(1)-(4) and 14 CFR § 91.417(a)(2)(v). The record must be maintained as required by 14 CFR 91.417, 121.380, or 135.439; or

(5) If there is a crack in the tailboom assembly, before further flight, replace it with an airworthy tailboom assembly.

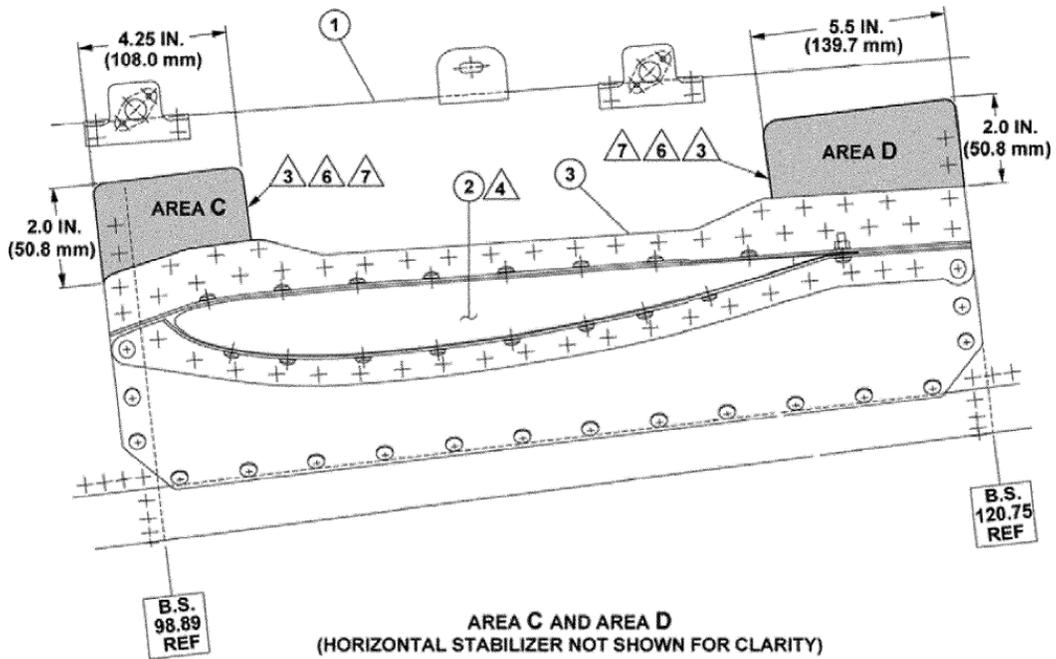
(B) Within 25 hours TIS, or 30 days, whichever comes first, and thereafter at intervals not to exceed 50 hours TIS, clean and inspect for a crack around each fastener and just above the edge of the upper stabilizer support in the "C" and "D" areas on the left side of the tailboom assembly, as depicted in Figure 2 to Paragraph (e) of this AD, using a 10X or higher power magnifying glass.
