[Federal Register: December 16, 2004 (Volume 69, Number 241)]
[Rules and Regulations]
[Page 75236-75243]
From the Federal Register Online via GPO Access [wais.access.gpo.gov]
[DOCID:fr16de04-7]

[Docket No. FAA-2004-18744; Directorate Identifier 2004-CE-24-AD; Amendment 39-13910; AD 2004-25-22]

Airworthiness Directives; Great Lakes Aircraft Company, LLC, Models 2T-1A-1 and 2T-1A-2 Airplanes

2004-25-22 Great Lakes Aircraft Company, LLC: Amendment 39-13910; Docket No. FAA-2004-18744; Directorate Identifier 2004-CE-24-AD; Supersedes AD 79-20-08; Amendment 39-3580.

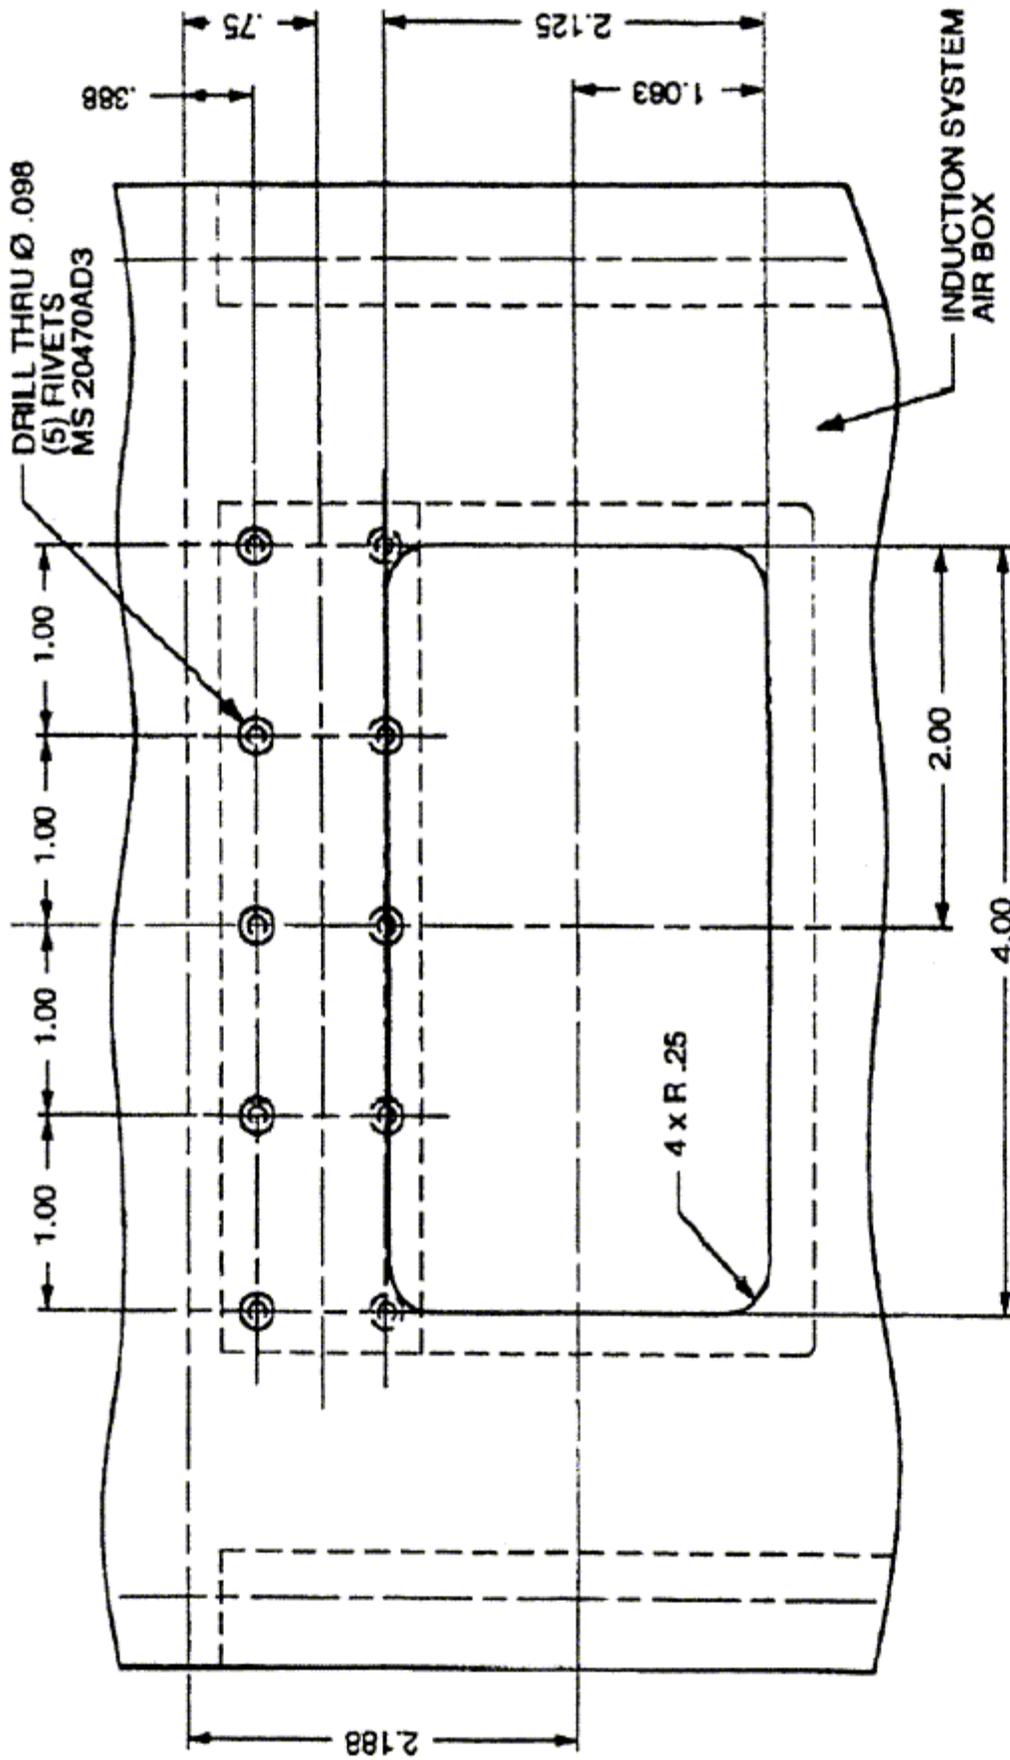
Figure 1

GREAT LAKES AIRCRAFT, TYPES 2T-1A-1 AND 2T-1A-2
ENGINE INDUCTION SYSTEM AD 79-20-08
ALTERNATE AIR DOOR INSTALLATION
FULL SCALE

(2) Visually inspect the alternate air door for distortion, heat damage, and cracks. If any damage is found, repair or fabricate a new door following Figure 1, Figure 2, and Figure 3 in this AD.	<i>For airplanes previously affected by AD 79–20–08:</i> Initially inspect at the next scheduled inspection required by AD 79–20–08 or within the next 25 hours TIS after January 28, 2005 (the effective date of this AD), whichever occurs later. Repetitively inspect thereafter at intervals not to exceed 100 hours TIS. <i>For airplanes not previously affected by AD 79–20–08:</i> Inspect within the next 25 hours TIS after January 28, 2005 (the effective date of this AD). Repetitively inspect thereafter at intervals not to exceed 100 hours TIS. <i>For all affected airplanes:</i> After each inspection, if damage is found during any inspection, before further flight, repair, replace the damaged alternate air door.	Not applicable.

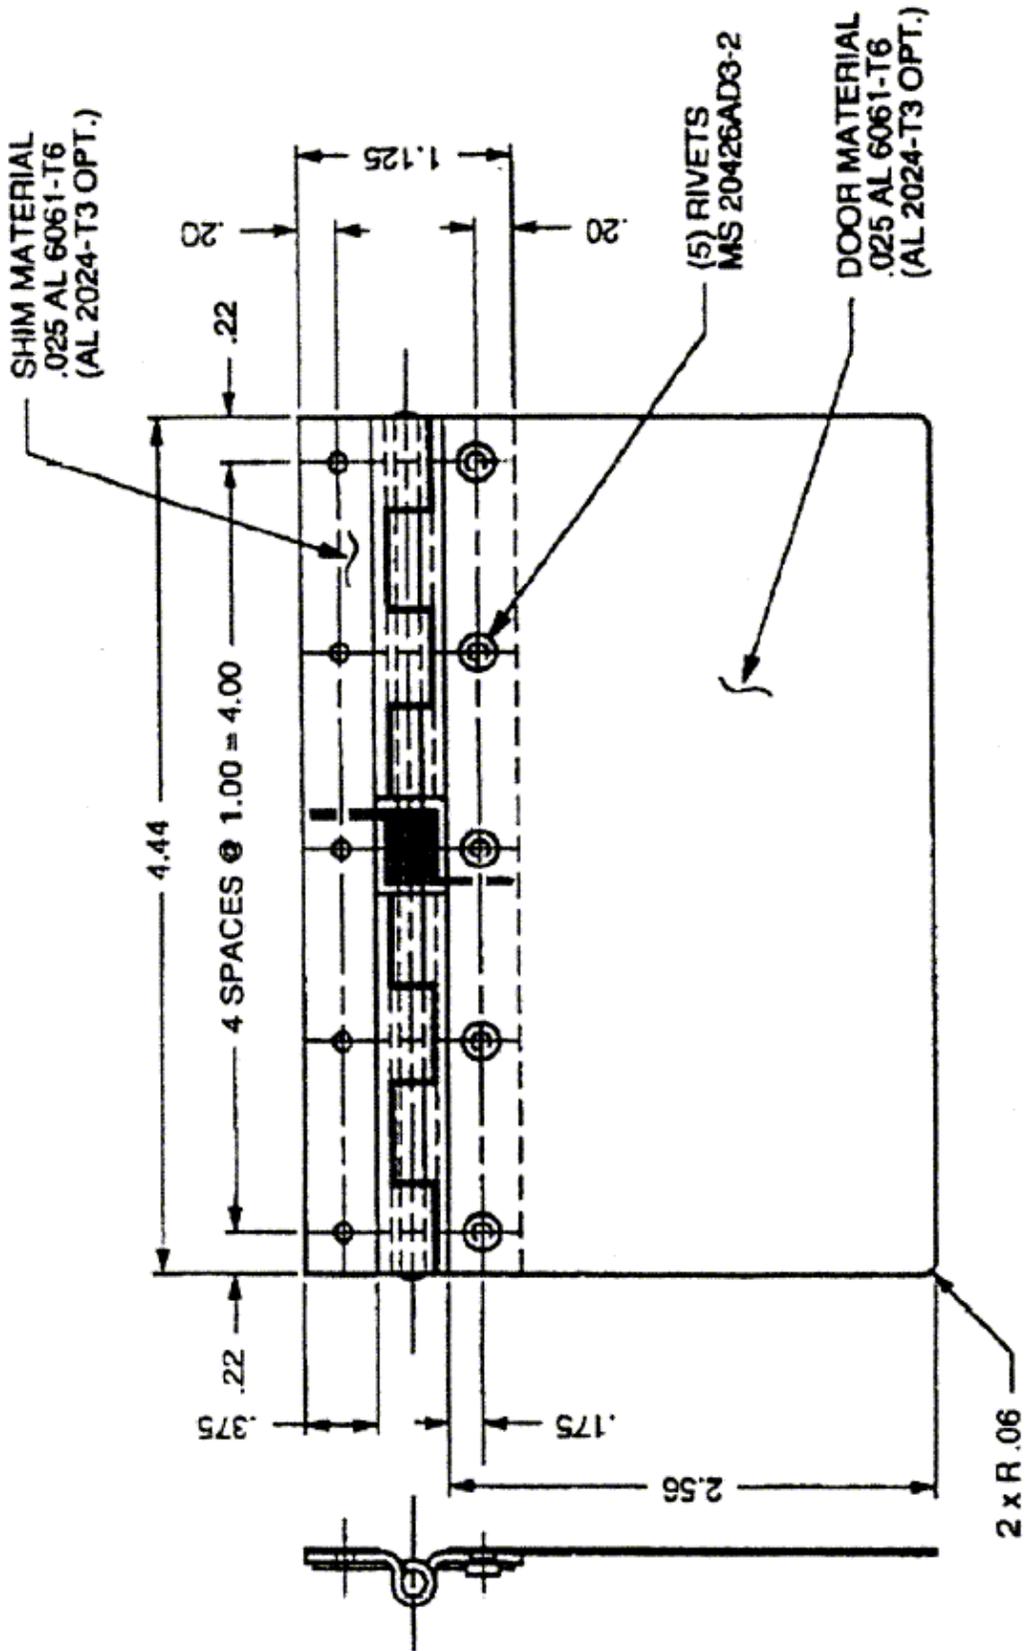
Figure 2

GREAT LAKES AIRCRAFT, TYPES 2T-1A-1 AND 2T-1A-2
ENGINE INDUCTION SYSTEM AD 79-20-08
ALTERNATE AIR DOOR FABRICATION DETAIL
FULL SCALE

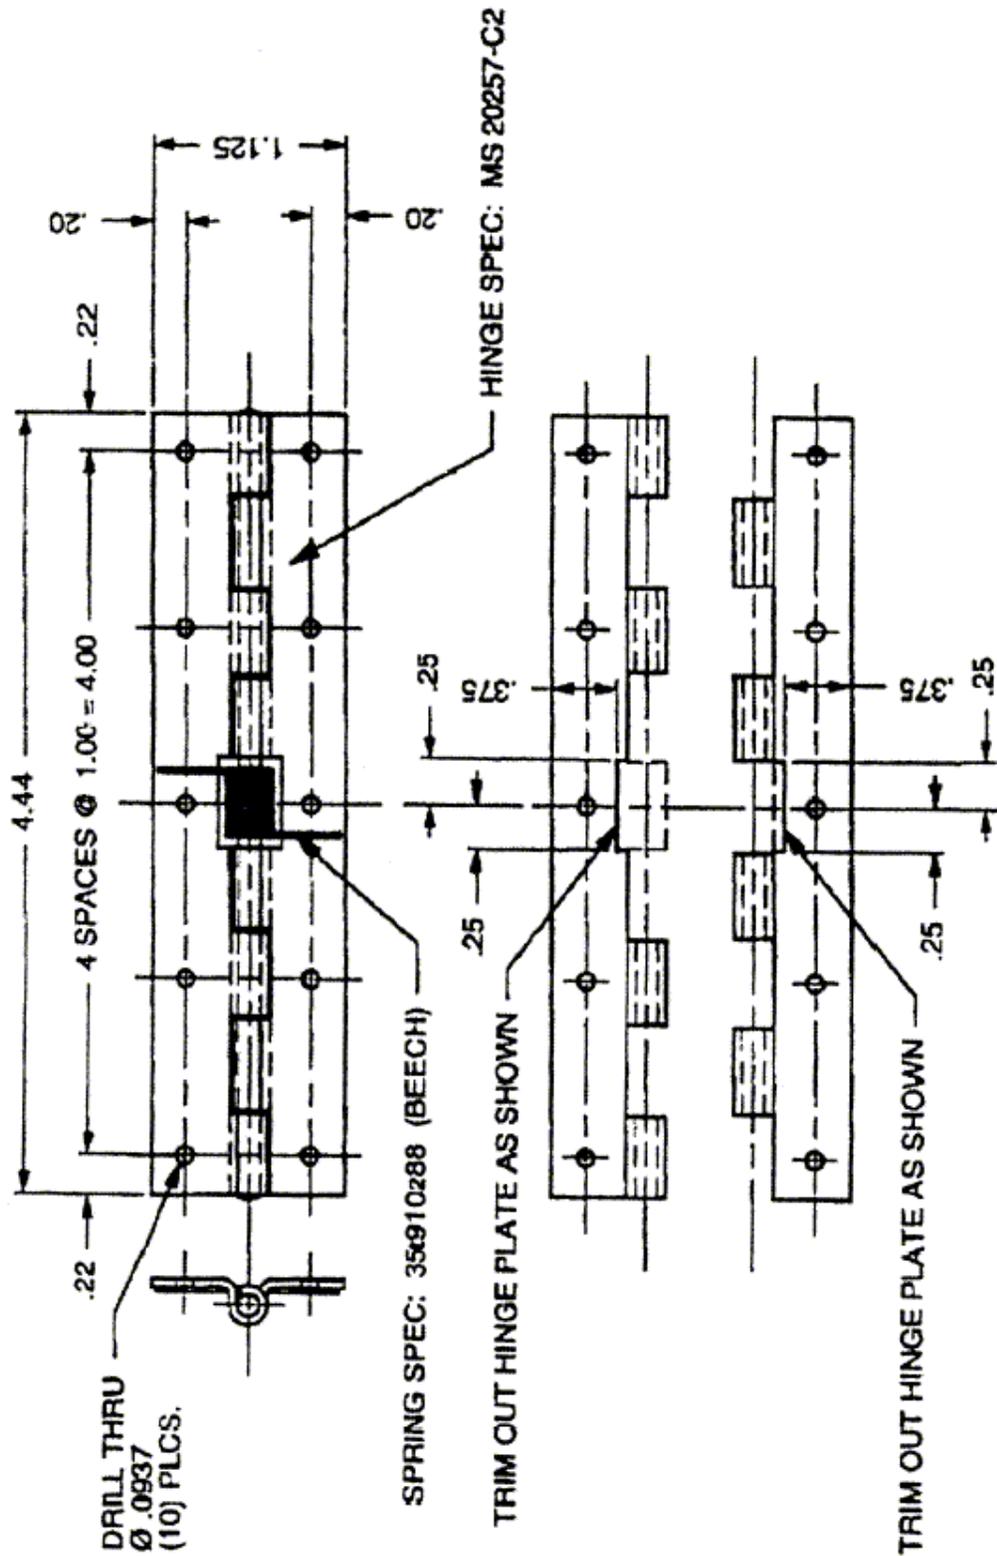
Figure 3

GREAT LAKES AIRCRAFT, TYPES 2T-1A-1 AND 2T-1A-2
 ENGINE INDUCTION SYSTEM AD 79-20-08
 ALTERNATE AIR DOOR HINGE DETAIL
 FULL SCALE
