[Docket No. FAA-2005-21680; Directorate Identifier 2004-SW-48-AD; Amendment 39-14341; AD 2005-21-03]

Airworthiness Directives; Bell Helicopter Textron Canada Model 206A, A-1, B, B-1, L, L-1, L-3, L-4 Helicopters

2005-21-03 Bell Helicopter Textron Canada: Amendment 39-14341. Docket No. FAA-2005-21680; Directorate Identifier 2004-SW-48-AD.

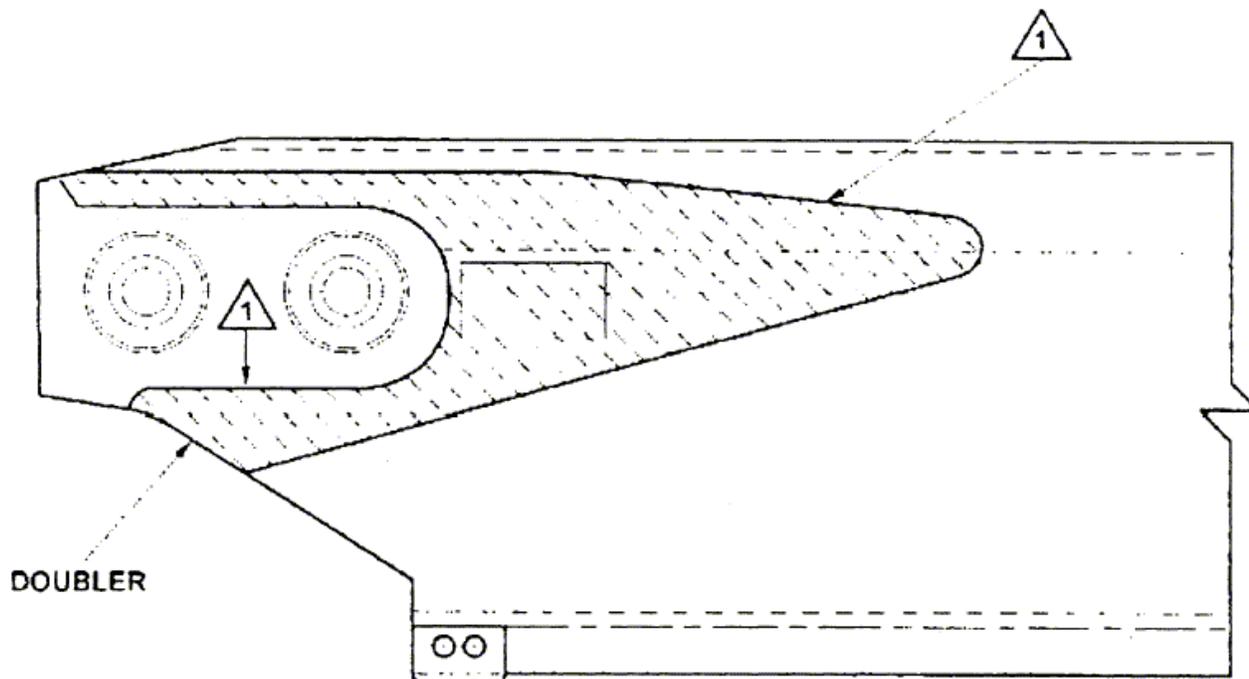
Transport Canada, the airworthiness authority for Canada, notified the FAA that an unsafe condition may exist on Model 206A, B, and L series helicopters. Transport Canada advises that an inadequate surface preparation on a limited number of blades resulted in two reported instances of blade root doubler de-bond. They also advise that to ensure blade integrity all suspected blades are to be checked daily until removed from service.

(a) Before the first flight of each day, clean each blade and visually check the blade root doublers for an edge void or de-bond on both sides of each blade as depicted in Figure 1 of this AD. An owner/operator (pilot), holding at least a private pilot certificate, may perform this visual check and must enter compliance with this paragraph into the helicopter maintenance records by following 14 CFR sections 43.11 and 91.417(a)(2)(v).

1 Inspect the doubler for an edge void or de-bond on both sides of each blade.

(b) If an edge void or a de-bond is found, before further flight, replace the blade with an airworthy blade with a serial number other than those to which this AD applies.

(c) Within 100 hours time-in-service, replace all affected, serial-numbered blades with airworthy blades with a serial number other than those to which this AD applies.
