[Federal Register: June 12, 2009 (Volume 74, Number 112)]
[Rules and Regulations]
[Page 27915-27917]
From the Federal Register Online via GPO Access [wais.access.gpo.gov]
[DOCID:fr12jn09-6]

[Docket No. FAA-2009-0484; Directorate Identifier 2008-SW-44-AD; Amendment 39-15924; AD 2009-12-01]

Airworthiness Directives; Bell Helicopter Textron, Inc. Model 47, 47B, 47B3, 47D, 47D1, 47E, 47G, 47G-2, 47G-2A, 47G-2A-1, 47G-3, 47G-3B, 47G-3B-1, 47G-3B-2, 47G-3B-2A, 47G-4, 47G-4A, 47G-5, 47G-5A, 47H-1, 47J, 47J-2, 47J-2A, and 47K Helicopters

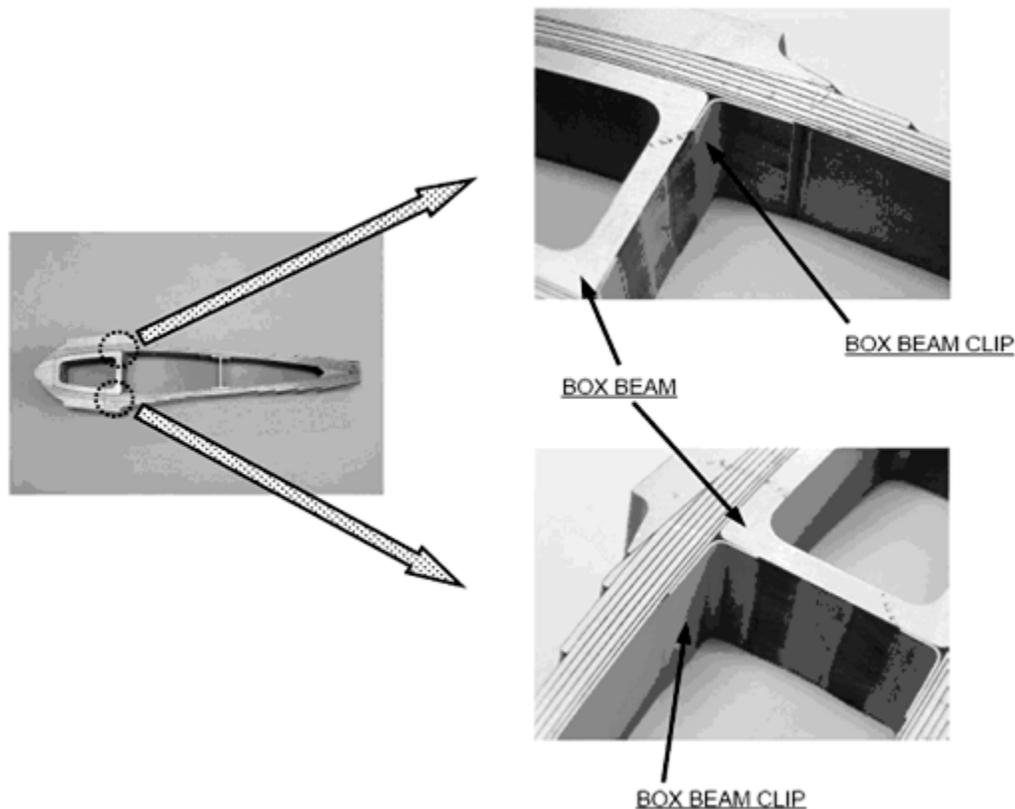
(a) Within 10 hours time-in-service (TIS), visually inspect the entire length of each upper and lower clip of each main rotor blade from the main rotor blade tip to the root by following Part II of the Accomplishment Instructions, paragraphs 1. through 8., of Bell Helicopter Textron, Inc. Alert Service Bulletin No. 47-08-25, dated May 26, 2008 (ASB) and referring to the depictions in Figures 1 and 2 of the ASB and Figure 1 of this AD for correct installation.

Figure 1 - Correct Installation of Clip for Box Beam

(b) Before further flight, if you find a main rotor blade with an incorrectly installed clip, replace that unairworthy main rotor blade with an airworthy main rotor blade that has a clip that is installed correctly.
