## **DEPARTMENT OF TRANSPORTATION**

### **Federal Aviation Administration**

**[Docket No. FAA-2012-0896; Directorate Identifier 2010-SW-070-AD; Amendment 39-17173; AD 2012-17-10]**

#### **Airworthiness Directives; Various Restricted Category Helicopters**

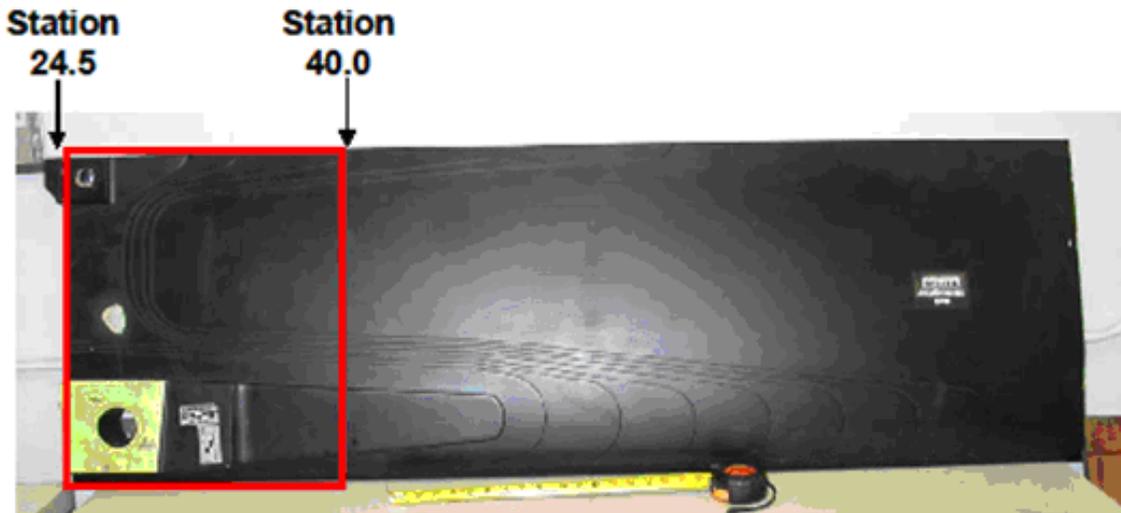
**Figure 1 to paragraph (e)(1)(ii)**

- (1) Within 25 hours time-in-service (TIS), and thereafter at intervals not to exceed 25 hours TIS:
  - (i) Wash the upper and lower surfaces of each affected M/R blade with a solution of cleaning compound (C-318) and water. Rinse thoroughly and wipe dry.
  - (ii) Using a 3x power or higher magnifying glass and a bright light, on each affected M/R blade, in an area from blade stations 24.5 to 40, including the entire width of the M/R blade chord, as depicted in Figure 1 to Paragraph (e) of this AD:

(A) Visually inspect the upper and lower grip plates and doublers of the M/R blade for an edge void, any corrosion, or a crack.

(B) Visually inspect the remaining upper and lower surfaces of the M/R blade for an edge void, any corrosion, or a crack.
