[Docket No. FAA-2007-28813; Directorate Identifier 2007-SW-09-AD; Amendment 39-15140; AD 2007-16-01]

Airworthiness Directives; Enstrom Helicopter Corporation Model F-28, F-28A, F-28C, F-28C-2, F-28C-2R, F-28F, F-28F-R, 280, 280C, 280F, 280FX, TH-28, 480, and 480B Helicopters

ACTION: Final rule; request for comments.

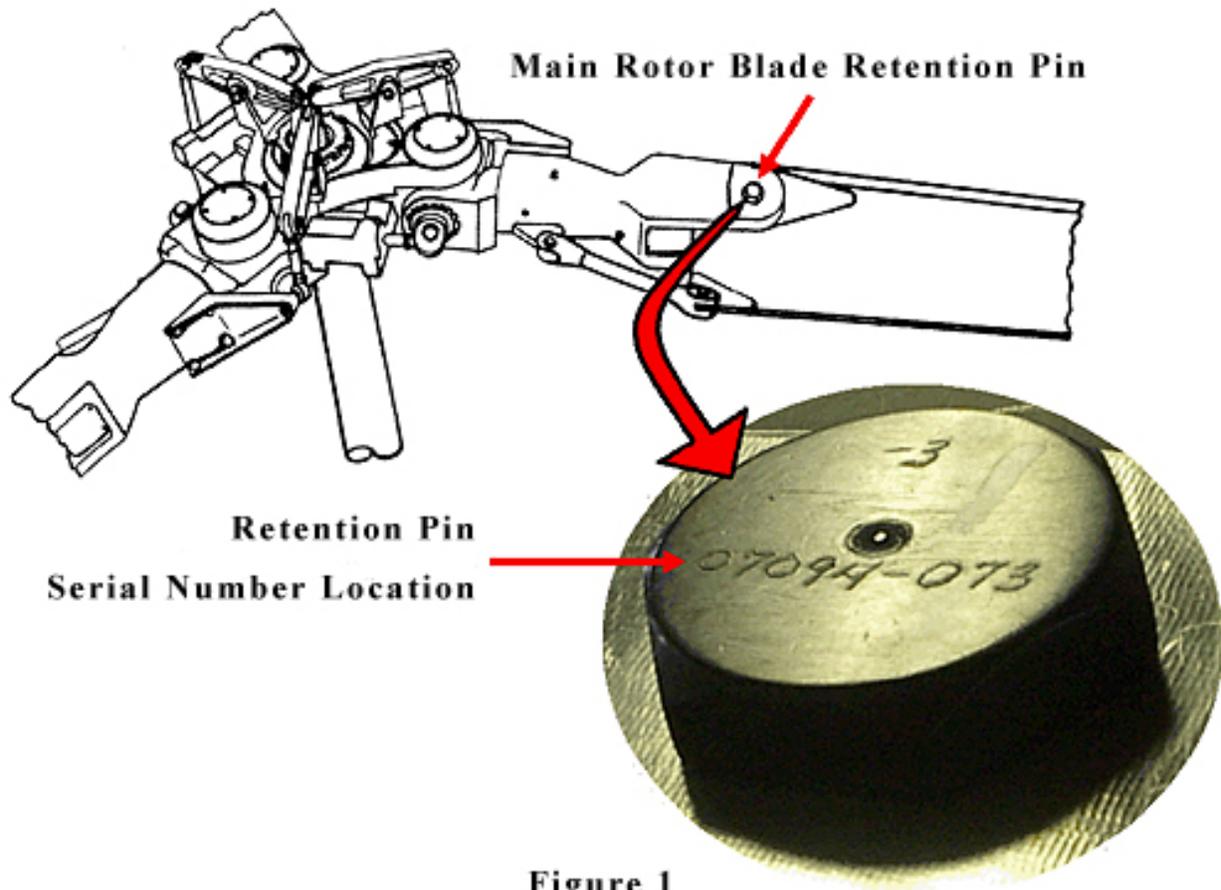
This amendment is prompted by a report from the manufacturer that some retention pins were manufactured from steel that did not meet the specifications cited on the engineering drawing. The actions specified in this AD are intended to prevent failure of a retention pin, separation of a main rotor blade from the helicopter, and subsequent loss of control of the helicopter.

(a) Before further flight, check the S/N that is marked on the head of each retention pin to see if it is a S/N that is listed in the Applicability section of this AD. See Figure 1 for the location of the S/N. If there is no serial number marked on the head of the retention pin (i.e., the retention pin head is blank), the retention pin does not need to be replaced and this determination constitutes a terminating action for the requirements of this AD for that retention pin.

(1) For a retention pin with 545 or more hours TIS, remove the retention pin and replace it with an airworthy retention pin with a S/N that is not listed in the Applicability section of this AD within the next 5 hours TIS or within 30 days, whichever occurs first.

(2) For a retention pin with less than 545 hours TIS, remove the retention pin and replace it with an airworthy retention pin with a S/N that is not listed in the Applicability section of this AD on or before reaching 550 hours TIS or within 30 days, whichever occurs first.
