[Docket No. FAA-2013-0574; Directorate Identifier 2008-SW-22-AD; Amendment 39-17766; AD 2014-04-07]

Airworthiness Directives; Bell Helicopter Textron Canada (Bell) Helicopters

ACTION: Final rule.

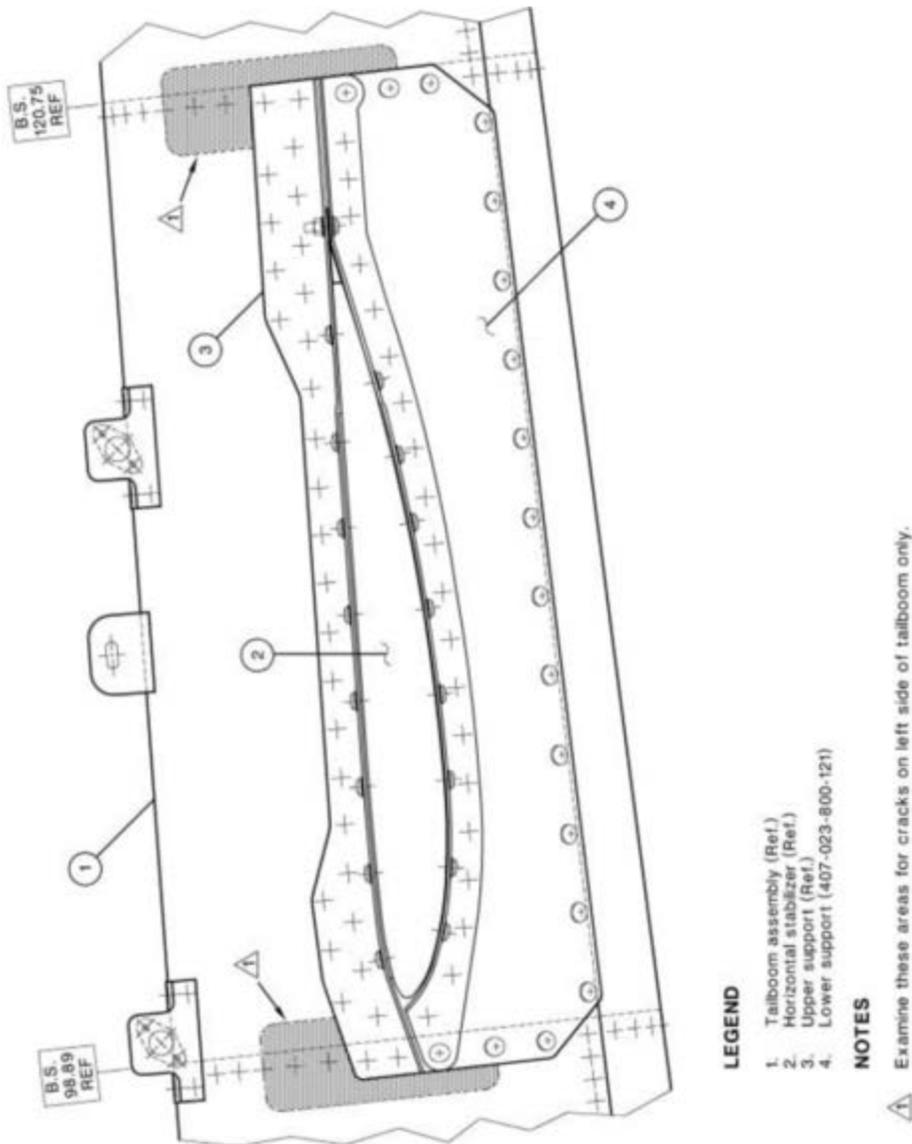
This AD defines the unsafe condition as cracks in the tailboom skin on the left side in the area of horizontal stabilizer, which could result in separation of the tailboom and subsequent loss of control of the helicopter.

(A) Before the first flight of each day, visually check the tailboom for a crack, as depicted in Figure 1 to Paragraph (f)(1)(i)(A) of this AD.

(3) If there is a crack, before further flight, replace the tailboom.
