[Docket No. 2001-SW-54-AD; Amendment 39-12770; AD 2002-11-09]

Airworthiness Directives; Bell Helicopter Textron Canada Model 407 Helicopters

2002-11-09 Bell Helicopter Textron Canada: Amendment 39-12770. Docket No. 2001-SW-54-AD.

Applicability: Model 407 helicopters, serial number 53000 through 53442, with flywheel, part number (P/N) 407-040-316-101, installed, certificated in any category.

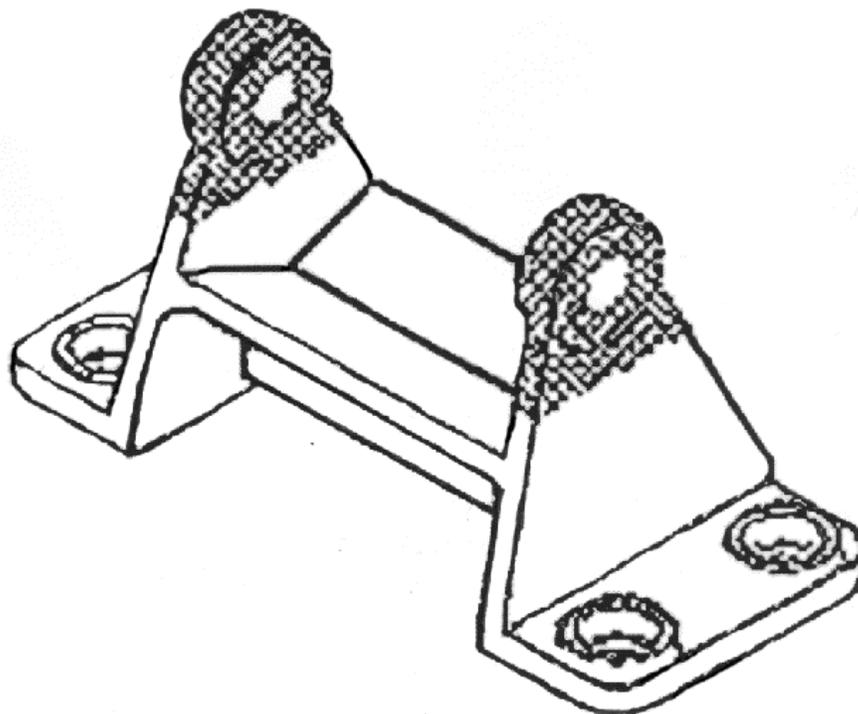
To detect a crack in the forward bearing hanger bracket (bracket) and to prevent loss of tail rotor drive or tail rotor control and subsequent loss of control of the helicopter, accomplish the following:

Bracket P/N 407-040-321-101/-103

(a) Within 25 hours time-in-service (TIS) and thereafter at intervals not to exceed 25 hours TIS, visually inspect each bracket, P/N 407-040-321-101 or -103, for a crack in the shaded area shown in Figure 1 of this AD. Remove any cracked bracket from service.
