**FEDERAL AVIATION ADMINISTRATION  
AIRWORTHINESS DIRECTIVES**

**SMALL AIRPLANES, ROTORCRAFT, GLIDERS,  
BALLOONS, & AIRSHIPS**

**BIWEEKLY 2012-22**

*10/22/2012 - 11/4/2012*

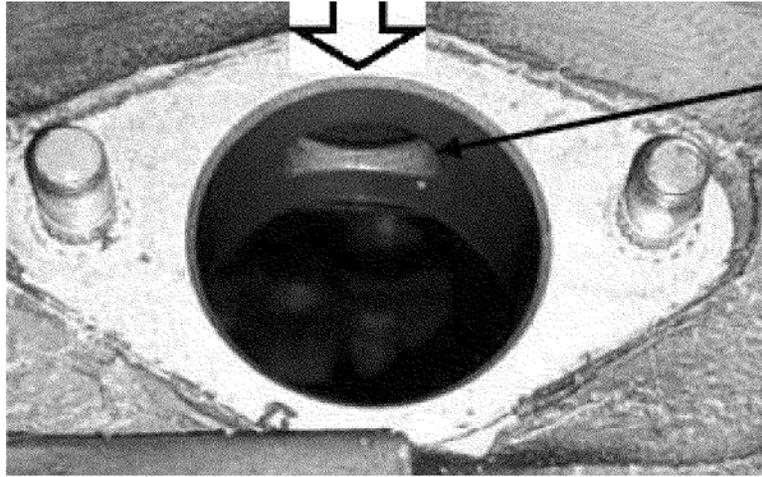
Figure 1 to paragraph (e)(1)(ii)

This AD defines the unsafe condition as a missing through-hole, joining the integrated collector to the magnetic plug. This condition could result in failure of the chip-detector system to detect deterioration of the main rotor mast lift bearing, failure of the lift bearing, and subsequent loss of control of the helicopter.

(ii) Determine if the hole above the magnetic plug is a through-hole as shown in figures 1 and 2 to paragraph (e)(1)(ii) of this AD.

(2) If the hole above the magnetic plug is not a through-hole, before further flight, replace the epicyclic module with an airworthy epicyclic module.

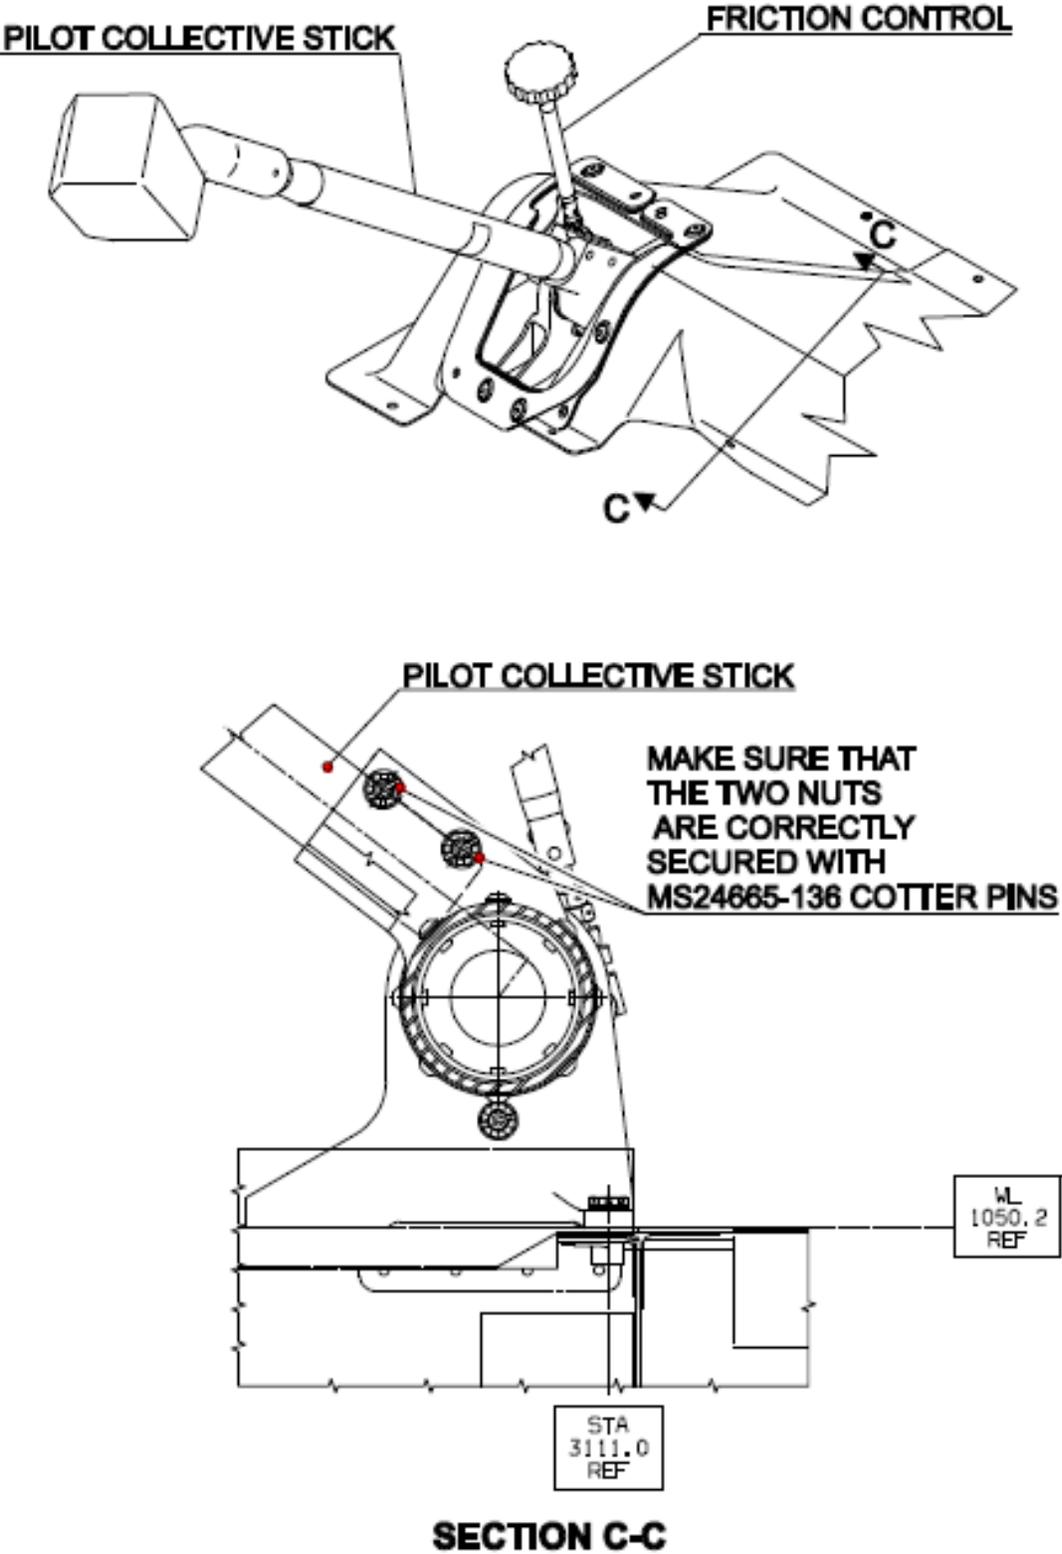
(1) Inspect the pilot collective stick installation to determine whether the self-locking nuts, part-number (P/N) MS17825-4, are secured with cotter pins, P/N MS24665-136, as depicted in

Figure 1 to paragraph (e)(1) of this EAD. If the self-locking nuts are not secured with cotter pins, before further flight, reinstall the pilot collective stick.

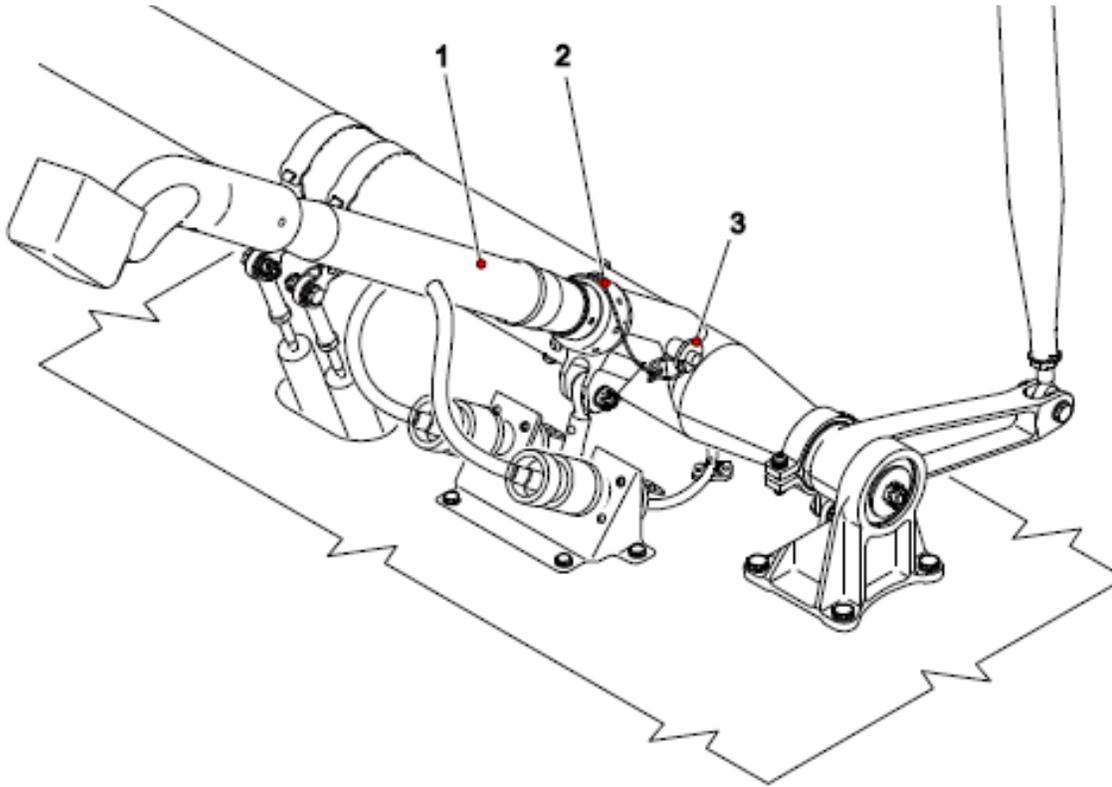
(2) Inspect the co-pilot collective stick installation to determine whether the ring nut (item 2) is loose and the quick-release pin (item 3) is installed as depicted in Figure 2 to paragraph (e)(2) of this EAD. If the ring nut is loose or the quick-release pin is not installed, before further flight, reinstall the co-pilot collective stick.

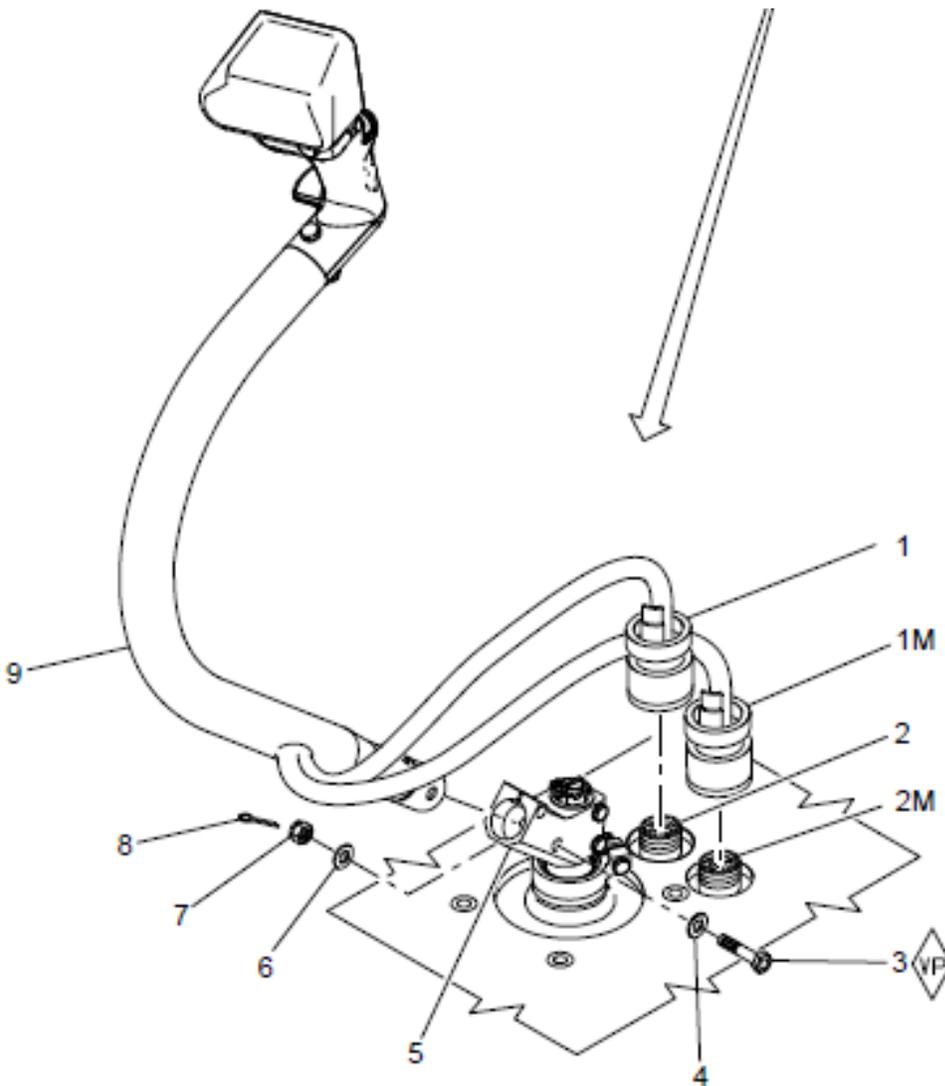
(3) Inspect the pilot cyclic stick installation for proper installation of the bolt (item 3), washer (item 4), self-locking nut (item 7), washer (item 6), and the cotter pin (item 8), as depicted in Figure 3 to paragraph (e)(3) of this EAD. If the pilot cyclic stick is not installed as depicted, before further flight, reinstall the pilot cyclic stick.

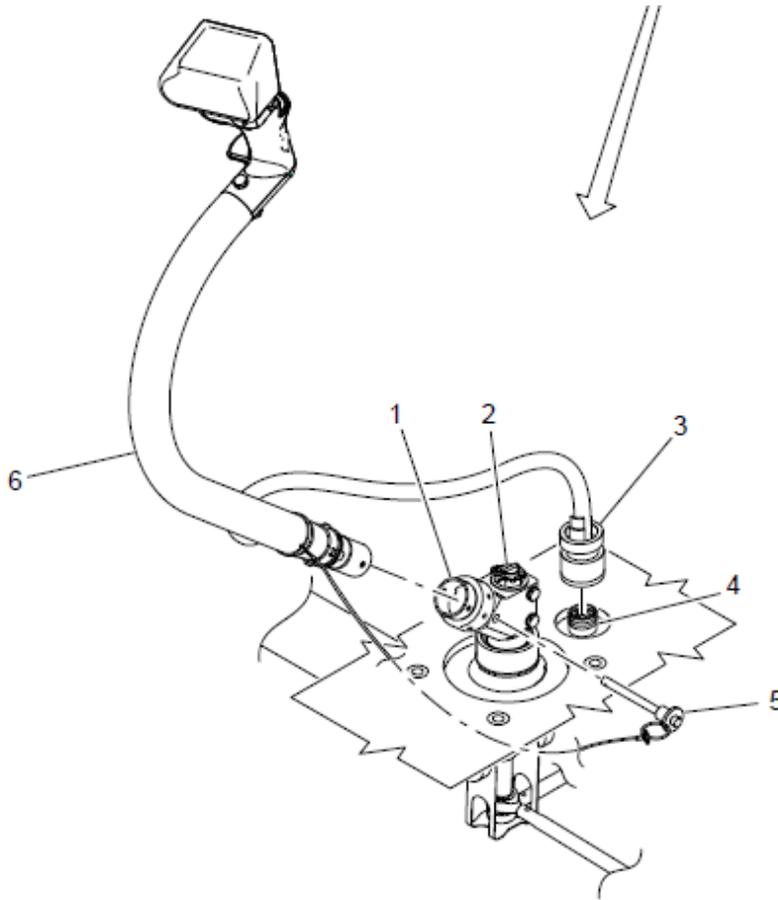
(4) Inspect the co-pilot cyclic stick installation to determine whether the ring nut (item 1) is loose and the quick-release pin (item 5) is installed as depicted in Figure 4 to paragraph (e)(4) of this EAD. If the ring nut is loose or the quick-release pin is not installed as depicted, before further flight, reinstall the co-pilot cyclic stick.
