[Docket No. 2003-SW-17-AD; Amendment 39-13215; AD 2003-08-51]

Airworthiness Directives; MD Helicopters, Inc. Model 369A, D, E, H, HE, HM, HS, F, and FF Helicopters; Correction

Airworthiness Directives; MD Helicopters, Inc. Model 369A, D, E, H, HE, HM, HS, F, and FF Helicopters

2003-08-51 MD Helicopters, Inc.: Amendment 39-13215. Docket No. 2003-SW-17-AD.

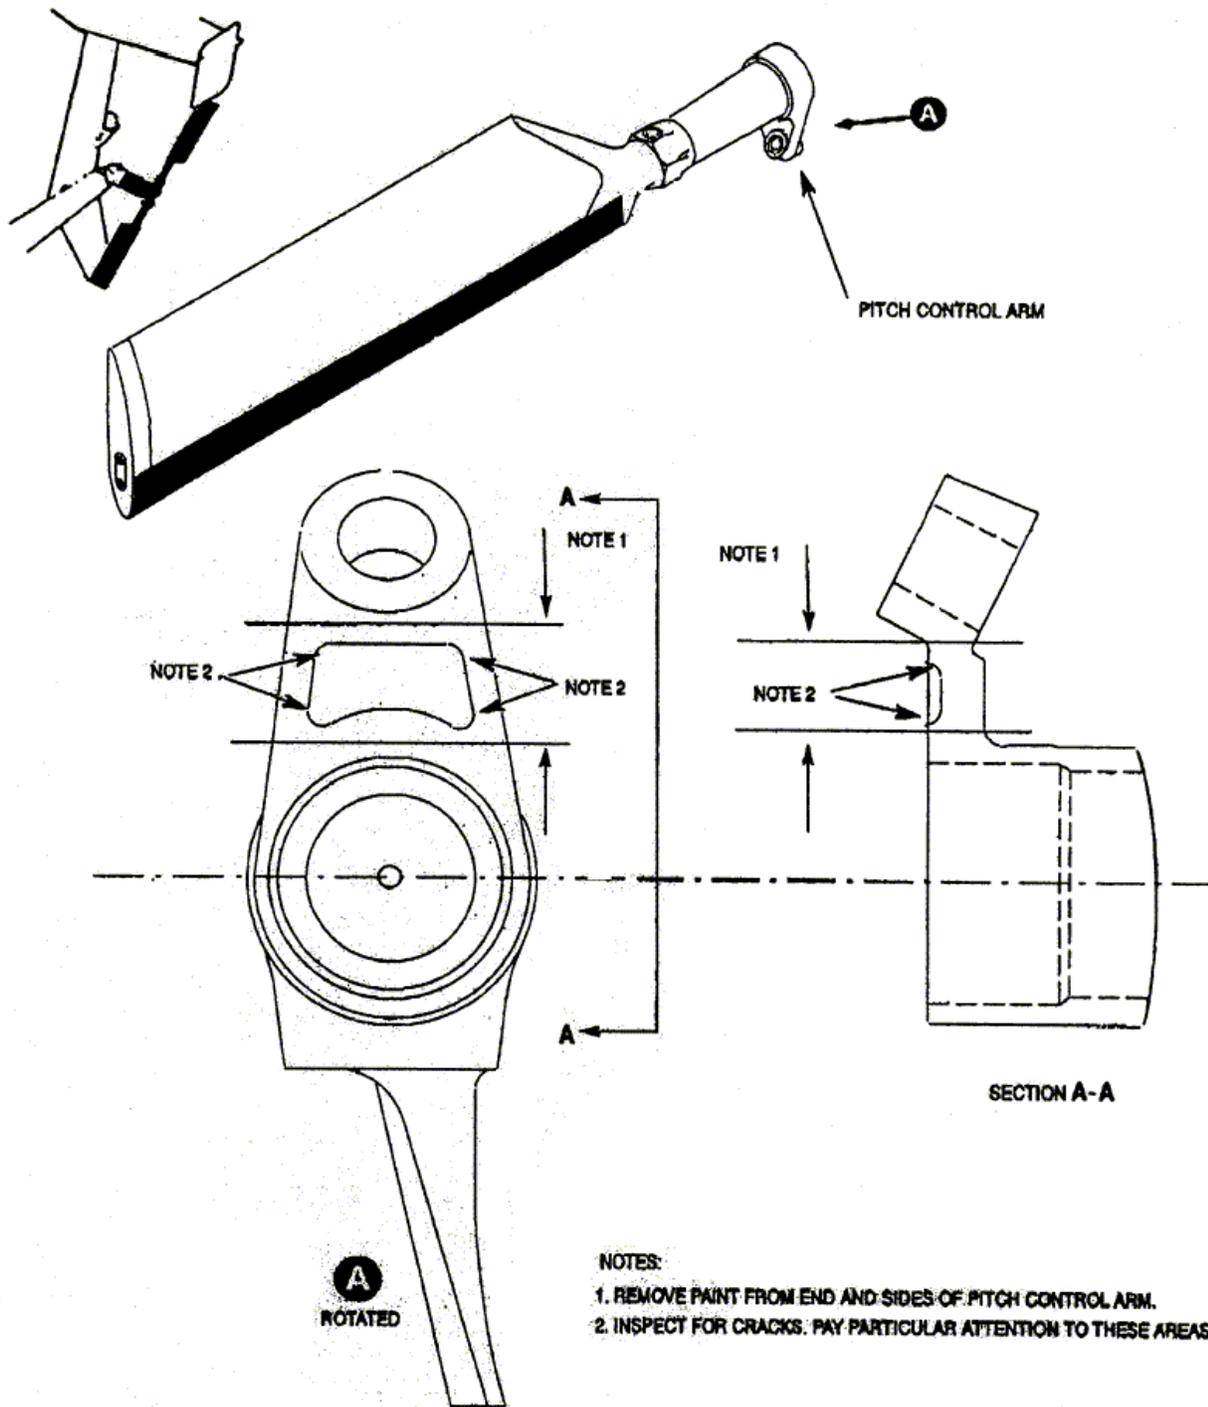
Figure 1. Tail Rotor Blade Assembly Inspection

To prevent a tail rotor blade pitch horn (pitch horn) from separating from the tail rotor blade, leading to an unbalanced condition, vibration, loss of tail rotor pitch control, and loss of directional control of the helicopter, accomplish the following:

(b) Before further flight, perform a one-time visual inspection of each pitch horn for a crack or corrosion in the area indicated by Note 2 in Figure 1 of this AD. Paint removal in accordance with Note 1 of Figure 1 of this AD is not required for the visual inspection.

(a) This airworthiness directive (AD) establishes a new retirement life of 400 hours time-in-service (TIS) for the tail rotor blades listed in the Applicability section. For helicopters with an affected tail rotor blade installed that has 390 through 700 hours TIS, remove and replace the tail rotor blade with an airworthy tail rotor blade within 10 hours TIS.

(d) For helicopters with a tail rotor blade installed that has more than 700 hours TIS, a one-time special flight permit to fly it to a repair facility may be issued only upon completion of an eddy current surface scan of each affected pitch horn (see Figure 1 of this AD). Paint removal in accordance with Note 1 of the Figure 1 of this AD IS required for the surface scan. If a crack is found, remove the tail rotor blade and replace it with an airworthy tail rotor blade before further flight.
