**FEDERAL AVIATION ADMINISTRATION
AIRWORTHINESS DIRECTIVES
LARGE AIRCRAFT**

BIWEEKLY 2010-02

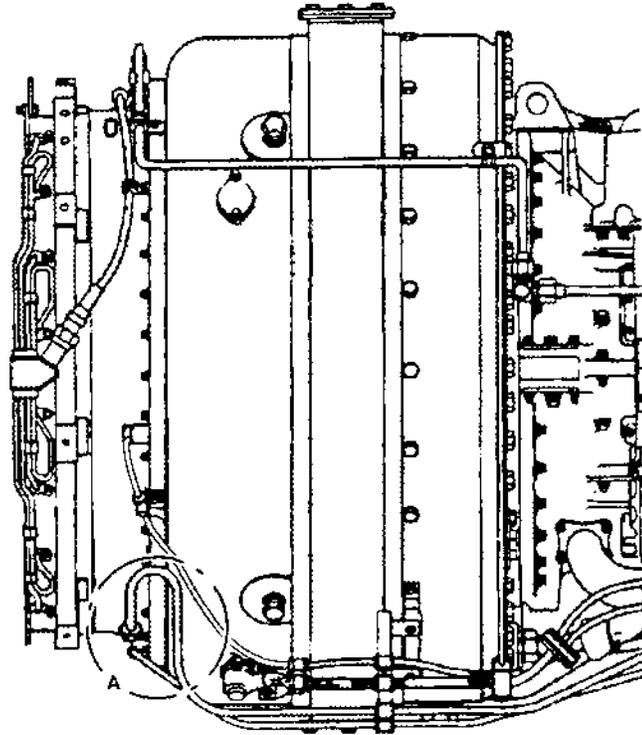
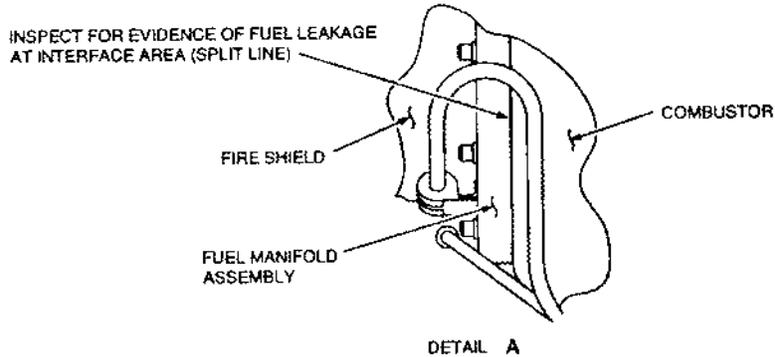
(2) With the engine operating, look for fuel leaking from the fuel manifold assembly to the fire shield interface area (see Figure 1 of this AD). No leaks allowed.

(5) Look for fuel leaking from the fuel manifold assembly to the fire shield interface area (see Figure 1 of this AD). No leaks allowed.

(3) If you find any leaks, shutdown the engine and replace the fuel manifold assembly with an FAA-approved serviceable assembly.

(6) If you find any leaks, replace the fuel manifold assembly with an FAA-approved serviceable assembly.
