EMERGENCY AIRWORTHINESS DIRECTIVE

AD #: 2007-26-51

2007-26-51 EUROCOPTER DEUTSCHLAND GMBH: Directorate Identifier
2007-SW-76-AD.

Applicability: Model EC135 helicopters, serial number (S/N) 0005 up to and including S/N 0444, except S/N 0028, and with tail rotor control rod (control rod), part number L672M2005207, installed, certificated in any category.

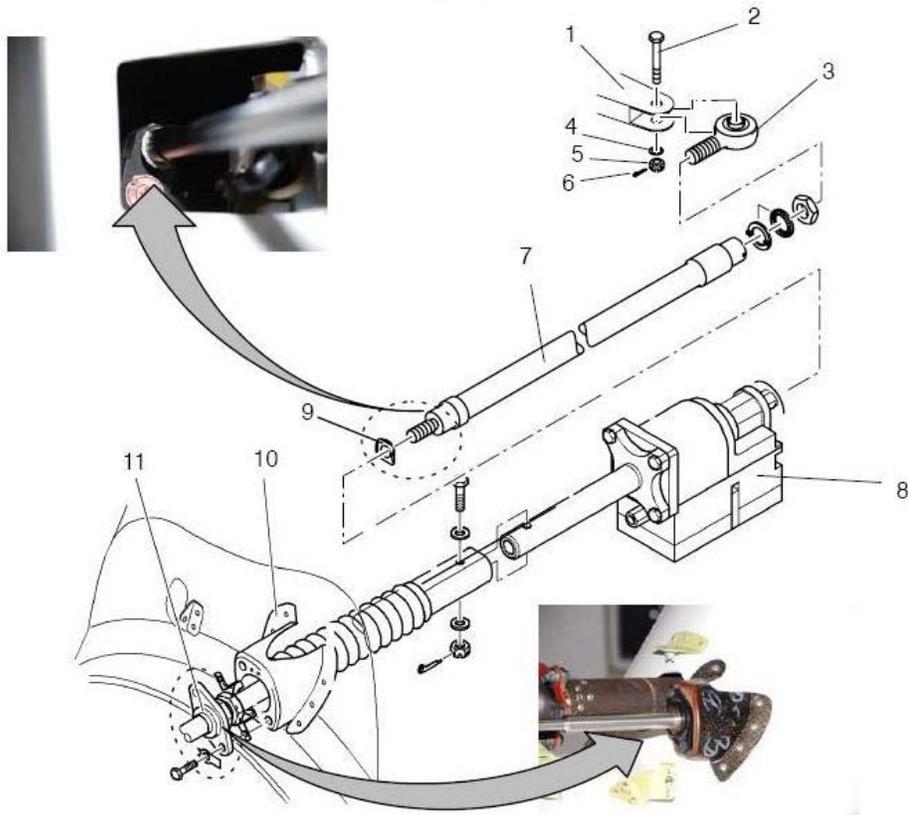
Ball Pivot and Control Rod
Figure 1

This Emergency Airworthiness Directive (EAD) is prompted by a report of a fatal accident involving the failure of a tail rotor control rod (control rod). This condition, if not corrected, could result in the failure of a control rod and subsequent loss of control of the helicopter.

(a) Within 5 hours time-in-service (TIS), inspect the control rod, shown in item 7, Figure 1, of this AD, with the parts identified in parenthesis as follows:

(1) Pull the control rod (7) until it reaches its stop position. Inspect attachment hardware of control rod (7) for a tight fit. Manually inspect for possible relative motion between control rod (7) and yaw actuator (8).

(2) Inspect the locking plate (9) for a tight fit.

(3) Visually inspect the attachment hardware between control rod (7) and yaw actuator (8) for play or thread exposure. If play or thread exposure is found, before further flight, replace the control rod with an airworthy control rod.

(b) Inspect the ball pivot as shown in item 11, Figure 1, of this AD by removing the tail rotor drive shaft fairing and inspecting for a loose bearing or play. If a loose bearing or play is found, before further flight, replace the ball pivot with an airworthy ball pivot.
