[Docket No. 2002-NM-128-AD; Amendment 39-13269; AD 2003-16-16]

Airworthiness Directives; Boeing Model 747-400 Series Airplanes Equipped With General Electric Model CF6-80C2 Series Engines

2003-16-16 Boeing: Amendment 39-13269. Docket 2002-NM-128-AD. Supersedes AD 2000-09-03, Amendment 39-11711.

Applicability: Model 747-400 series airplanes equipped with General Electric (GE) Model CF6-80C2 series engines, certificated in any category.

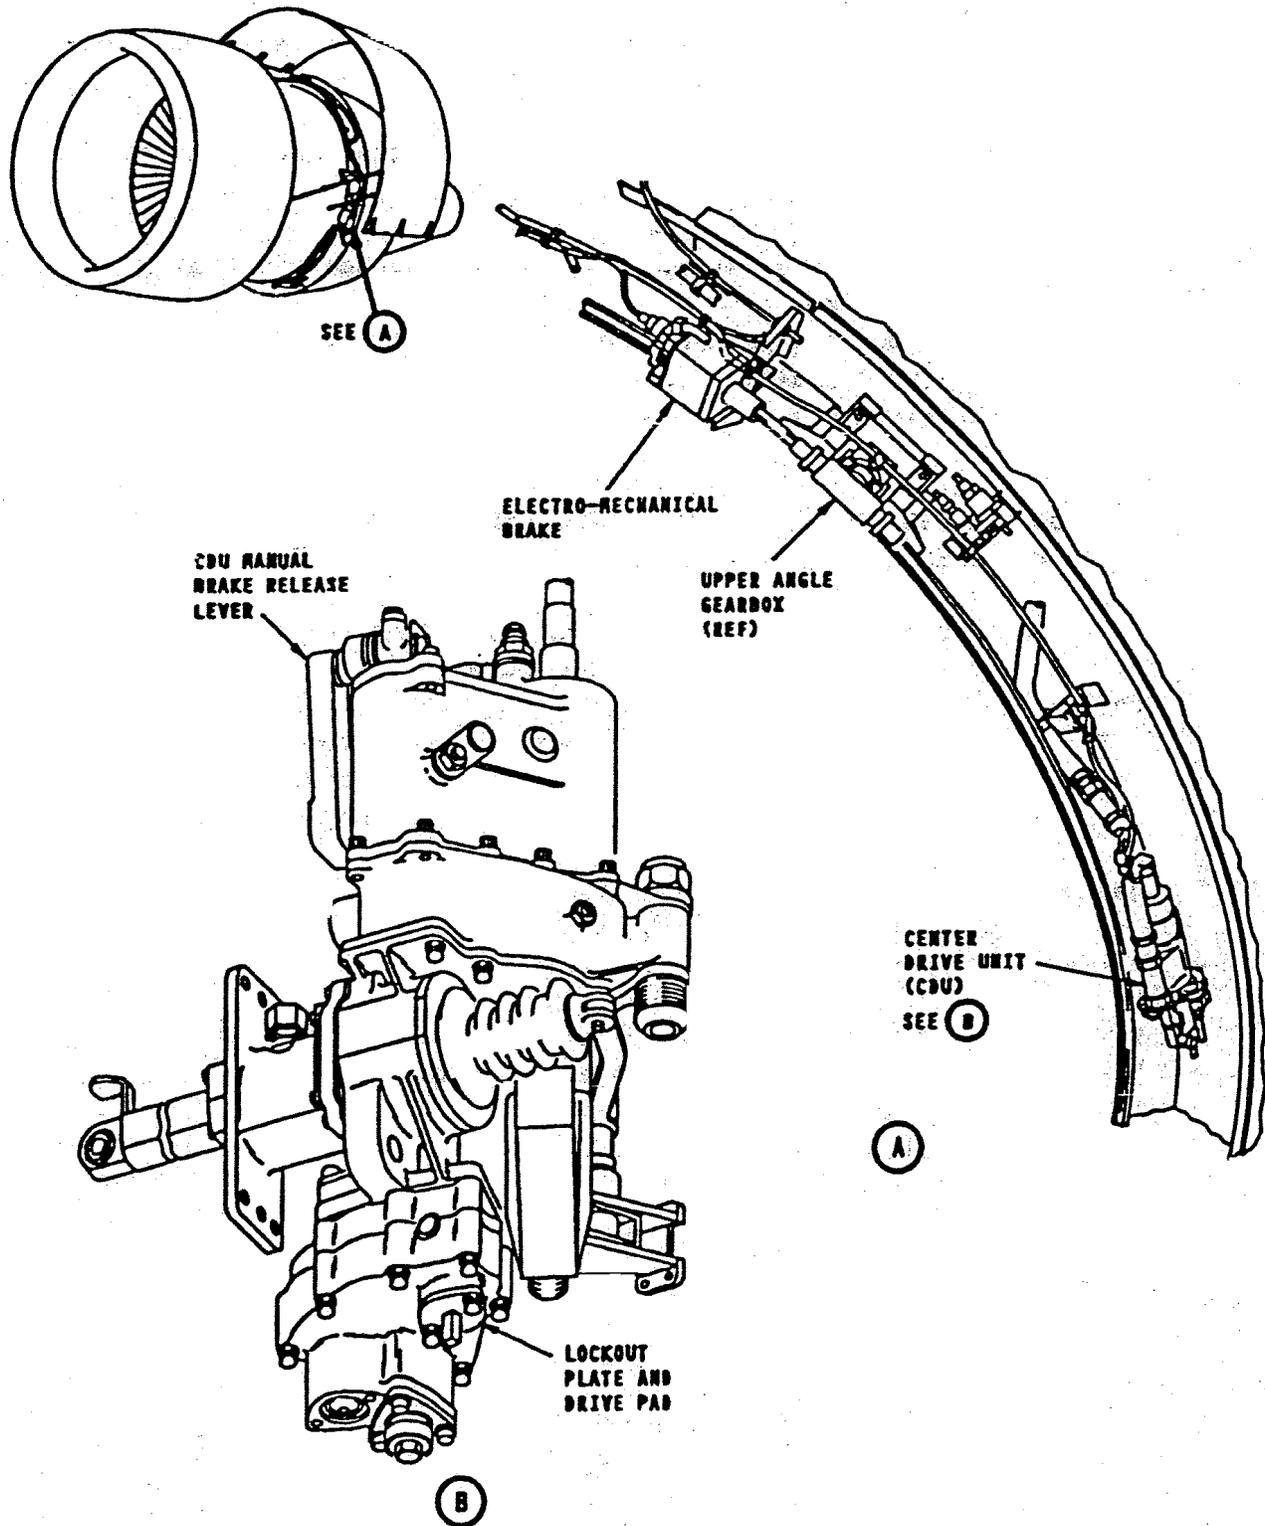
**Electro-Mechanical Brake and CDU Cone Brake Torque Check
Figure 1**

1. This procedure contains steps to do a check of the holding torque of the CDU cone brake.
2. CDU cone brake check (Figure 1):

Caution: Do not use more than 100 pound-inches of torque when you do this check. Excessive torque will damage the CDU.

Note: The cone brake prevents movement in the extend direction only. If you try to measure the holding torque in the retract direction, you will get a false reading.

- (8) If the torque is less than 15 pound-inches, you must replace the CDU.
- (9) Reinstall the lockout plate.
