[Docket No. FAA-2012-0716; Directorate Identifier 2012-SW-011-AD; Amendment 39-17121; AD 2012-14-07]

Airworthiness Directives; Bell Helicopter Textron Canada Helicopters

2012-14-07 Bell Helicopter Textron Canada Helicopters: Amendment 39-17121; Docket No. FAA-2012-0716; Directorate Identifier 2012-SW-011-AD.

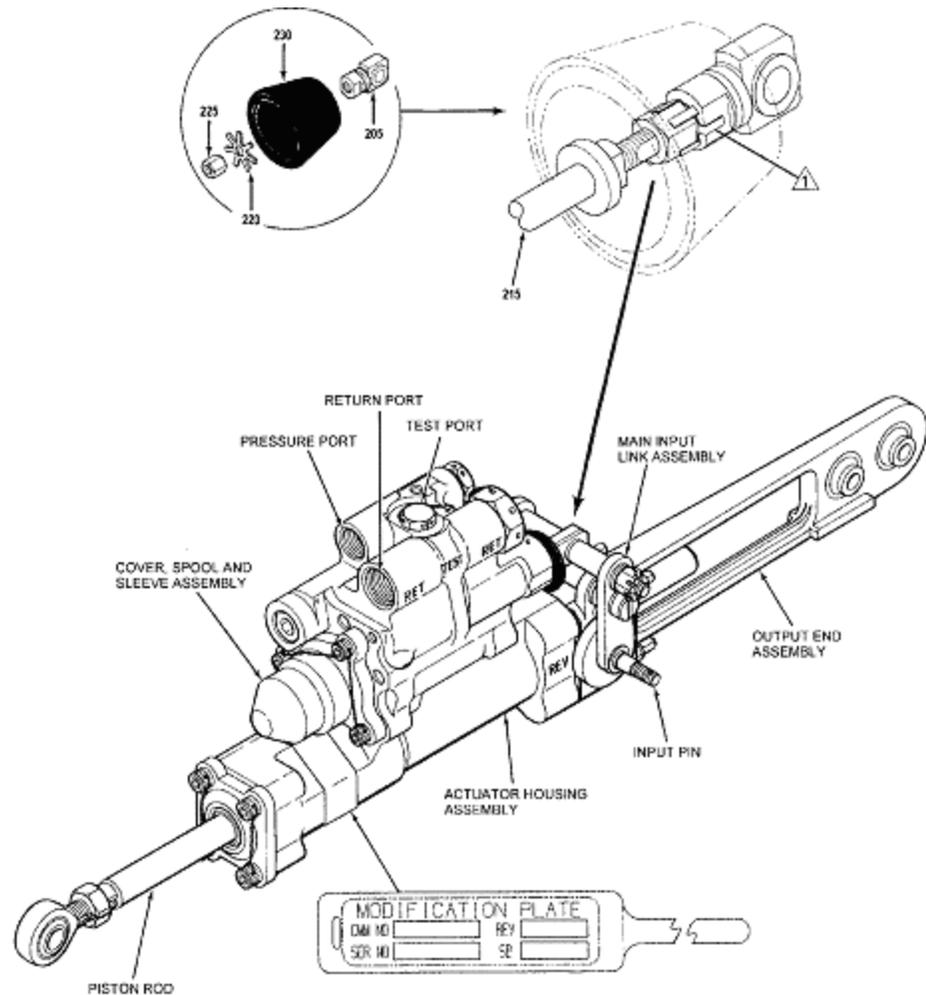
This AD defines the unsafe condition as a loose or misaligned part in the servo that could lead to failure of the servo and subsequent loss of helicopter control.

ACCEPTABLE CONDITION
 A MINIMUM OF ONE TAB SHALL BE IN LINE AND BENT FLUSH WITH THE NUT FLAT SURFACE AND A MINIMUM OF ONE TAB SHALL BE IN LINE AND BENT FLUSH WITH THE CLEVIS ASSEMBLY FLAT SURFACE

(iii) If the shaft does not turn independently, inspect to determine if at least one tab of the lock washer is bent flush against a flat surface of the nut and if at least one tab of the lock washer is bent flush against a flat surface of the clevis assembly.

(i) Retract the boot depicted as 230 in Figure 1 to Paragraph (f) of this AD.

(ii) Applying only hand pressure, determine whether the nut, the shaft, or the clevis assembly, depicted as items 225, 215 and 205, respectively, in Figure 1 to Paragraph (f) of this AD, turn independently. If the shaft turns independently of the nut or clevis assembly, before further flight, replace the servo with an airworthy servo.

(iv) If at least one lock washer tab is not aligned and bent flush with a nut flat surface and at least one lock washer tab is not aligned and bent flush with a flat surface of the clevis assembly, before further flight, replace the servo with an airworthy servo.

(v) If any tab of the lock washer is not bent flush against either a flat surface of the nut or clevis assembly, bend the tab flush against a flat surface.

(2) After accomplishing paragraphs (f)(1)(i) through (f)(1)(v), vibro-etch the letter "V" at the end of the part number on the data plate.
