[Docket No. FAA-2014-0034; Directorate Identifier 2013-SW-006-AD; Amendment 39-17948; AD 2014-16-24]

Airworthiness Directives; Airbus Helicopters Deutschland GmbH (Previously Eurocopter Deutschland GbmH) (Airbus Helicopters) Helicopters

ACTION: Final rule.

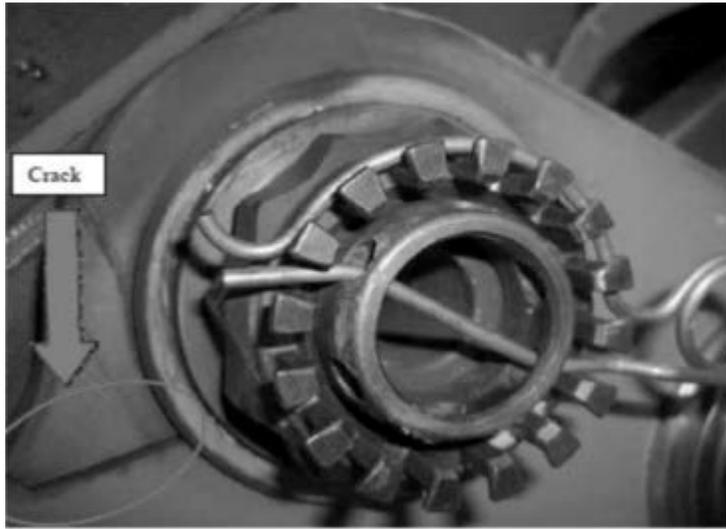
Figure 1 to Paragraph (f)(1)

This AD defines the unsafe condition as a crack in the MRH shaft flange, which could result in failure of the MRH and subsequent loss of control of the helicopter.

(1) Before further flight, and thereafter at intervals not to exceed 6 hours time-in-service (TIS), check the MRH shaft lower flange and the visible area of the MRH shaft upper flange for a crack. Figures 1 and 2 to Paragraph (f)(1) of this AD are examples of cracks that have been discovered in the MRH shaft lower flange. The actions required by this paragraph may be performed by the owner/operator (pilot) holding at least a private pilot certificate, and must be entered into the aircraft records showing compliance with this AD in accordance with 14 CFR 43.9 (a)(1) through (4) and 14 CFR 91.417(a)(2)(v). The record must be maintained as required by 14 CFR 91.417, 121.380, or 135.439.

(3) If there is a crack in the upper or lower MRH shaft flange, before further flight, replace that MRH shaft with an airworthy MRH shaft. Replacing the MRH shaft with an MRH shaft having a P/N listed in paragraph (a) of this AD does not constitute terminating action for the requirements of this AD.
